# Analytical Approach to Determining Minor, Moderate, and Major Flood Stages

William B. Reed, Senior Hydrologist, 1  
Colorado Basin River Forecast Center

# Hydrologic Response of Post-Burn Watersheds in Southeast Arizona

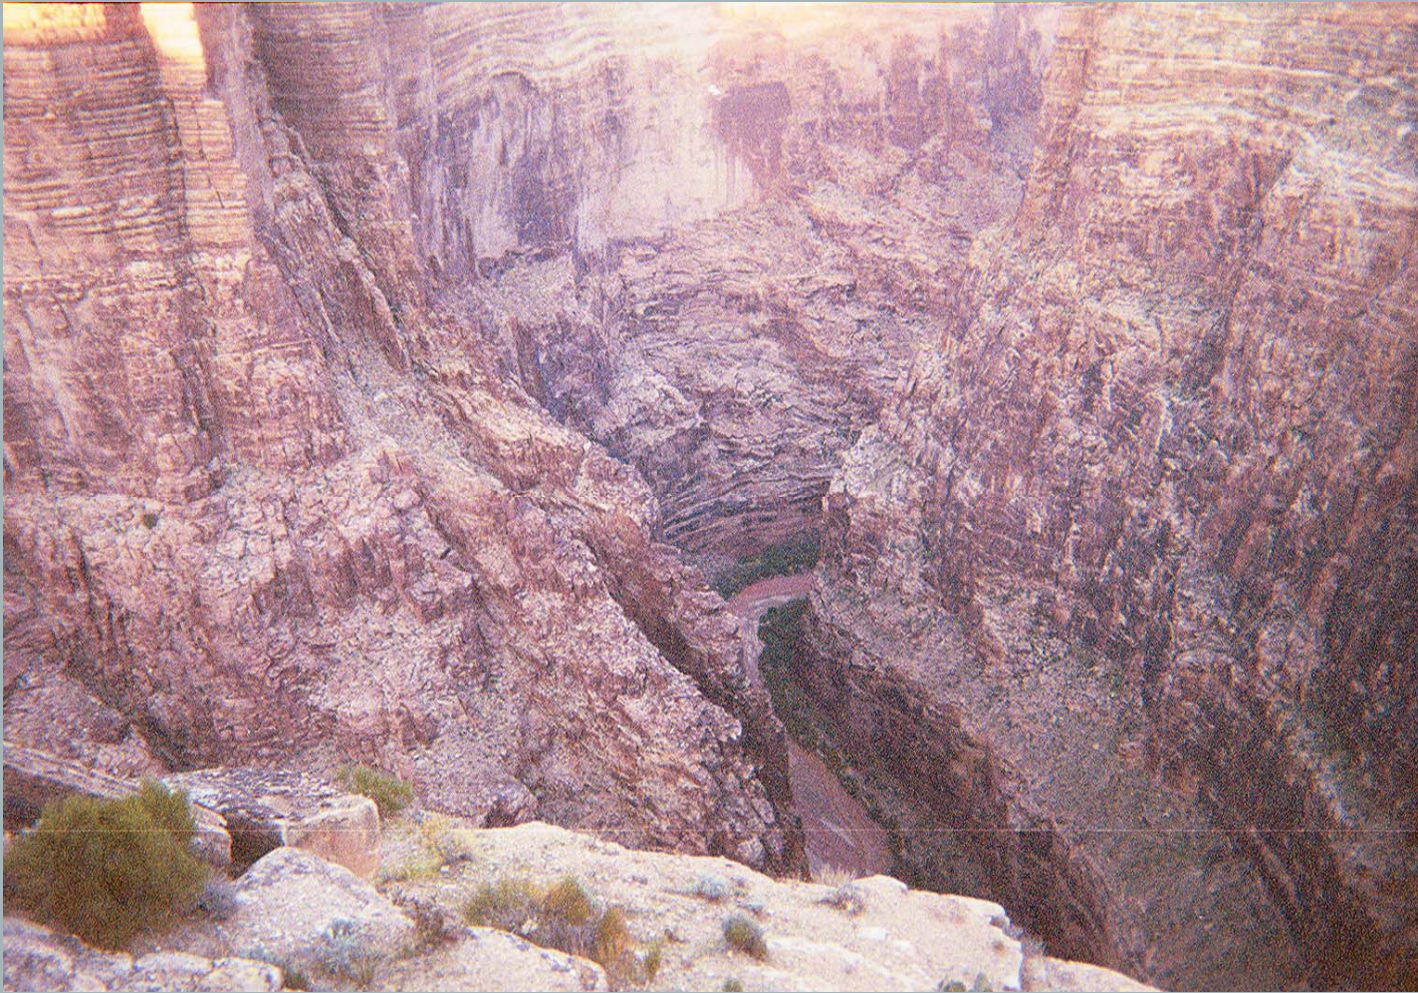
**In some cases, bank full may be meaningless but bank-to-bank one to two feet deep could be critical.**

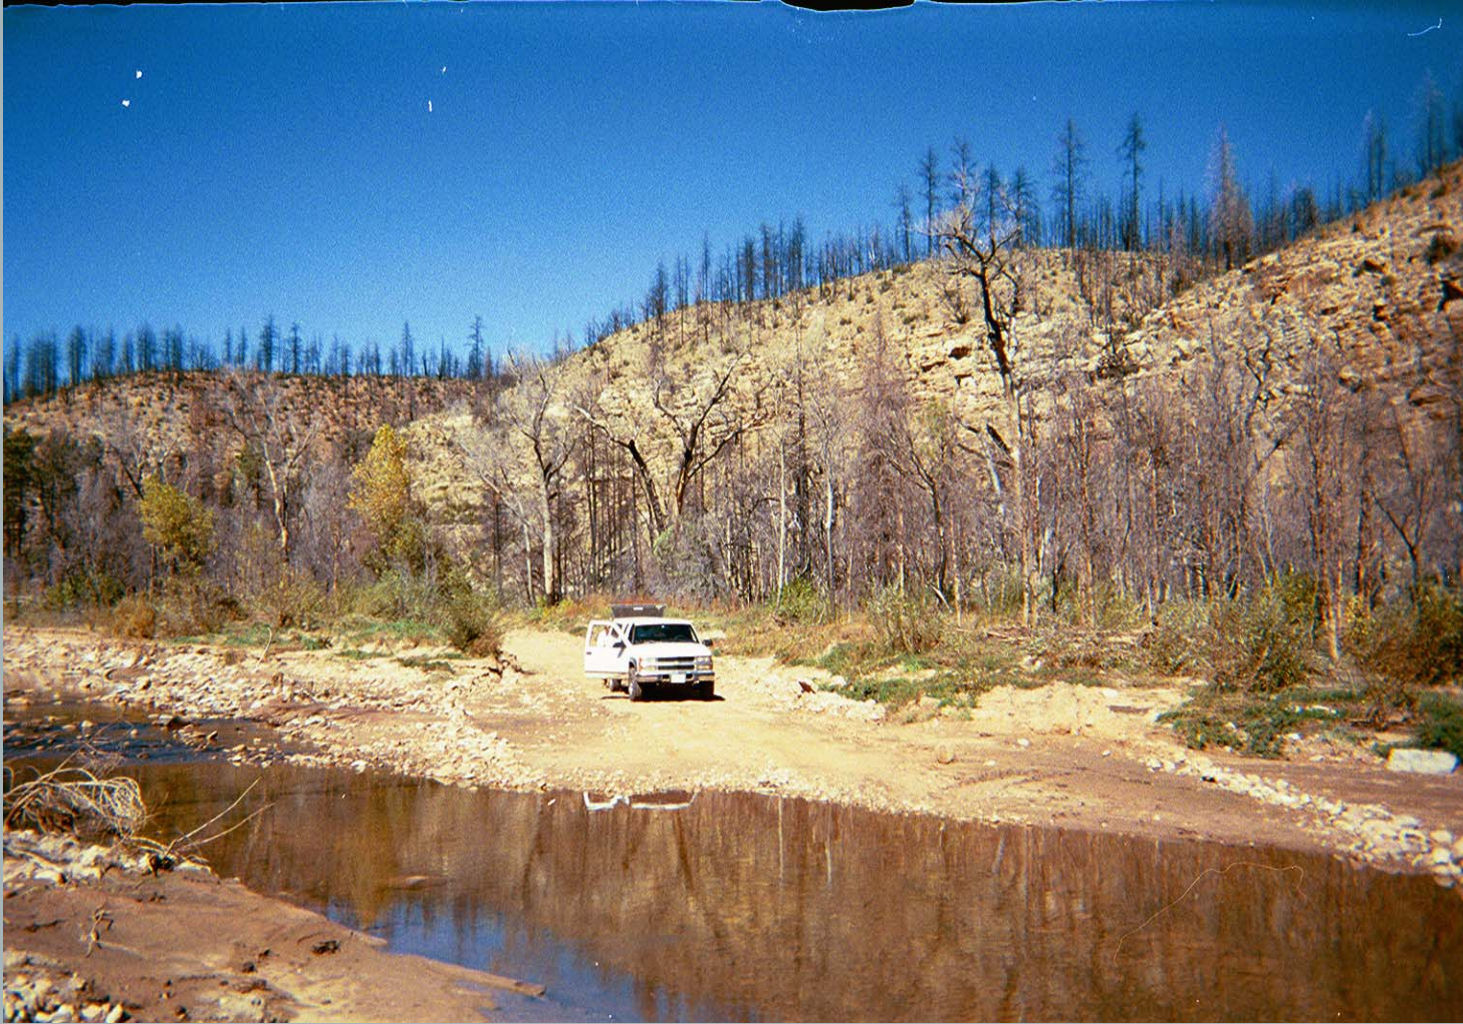
**Burned Areas also need to be watched. Extremes more likely to occur during recovery period.**

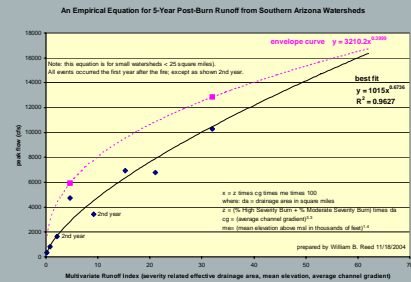
## An Empirical Formula to Estimate 5-year Peak Discharge from Small Watersheds in Southeast Arizona

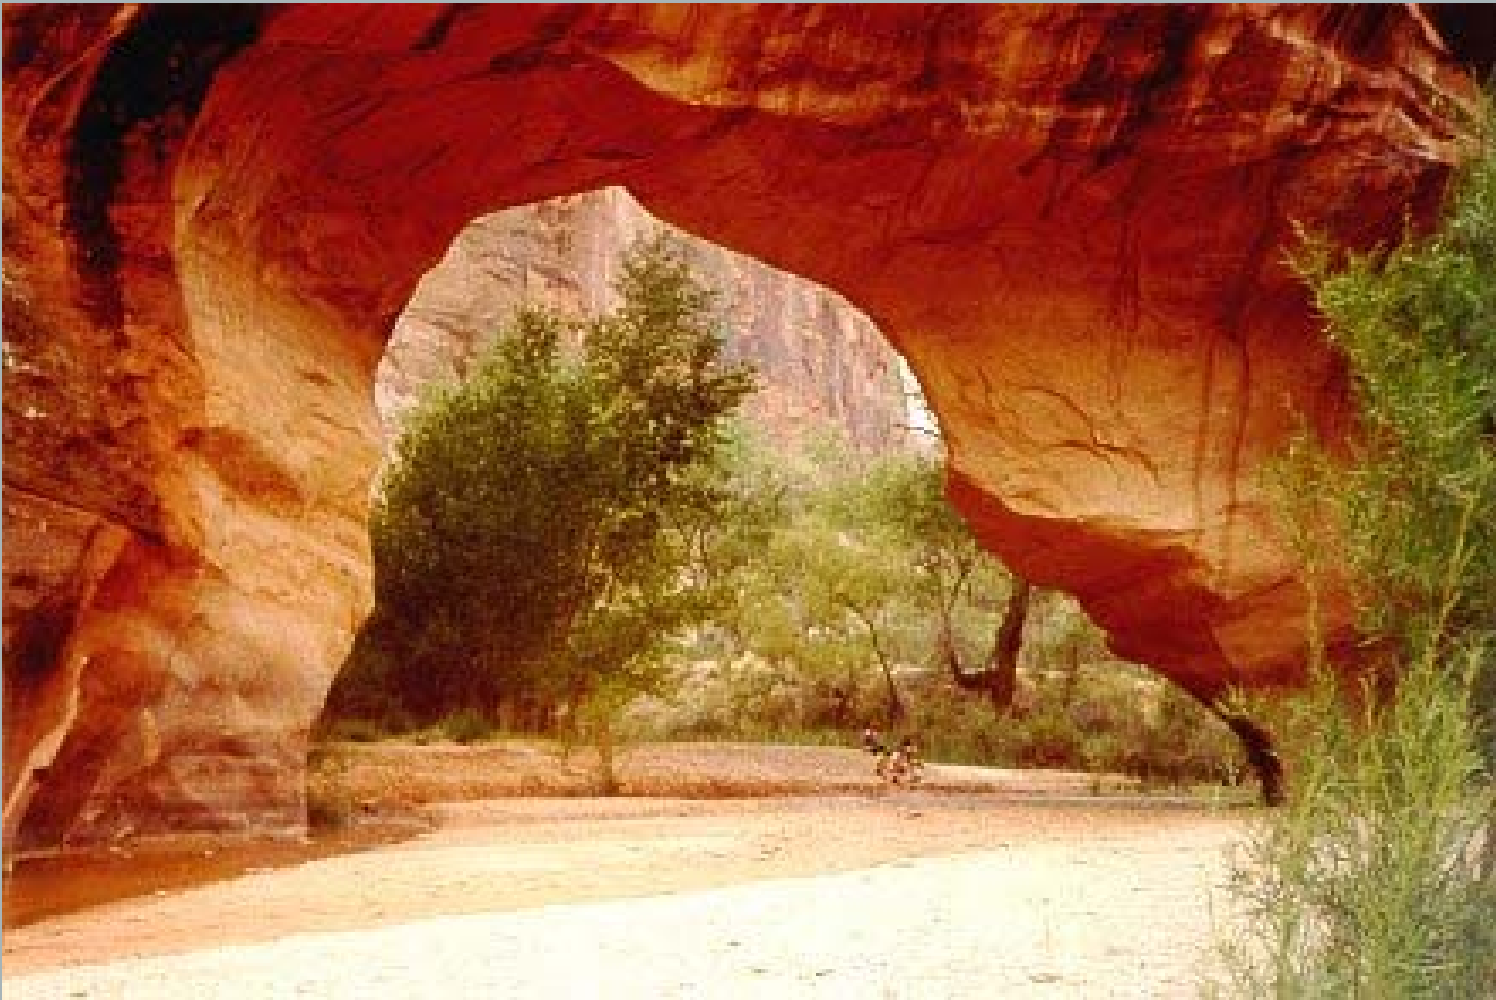
Coyote Natural Bridge, 2002 9

**Floods occur in the wilderness, be it a slot canyon or under a natural bridge, these areas present unique flood hazard situations.**

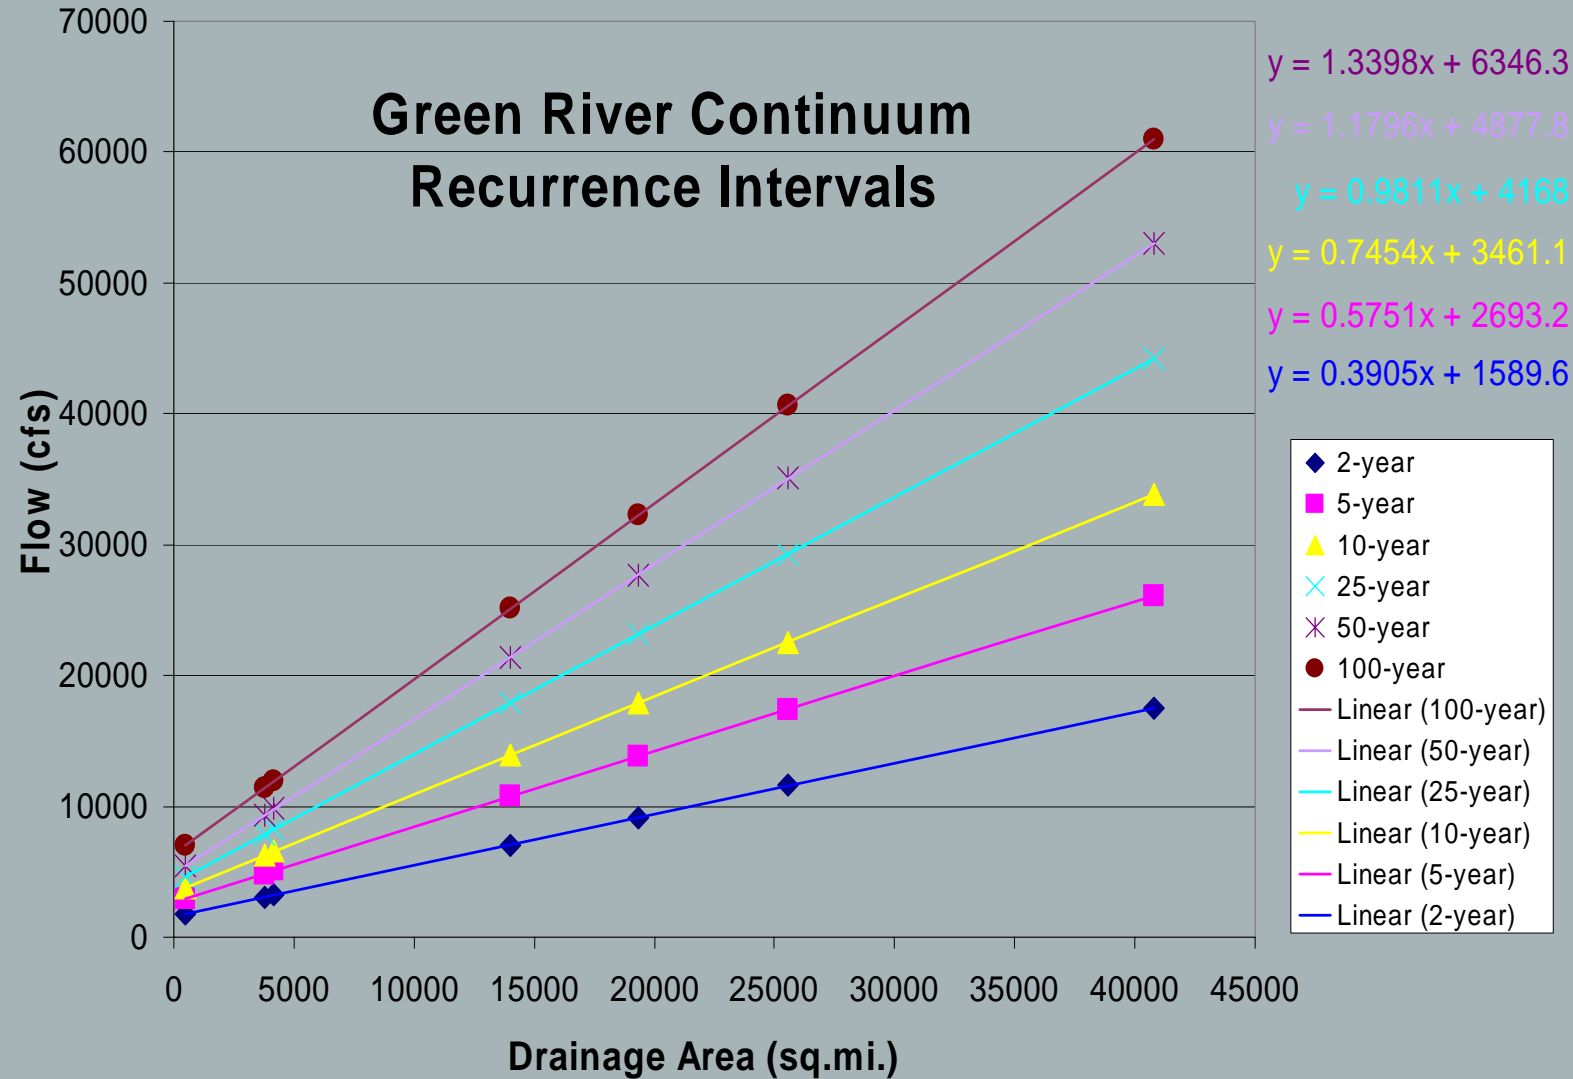
## Green River Continuum Recurrence Intervals

# 6. Check River Continuum (flow)
