Trip Report for Travel to Lower Green River Basin November 12, 2009

Itinerary: On November 12th Bill Reed, CBRFC, and Tim Bardsley, Utah NRCS, travelled by POV from Salt Lake City (SLC) to Lower Green River Basin and returned the same day. They left SLC at 5:30 am, arrived at Huntington Power Plant at 8:00 am for a meeting regarding data availability with Cody Allred, a PacifiCorp employee, and then accompanied by Cody visited sites on Power Plant property including a water supply forecast point. Tim and Bill subsequently visited other sites in the Lower Green Basin on their own, including other water supply forecast points, and returned to SLC arriving at 7:00 pm. Total mileage: 467 miles.

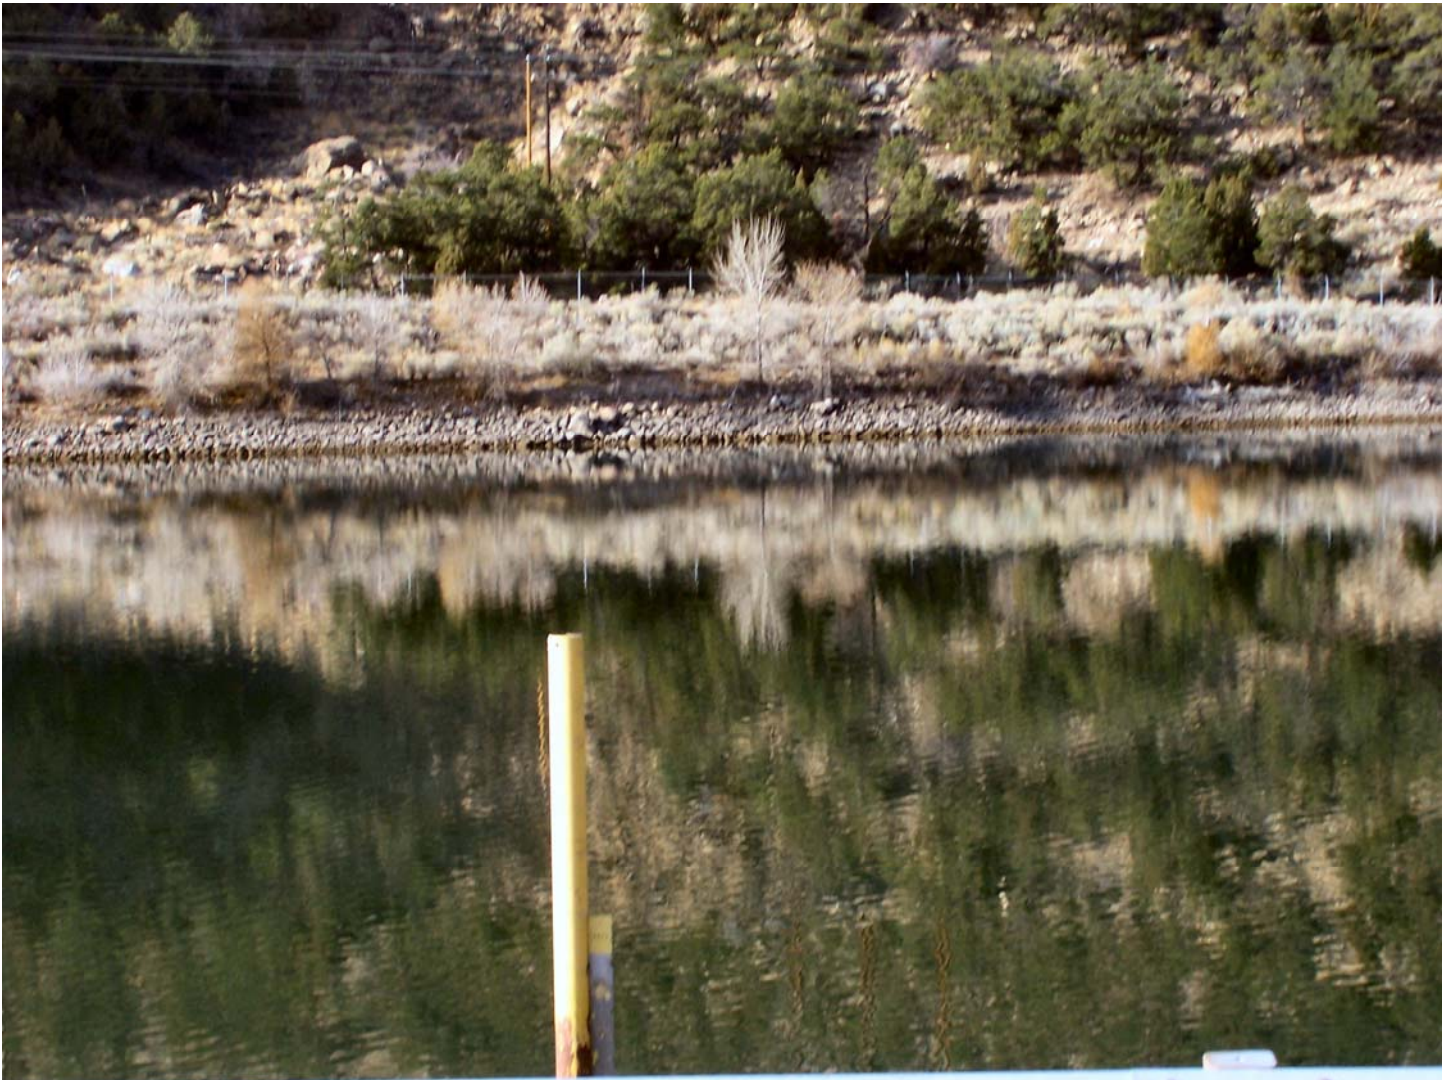
Photo 1: Holding Pond for Power Plant Diversions.

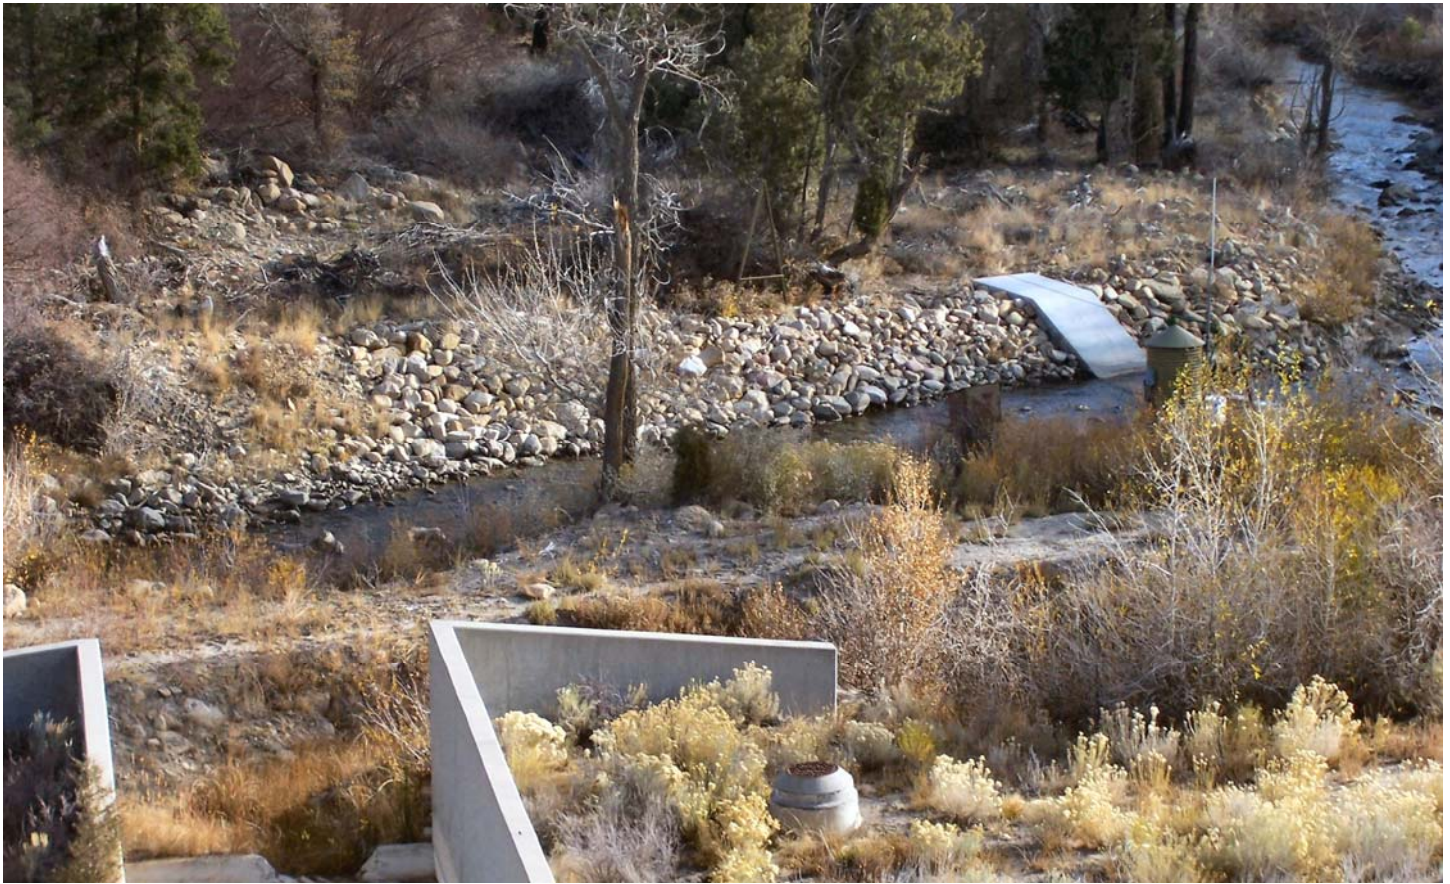
Photo 2: Spillway for holding pond at bottom left, old USGS gage right of center, new gage right of USGS gage. Flow is from left to right.

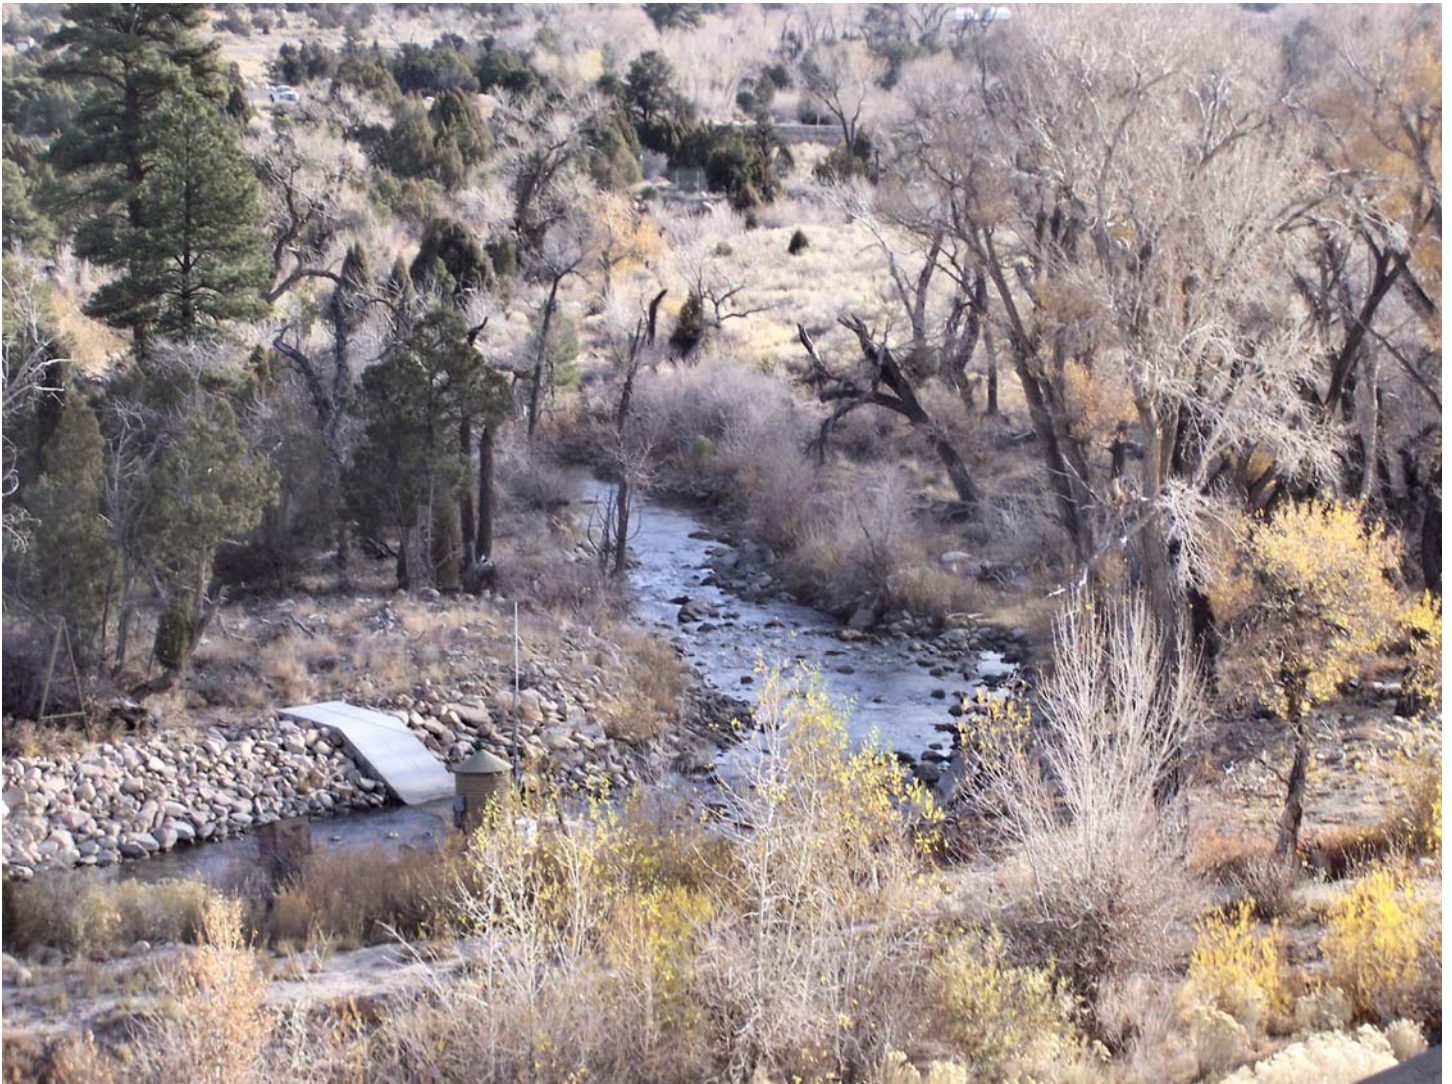
Photo 3: Huntington Creek gage. Latitude $39^{\circ}23'07''$, Longitude $111^{\circ}05'15''$. Drainage Area: 178 square miles. (N $39^{\circ}23.108'$, W $111^{\circ}05.310'$, elevation: ~ 6425 ft.)

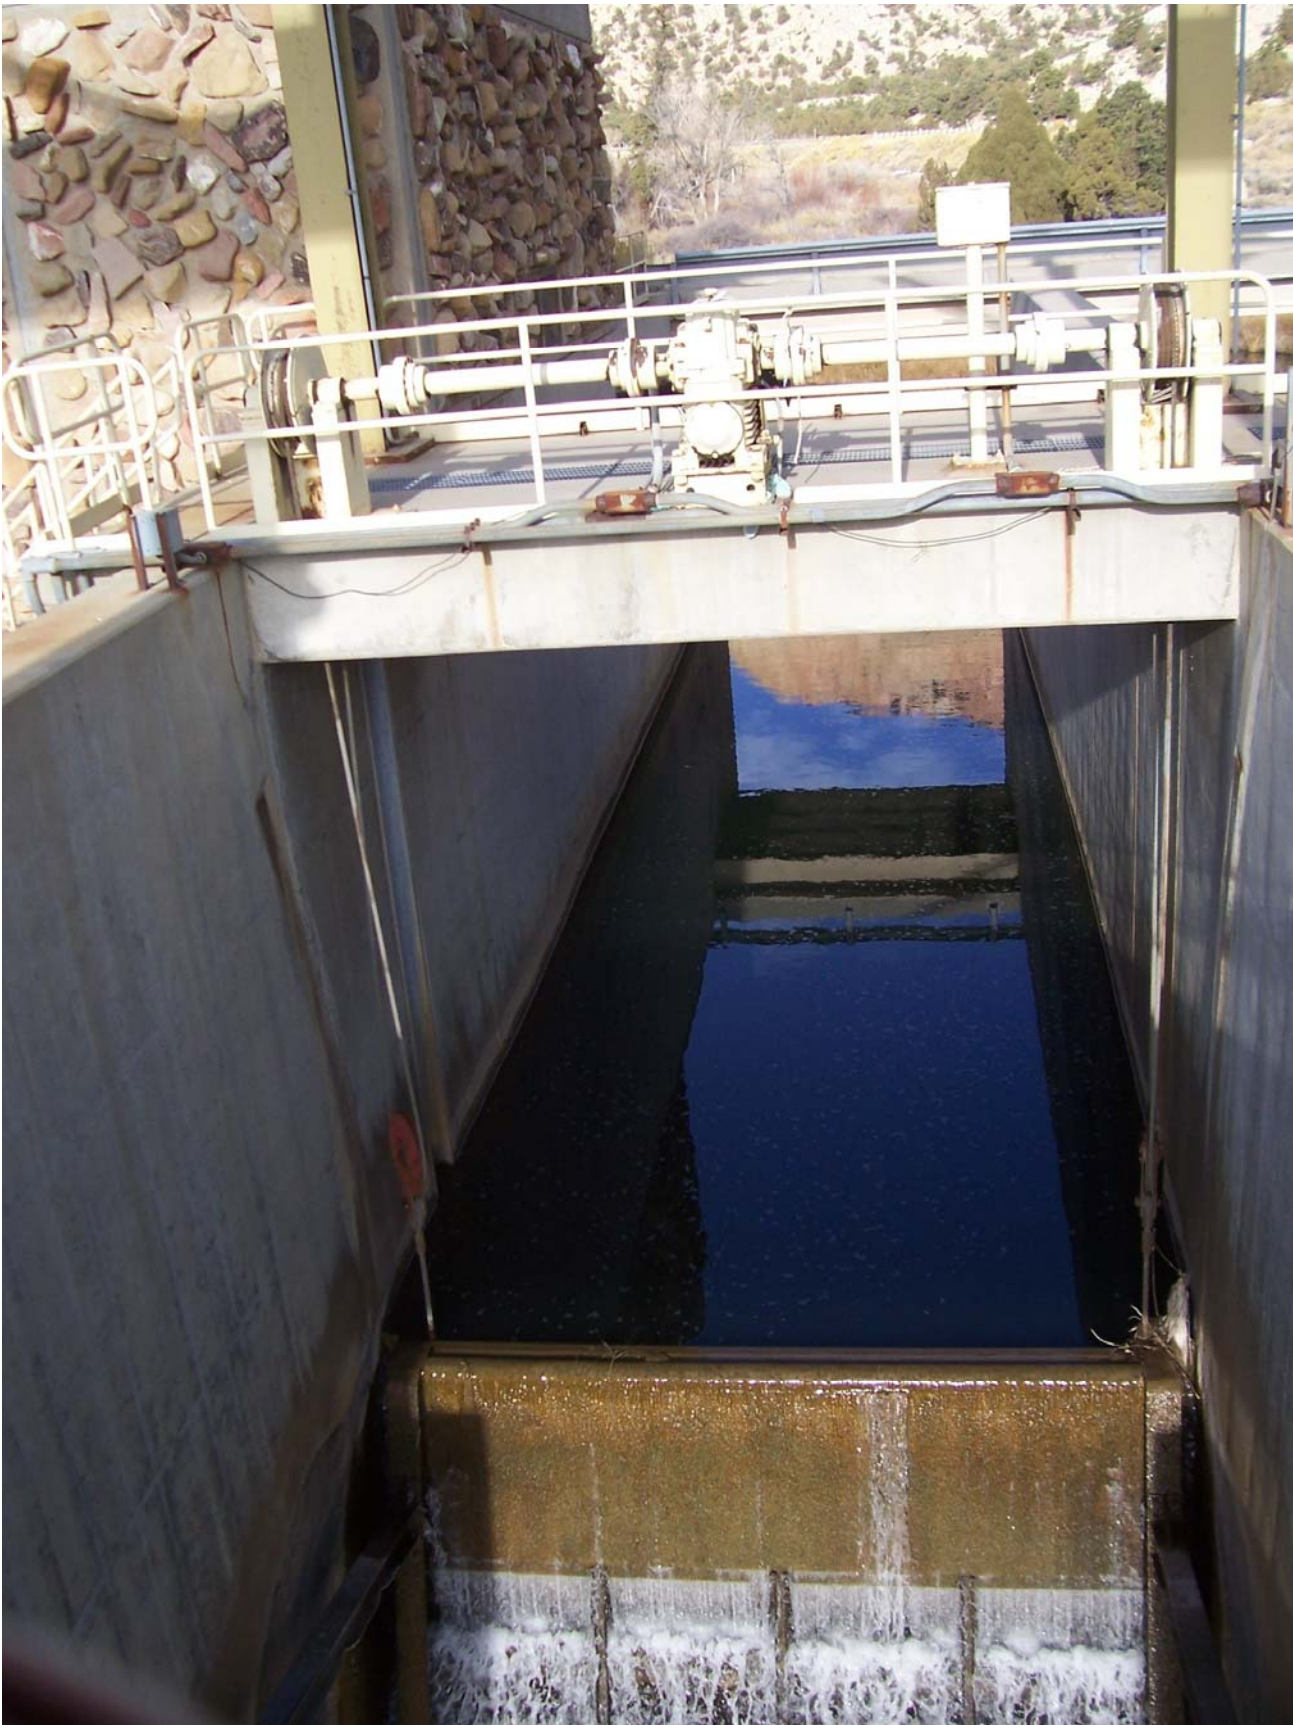
Photo 4: Control structure for Power Plant diversions upstream of gage. (N 39° 23.455', W 111° 05.550', elevation: ~6509 ft.) Inside of building not visited.

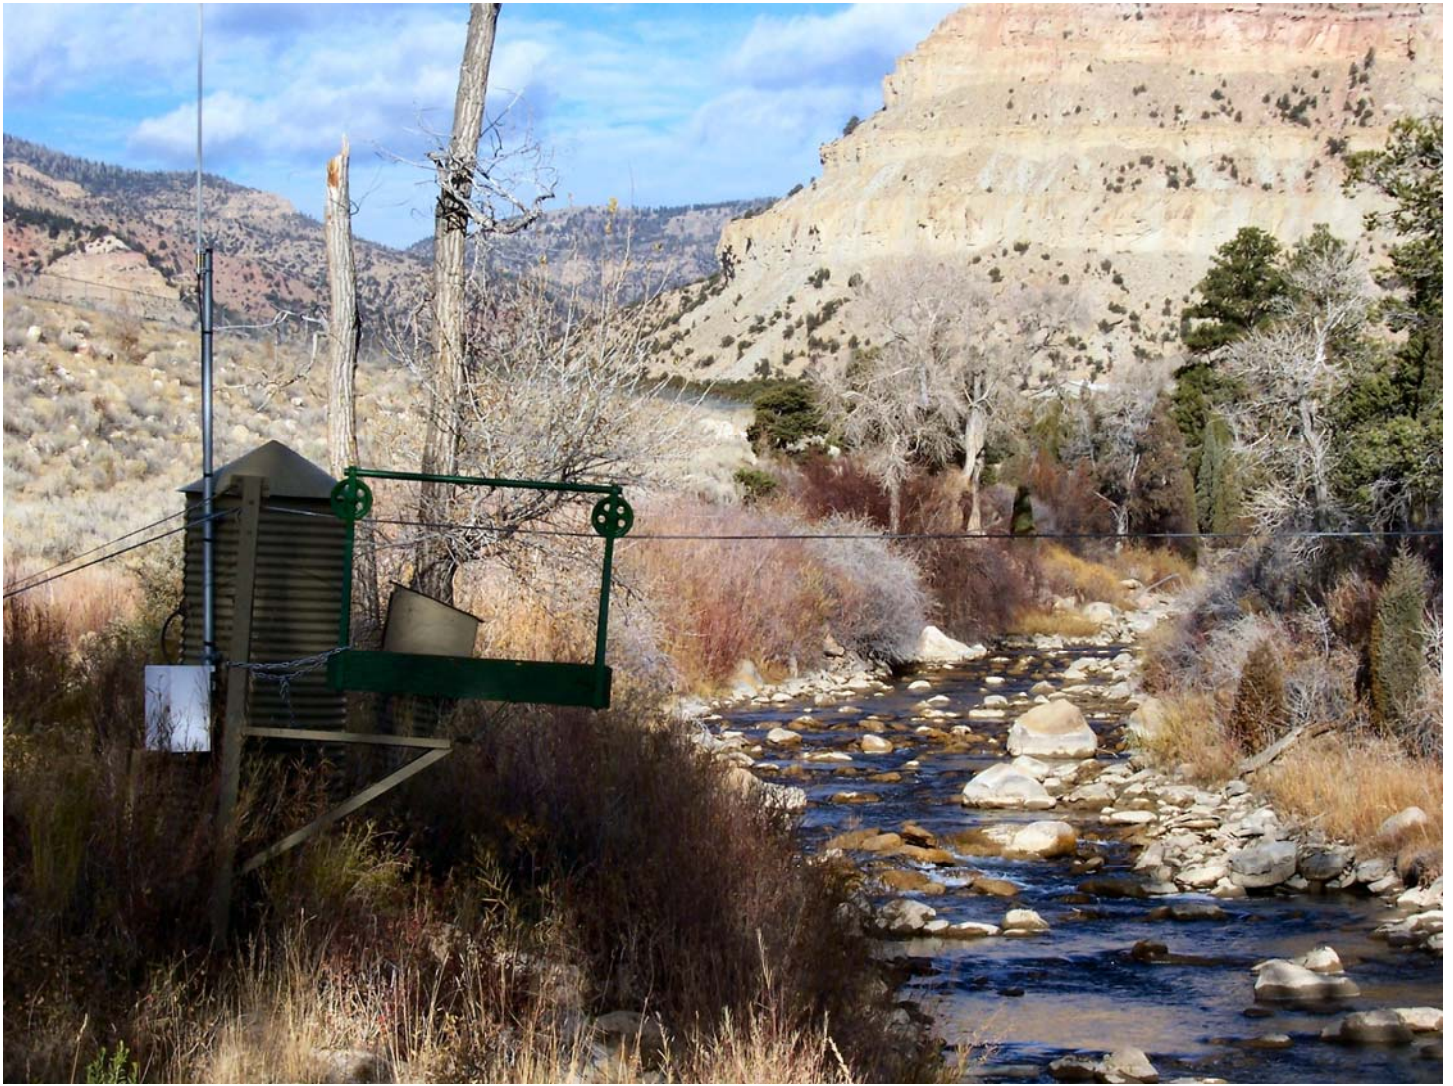
Photo 5: Huntington Creek gage, looking upstream, showing cable car.

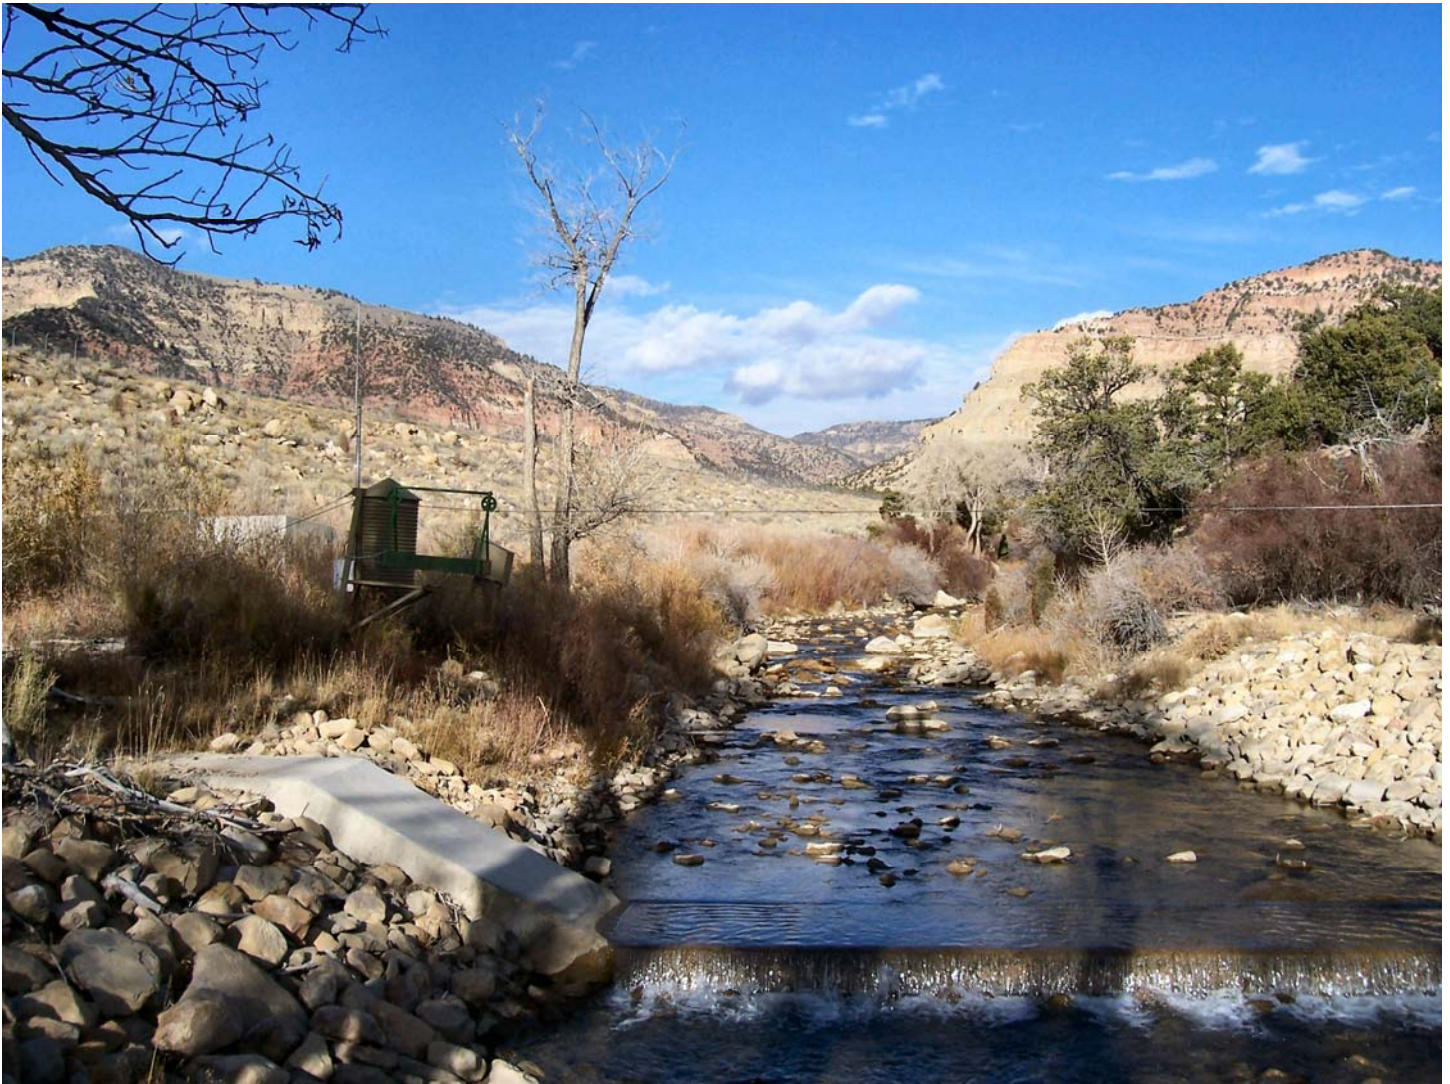
**Photo 6: Huntington Creek gage, looking upstream, showing control for gage in foreground.
William Reed, November 12, 2009**

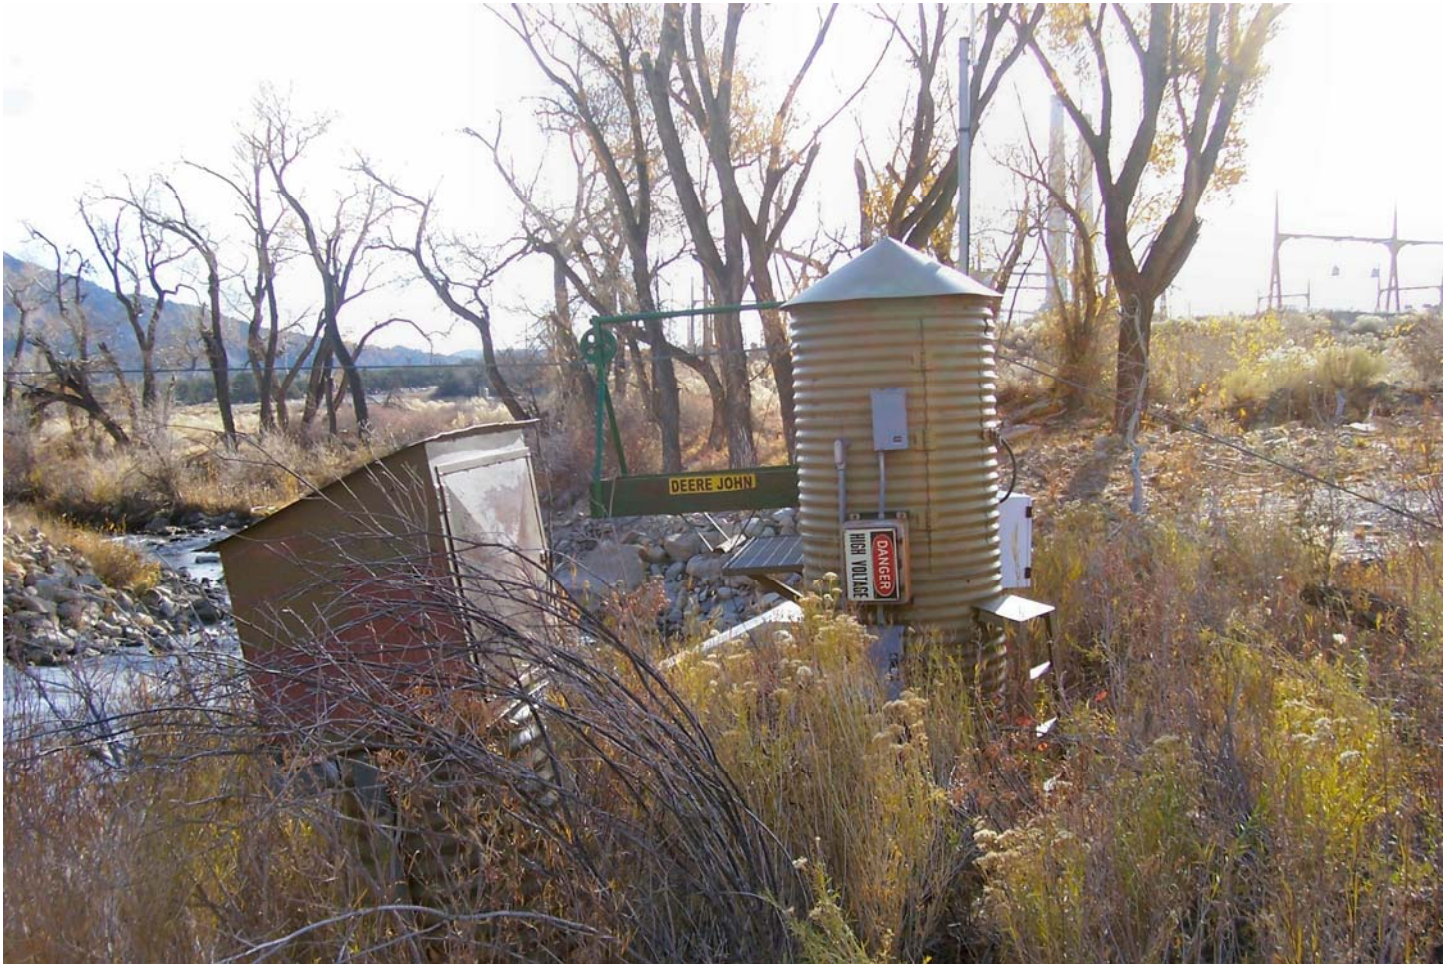
Photo 7: Huntington Creek gage, looking downstream, showing abandoned USGS gage upstream of new gage. Latitude $39^{\circ} 23' 07''$, Longitude $111^{\circ} 05' 15''$. Drainage Area: 178 square miles.

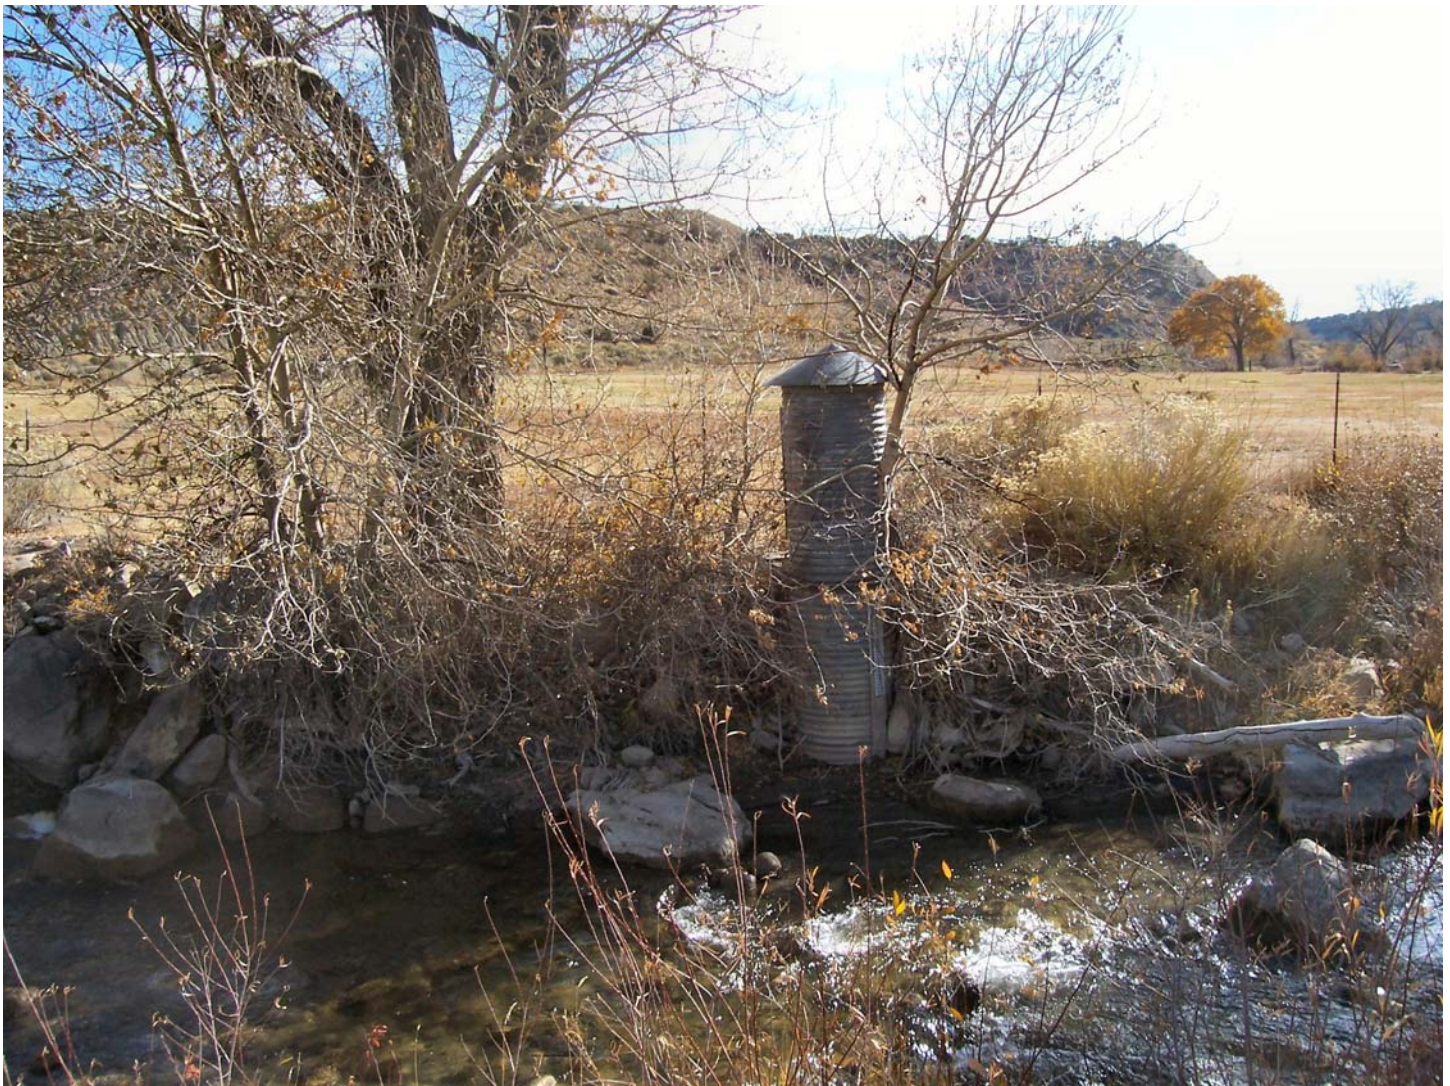
Photo 8: First USGS site abandoned, two structures are located at this site on opposite banks. Gage on left bank is shown. Latitude $39^{\circ}22'17''$, Longitude $111^{\circ}03'47''$. Drainage Area: 187 square miles. (N $39^{\circ}22.262$, W $111^{\circ}03.772'$, elevation ~ 6210 ft.)

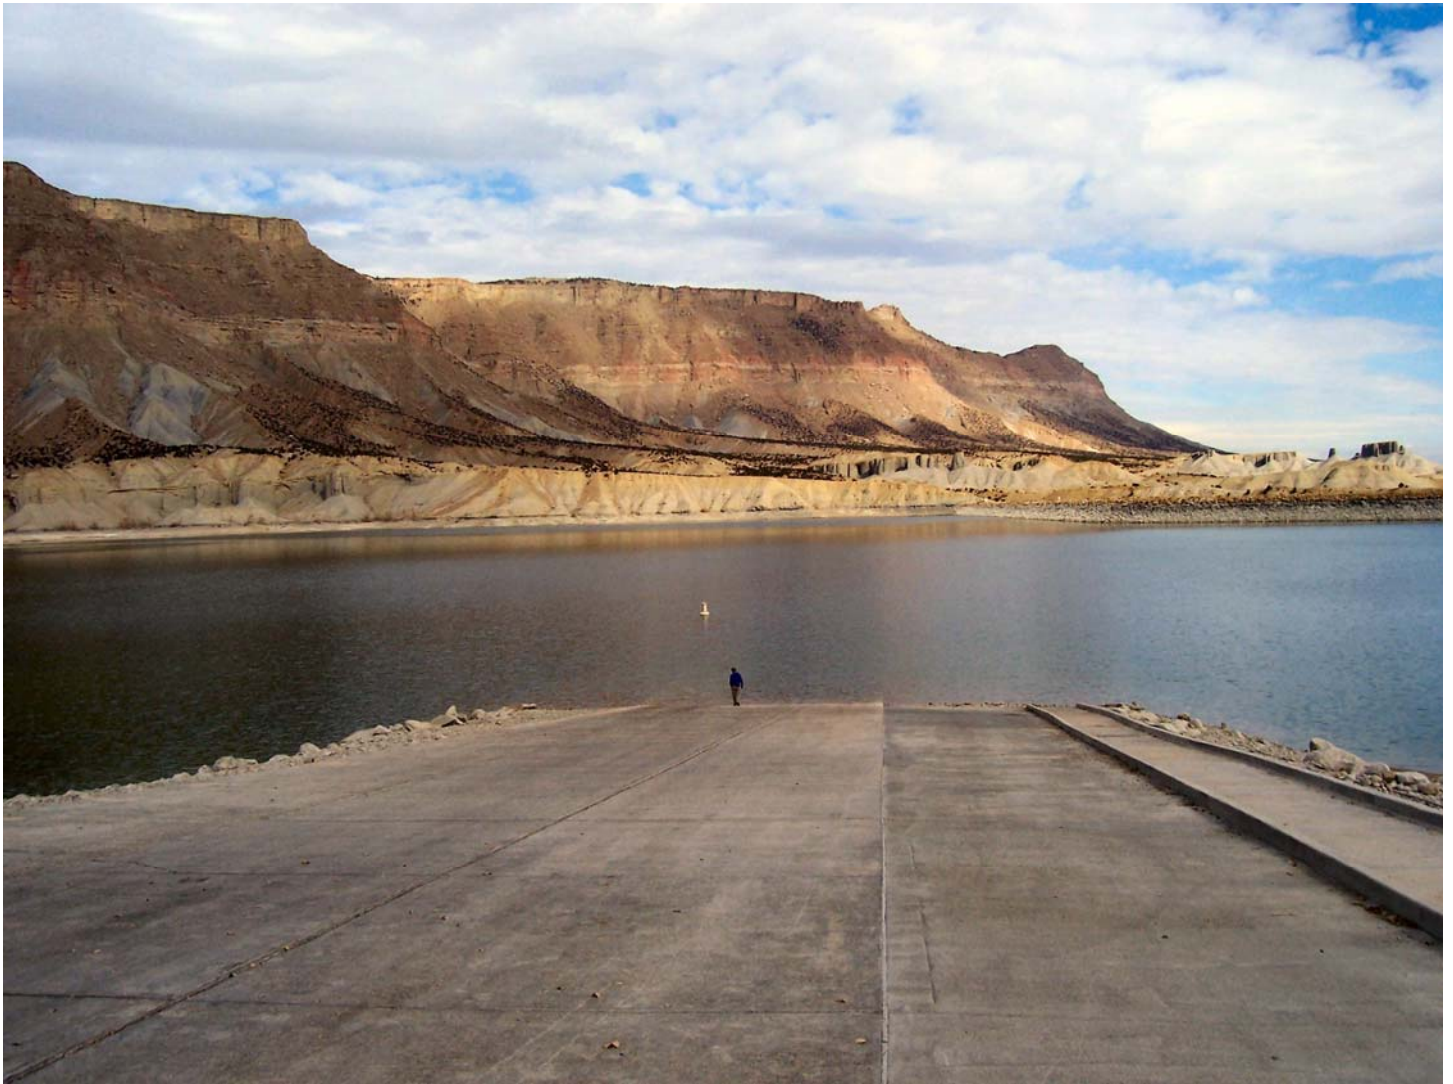
Photo 9: Millsite Reservoir, painted inclined staff gage along edge of this boat ramp.

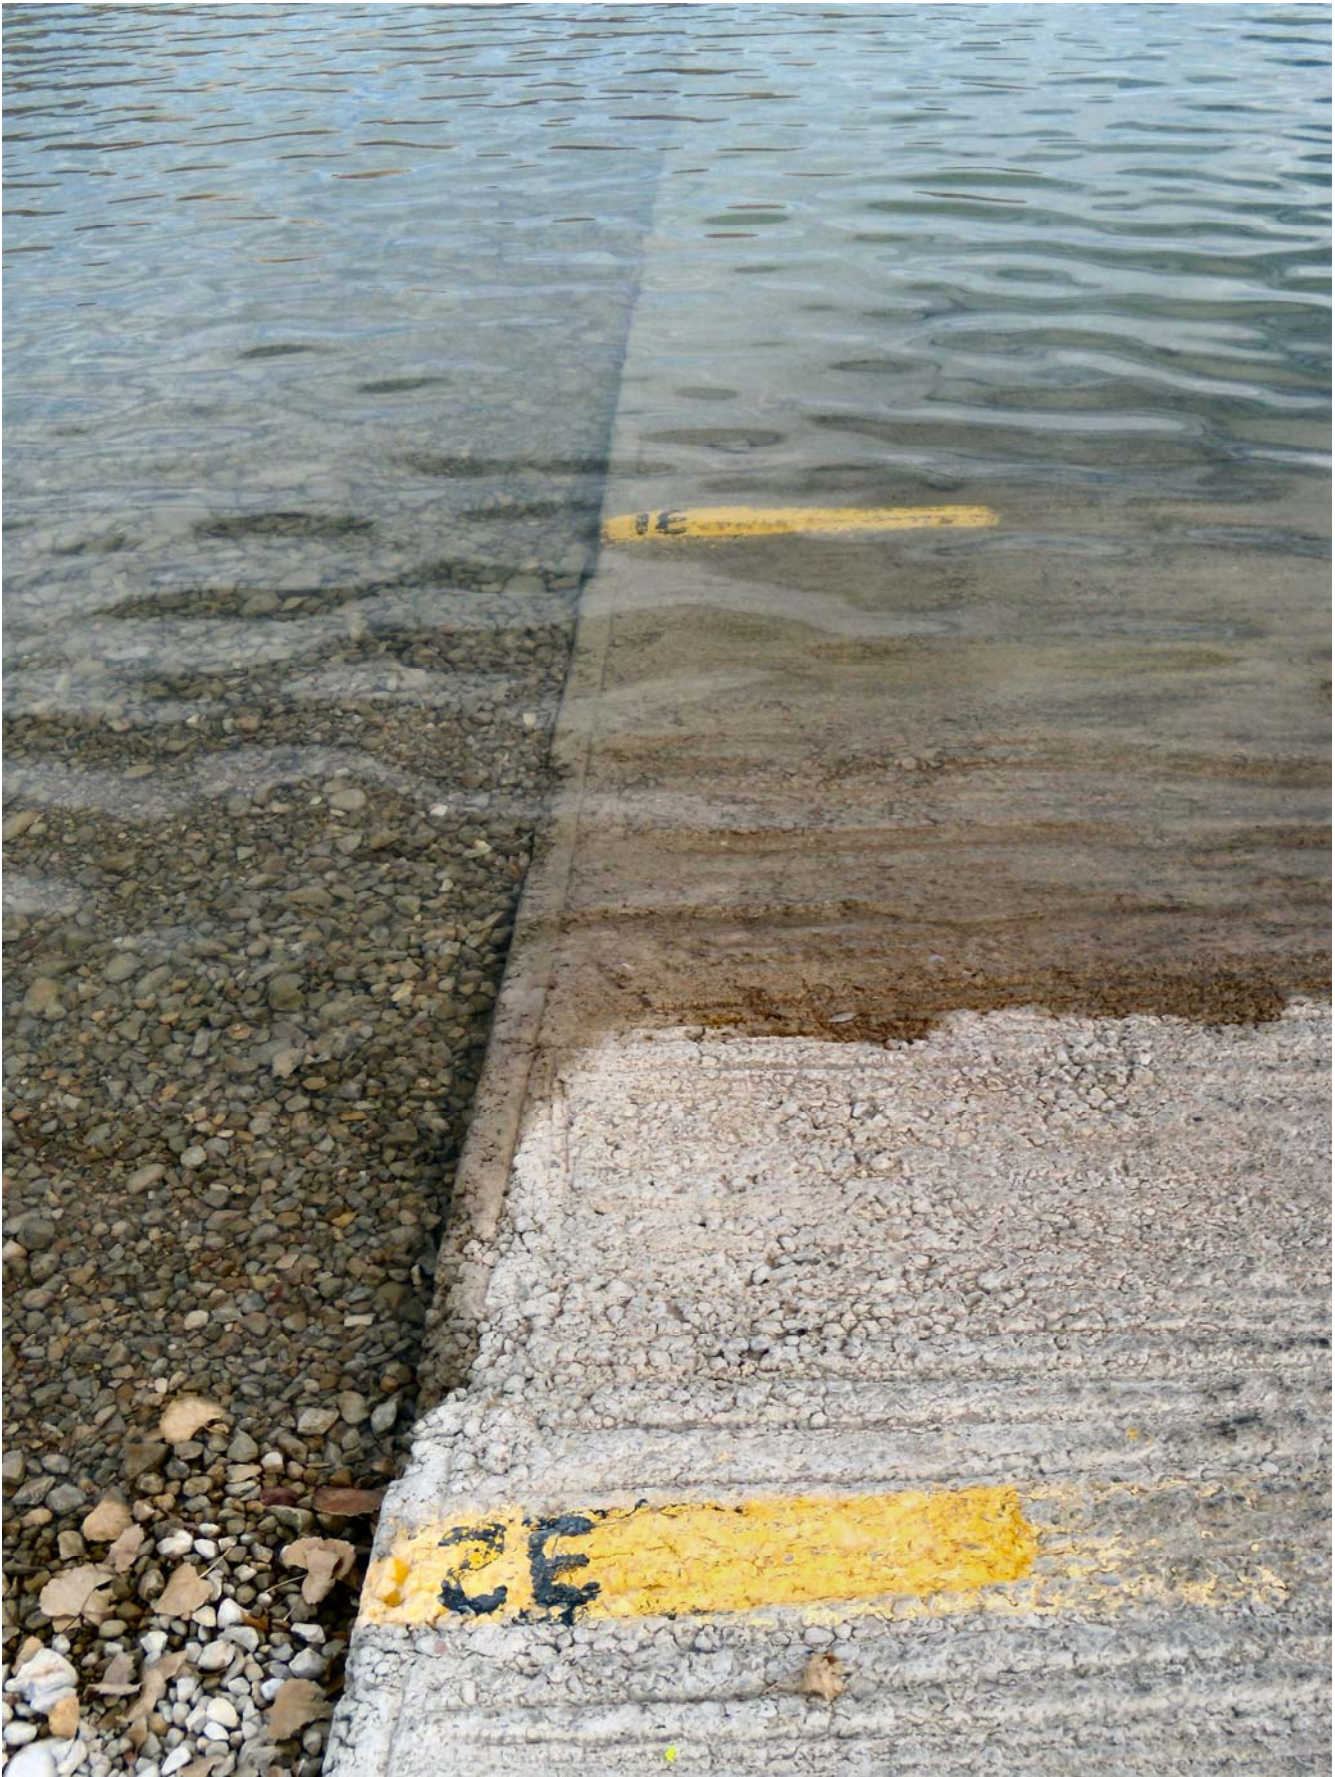
Photo 10: Painted inclined staff gage along edge of Millsite Reservoir boat ramp. EWCD website reported 31.58 feet.

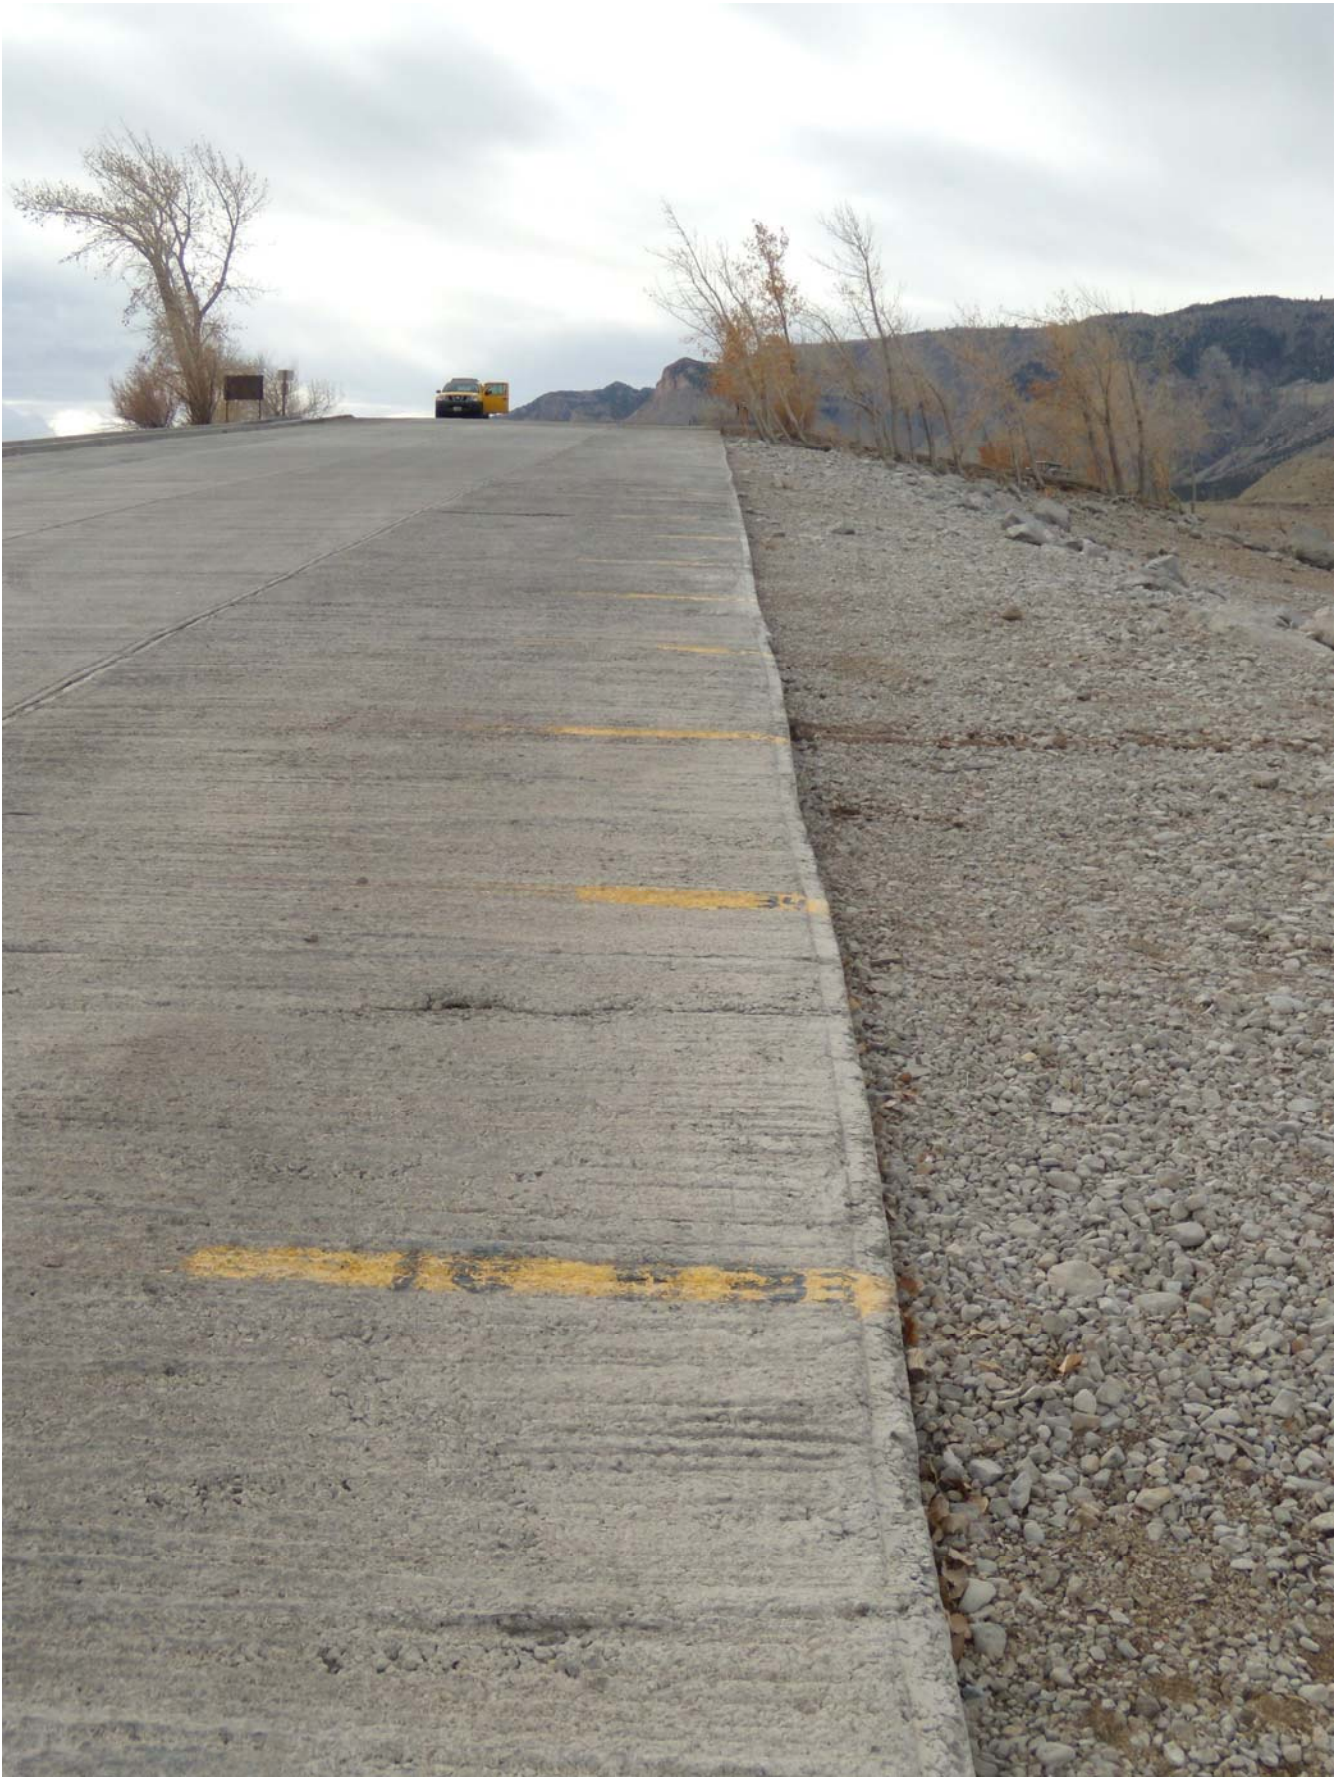
Photo 11: Painted inclined staff gage along edge of Millsite Reservoir boat ramp.

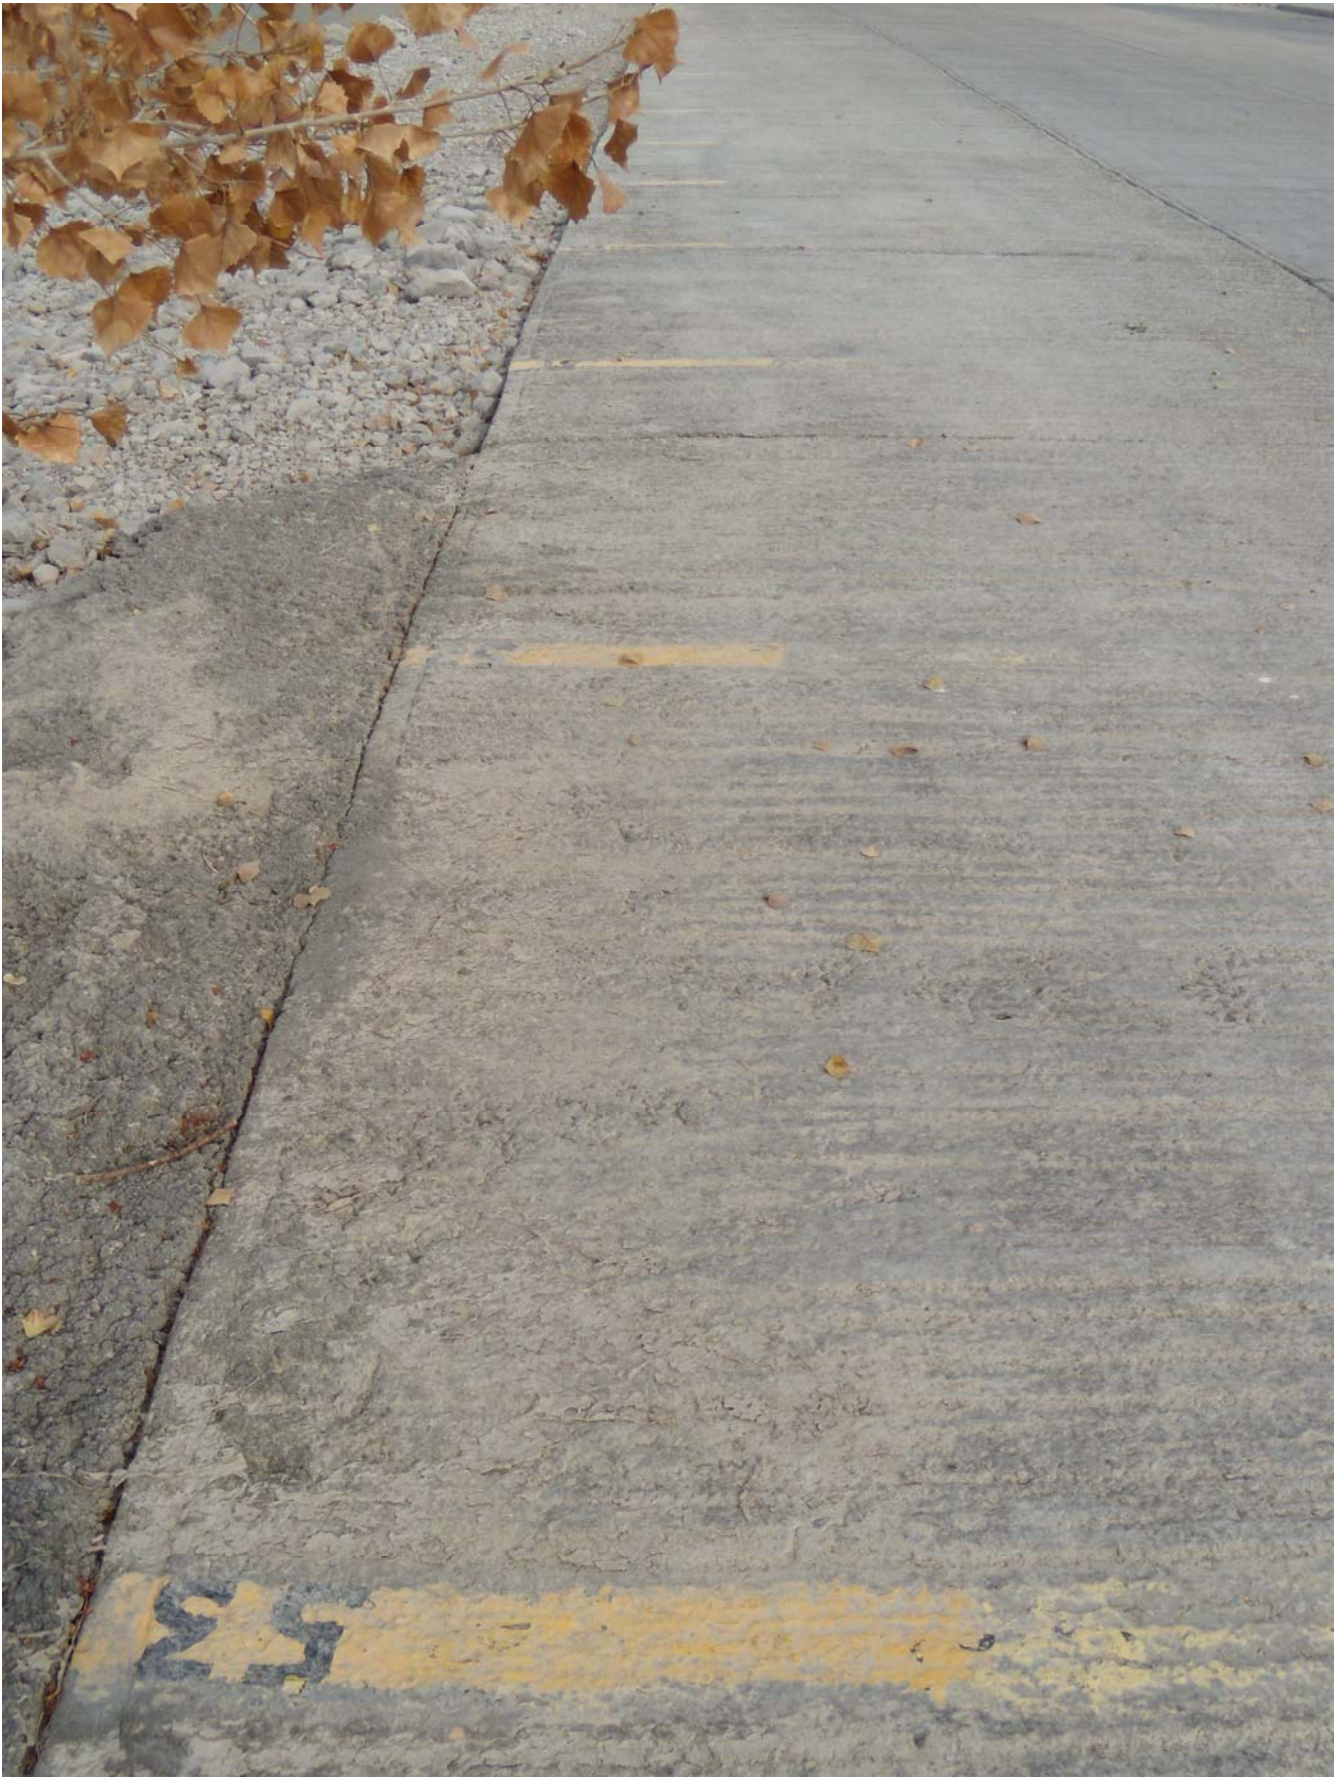
**Photo 12: Painted inclined staff gage along edge of Millsite Reservoir boat ramp. EWCD website reported 31.58 feet; therefore, the reservoir level was ~21.5 feet below this point near top of boat ramp.
Tim Bardsley, November 12, 2009**
