Trip Report for Travel to Lower Green River Basin November 12, 2009

Itinerary: On November 12th Bill Reed, CBRFC, and Tim Bardsley, Utah NRCS, travelled by POV from Salt Lake City (SLC) to Lower Green River Basin and returned the same day. They left SLC at 5:30 am, arrived at Huntington Power Plant at 8:00 am for a meeting regarding data availability with Cody Allred, a PacifiCorp employee, and then accompanied by Cody visited sites on Power Plant property including a water supply forecast point. Tim and Bill subsequently visited other sites in the Lower Green Basin on their own, including other water supply forecast points, and returned to SLC arriving at 7:00 pm. Total mileage: 467 miles.

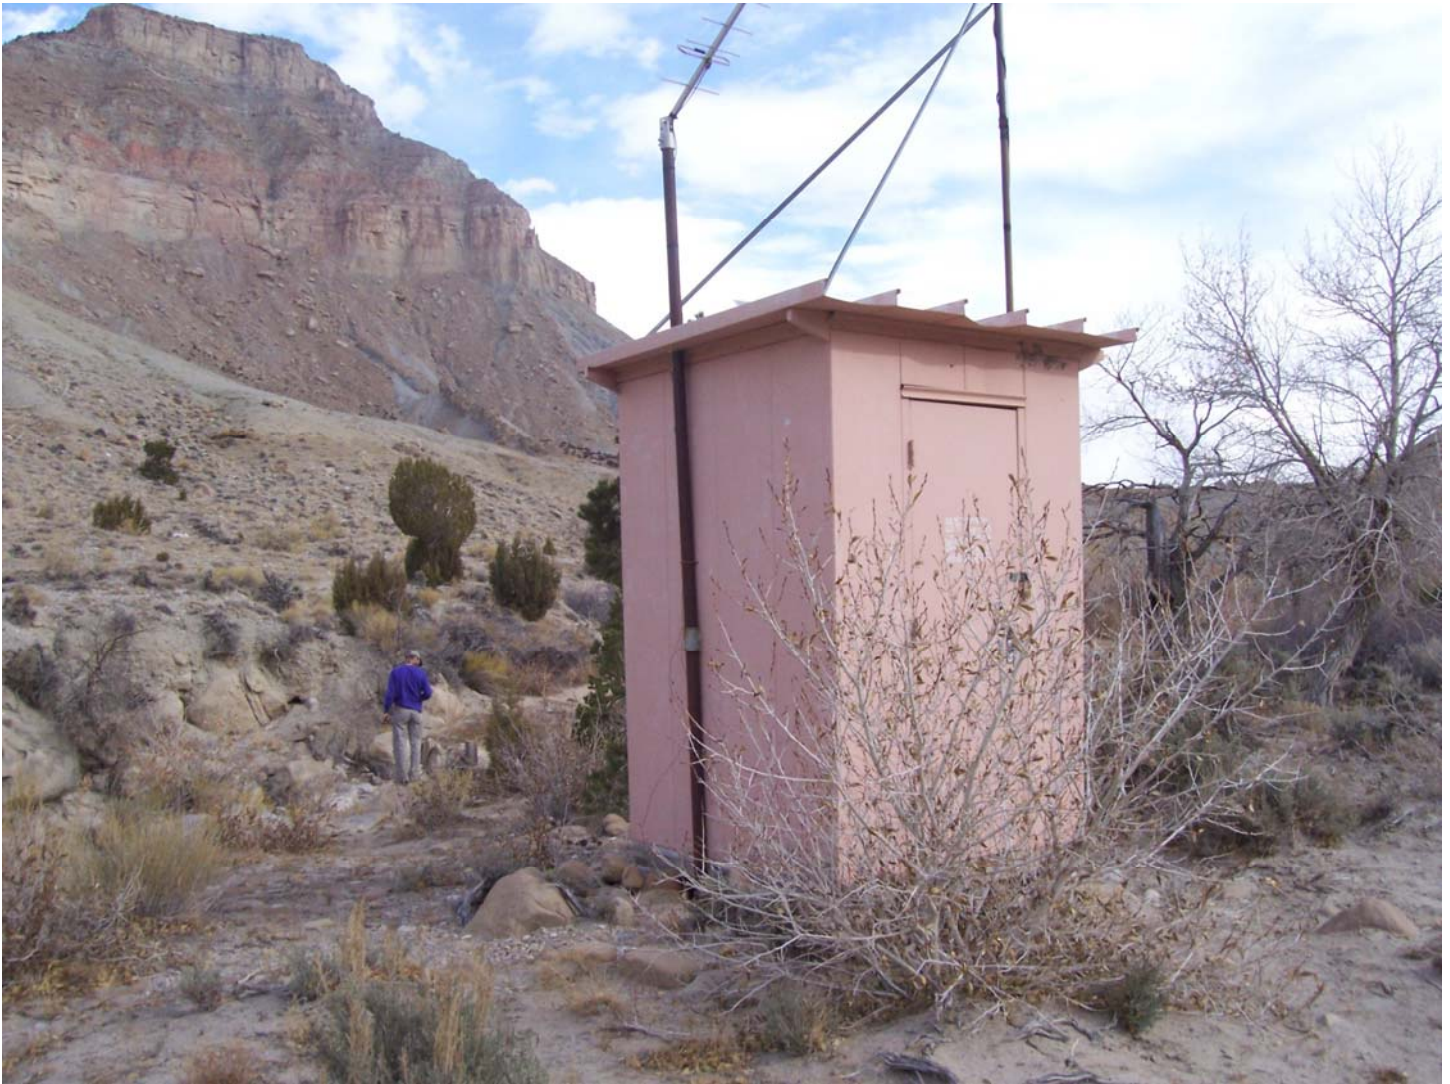
**Photo 13: USGS 09326500 Ferron Creek gage house. Latitude 39° 06'15", Longitude 111° 12'57".
Drainage area: 138 square miles. (N 39° 06.230, W 111° 13.074, elevation ~6257 ft.)
William Reed, November 12, 2009**

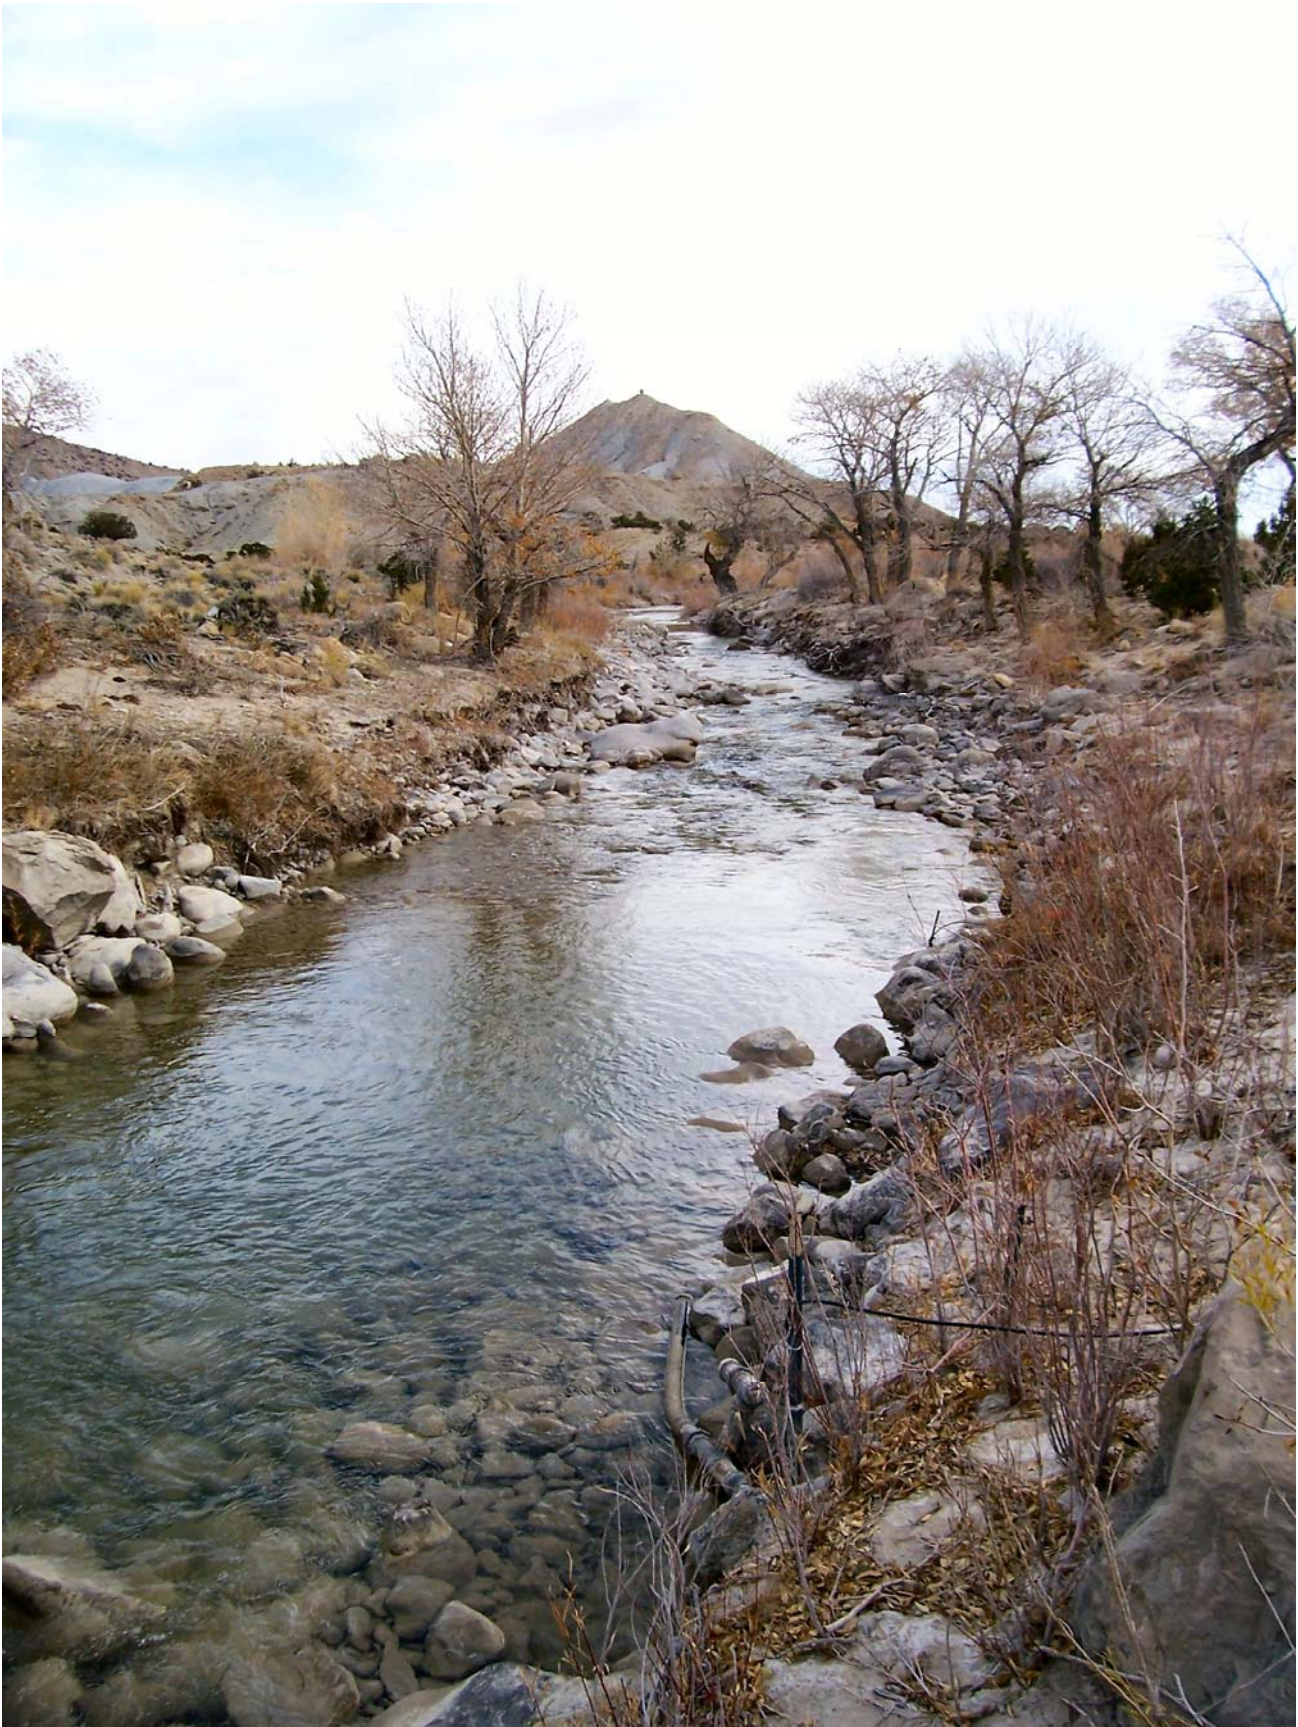
Photo 14: Ferron Creek, looking downstream, showing gage intake.

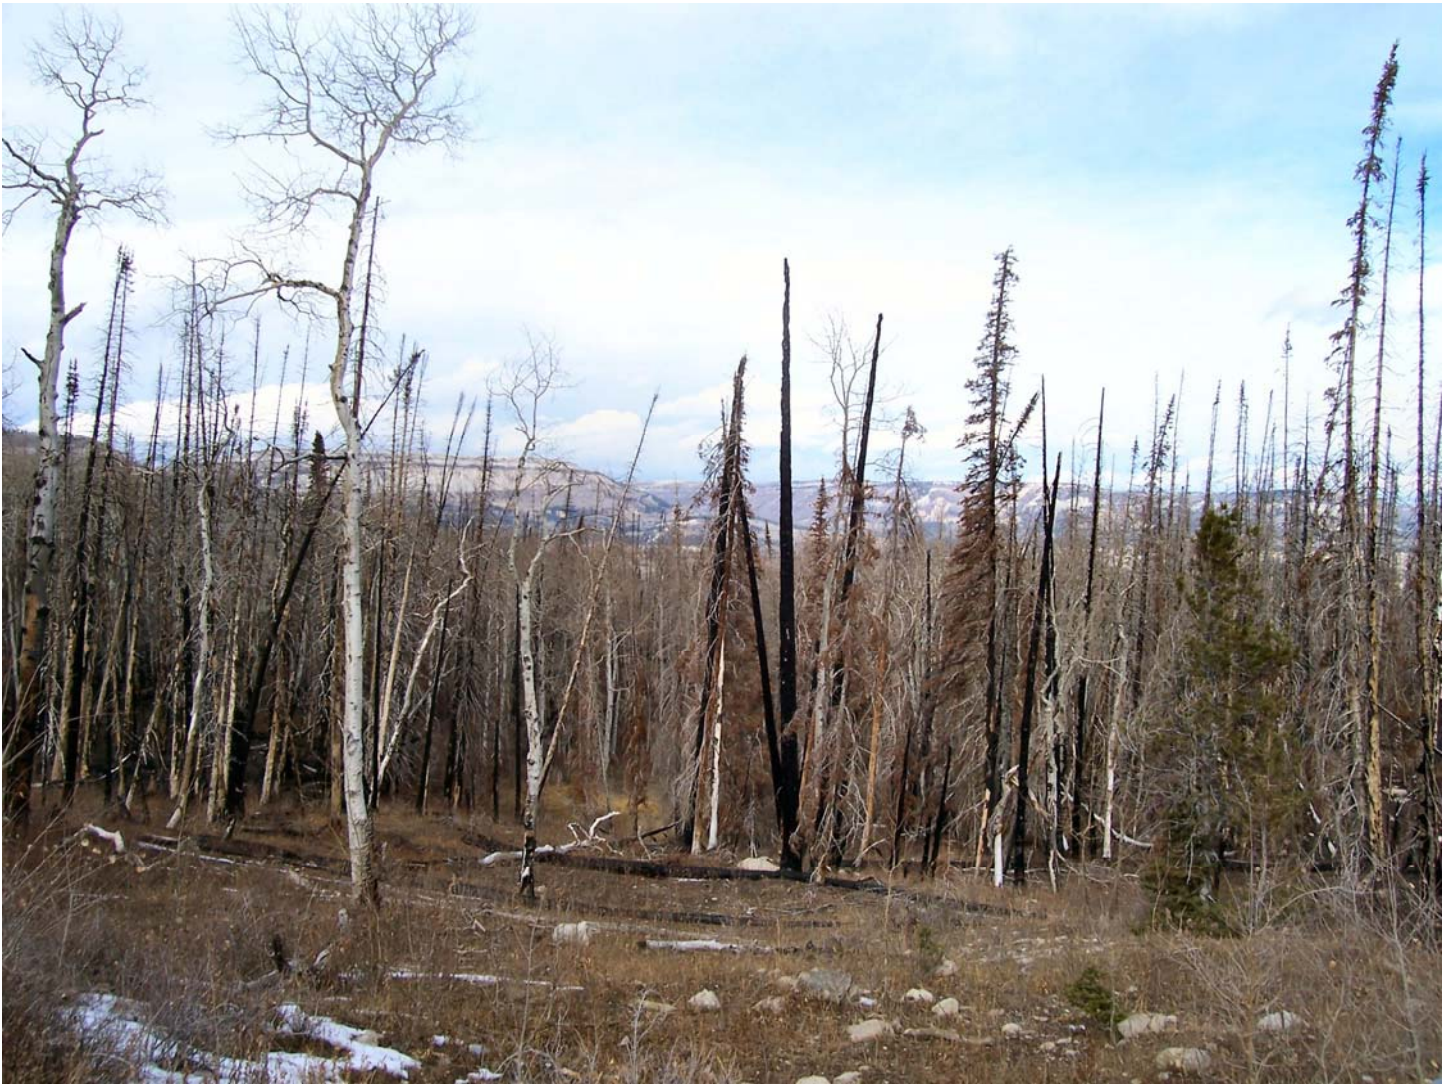
Photo 17: Ferron Creek Drainage, recovering burned area. (N 39° 08.130, W 111° 23.969, elevation ~9500ft.)

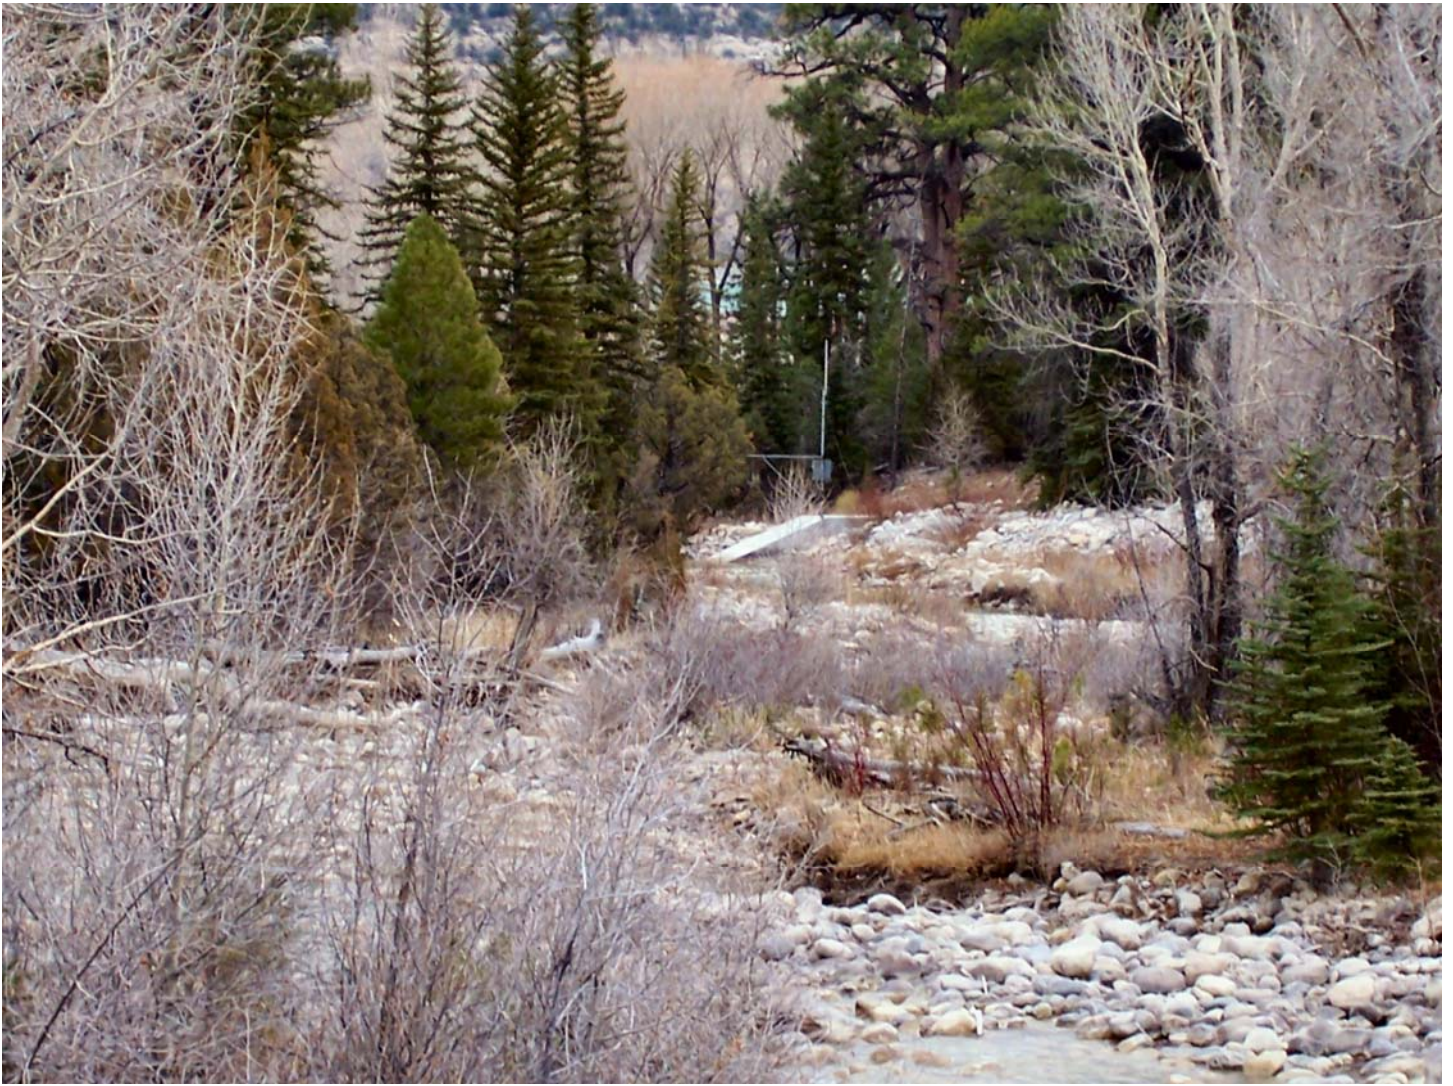
Photo 21: Seely Creek gage. Looking downstream from Forest Road 170.

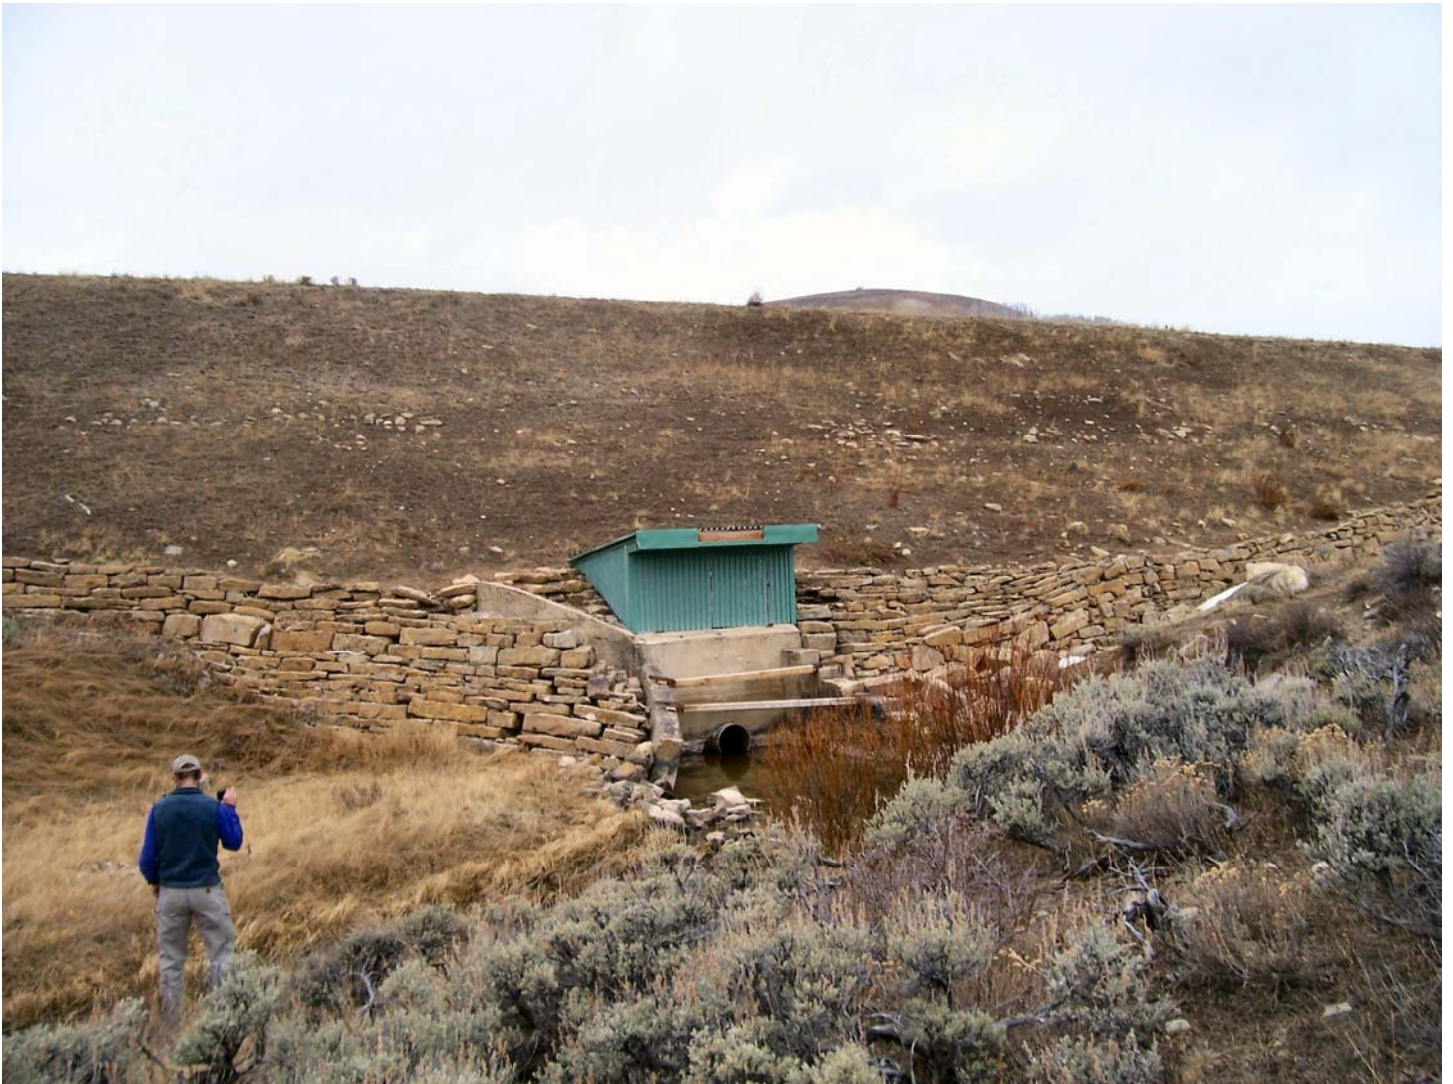
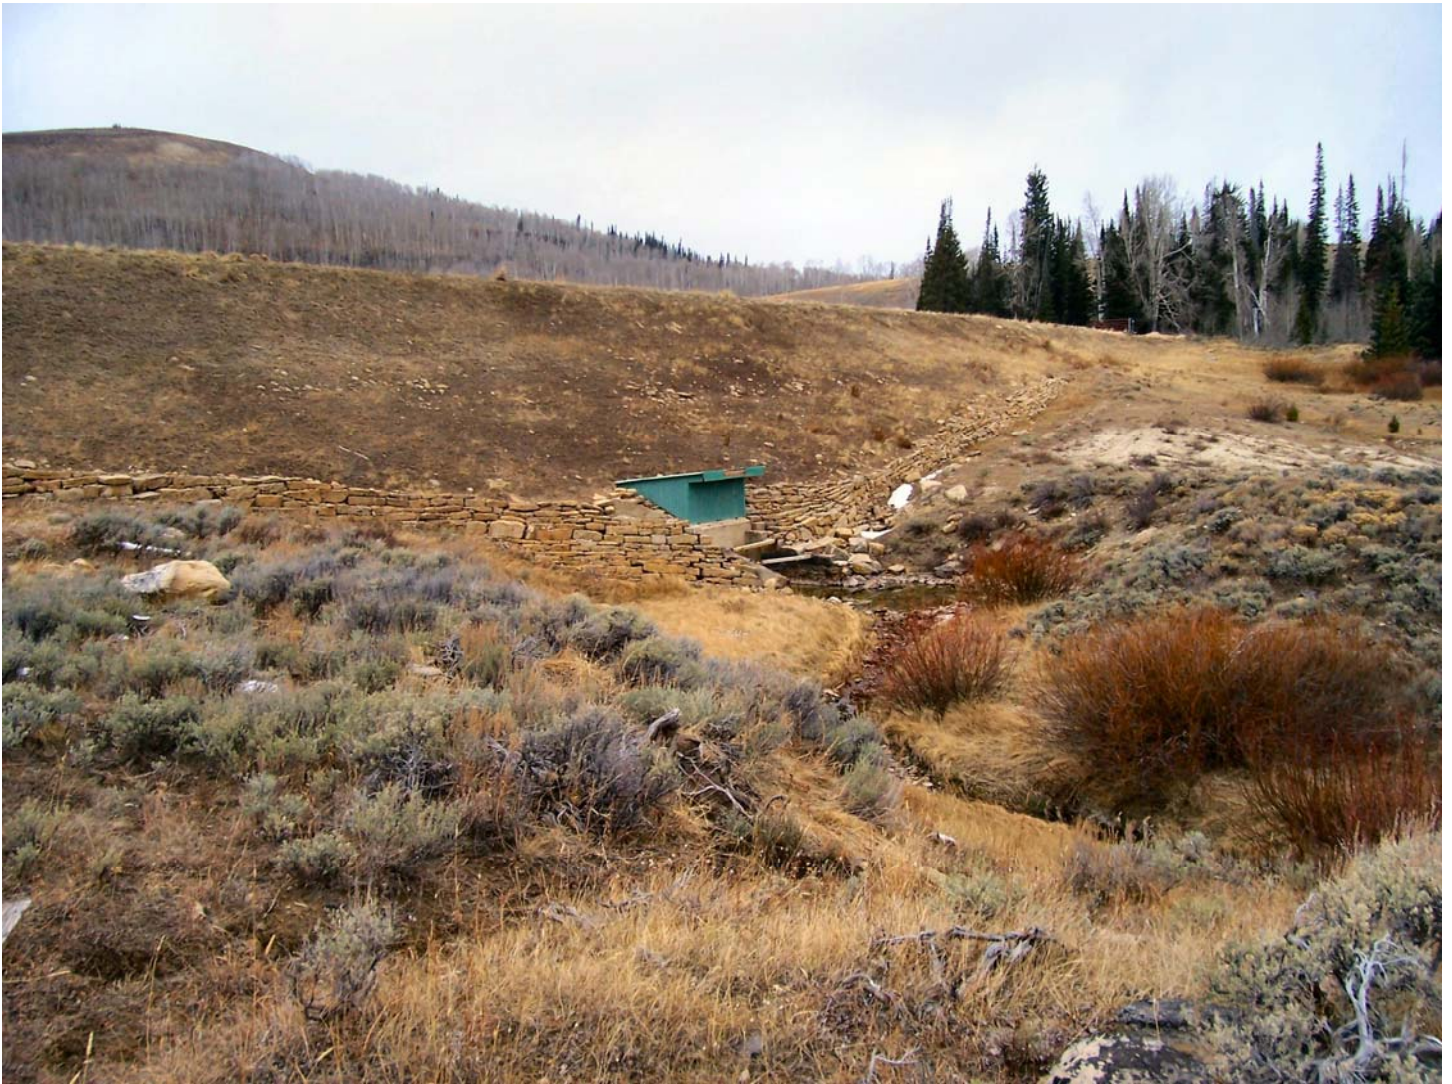
Photo 23: Rolfson Reservoir Dam.

Photo 24: Rolfson Reservoir Dam.

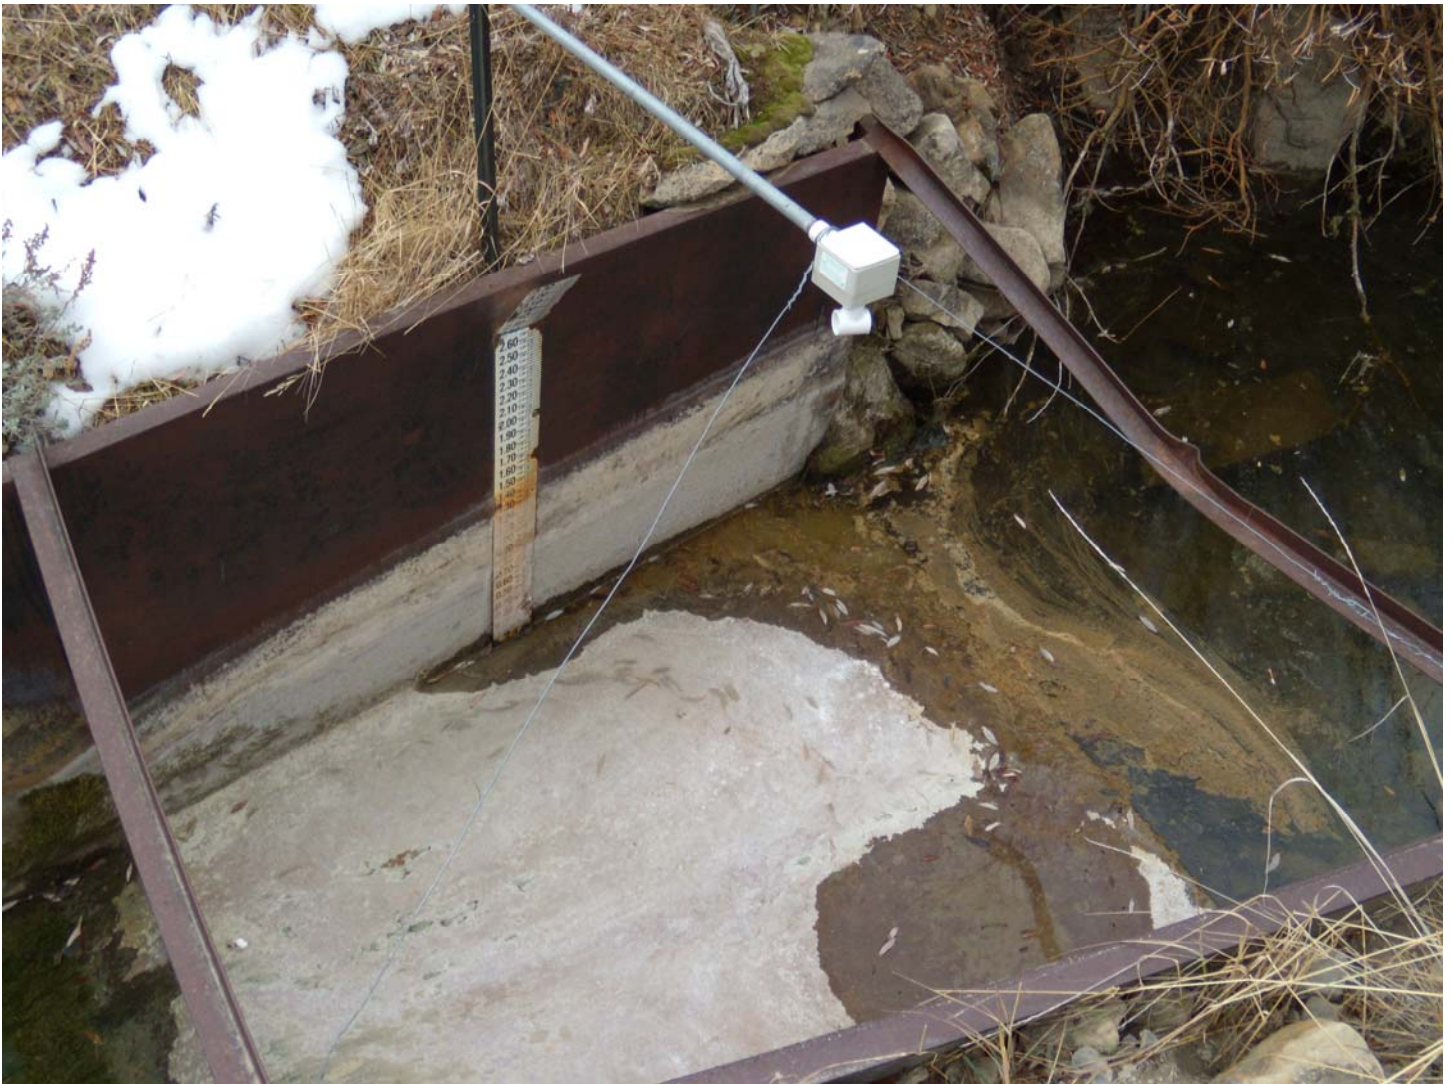
Photo 25: Rolfson Reservoir Dam outflow gage.

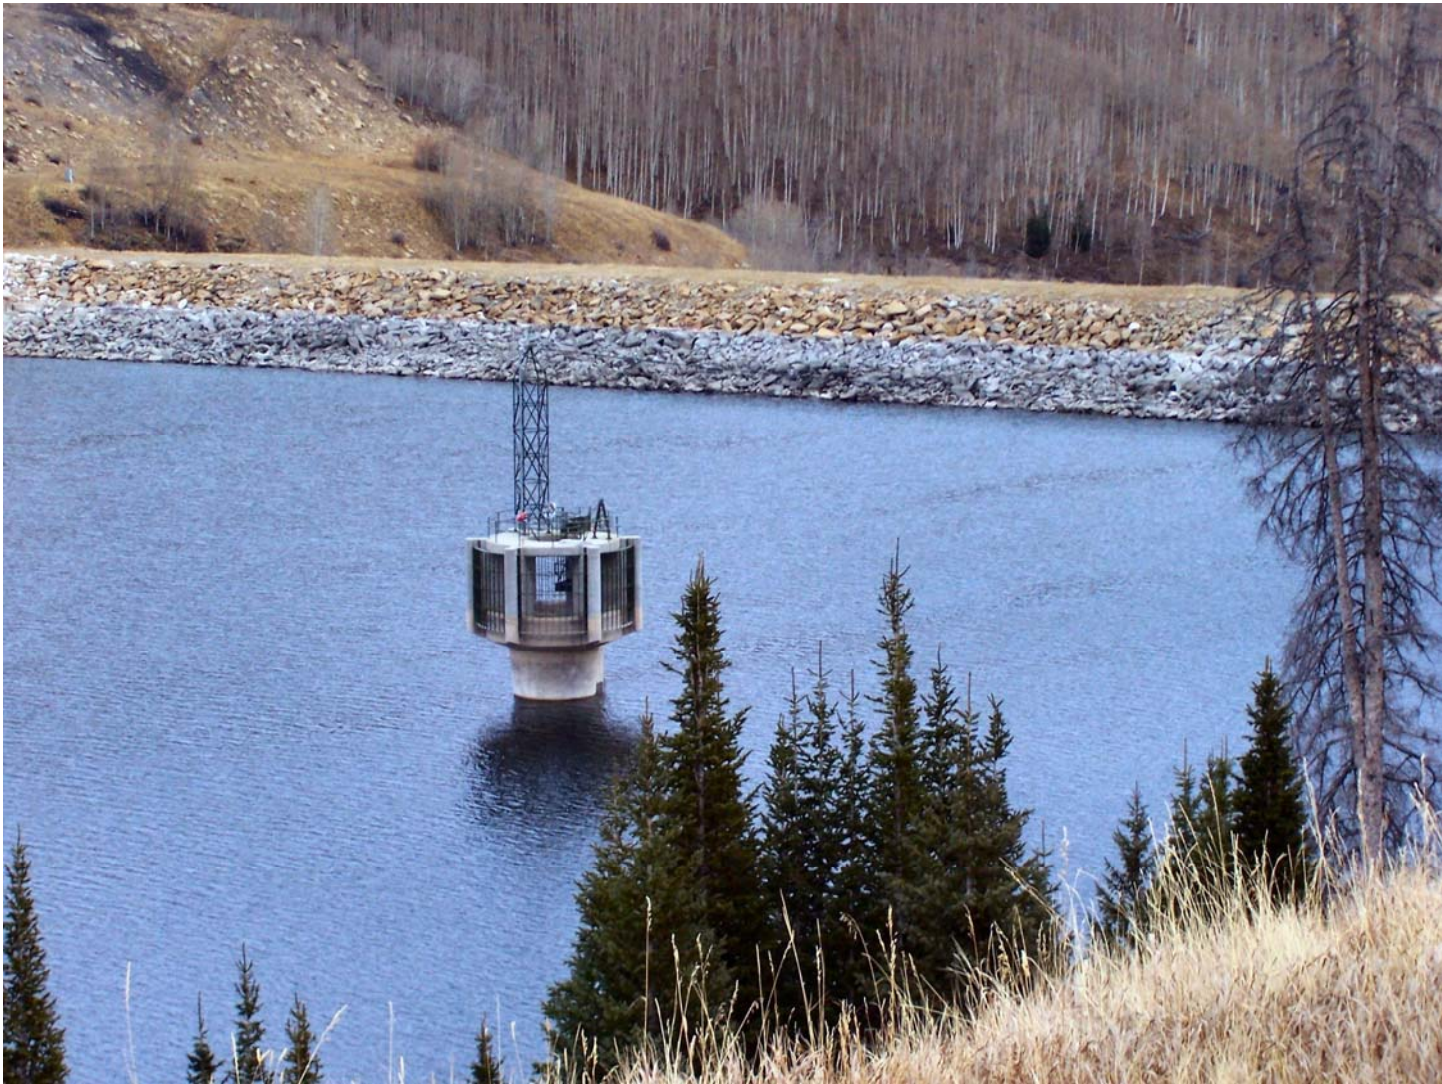
Photo 29: Electric Lake and dam.

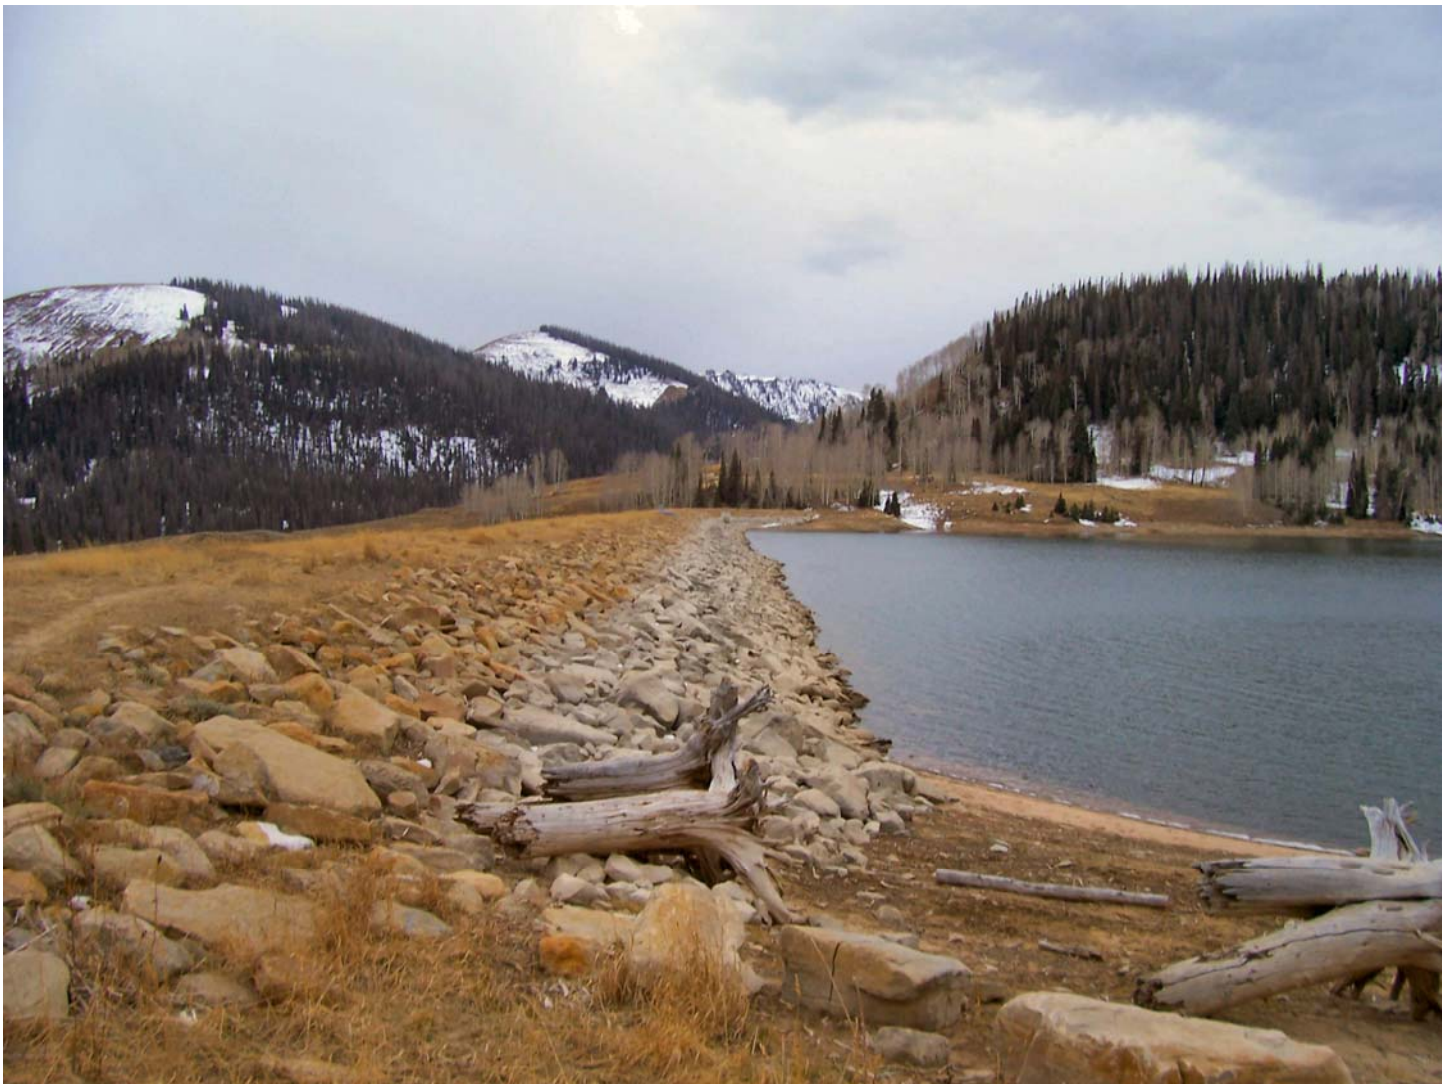
Photo 31: Huntington Reservoir and dam.

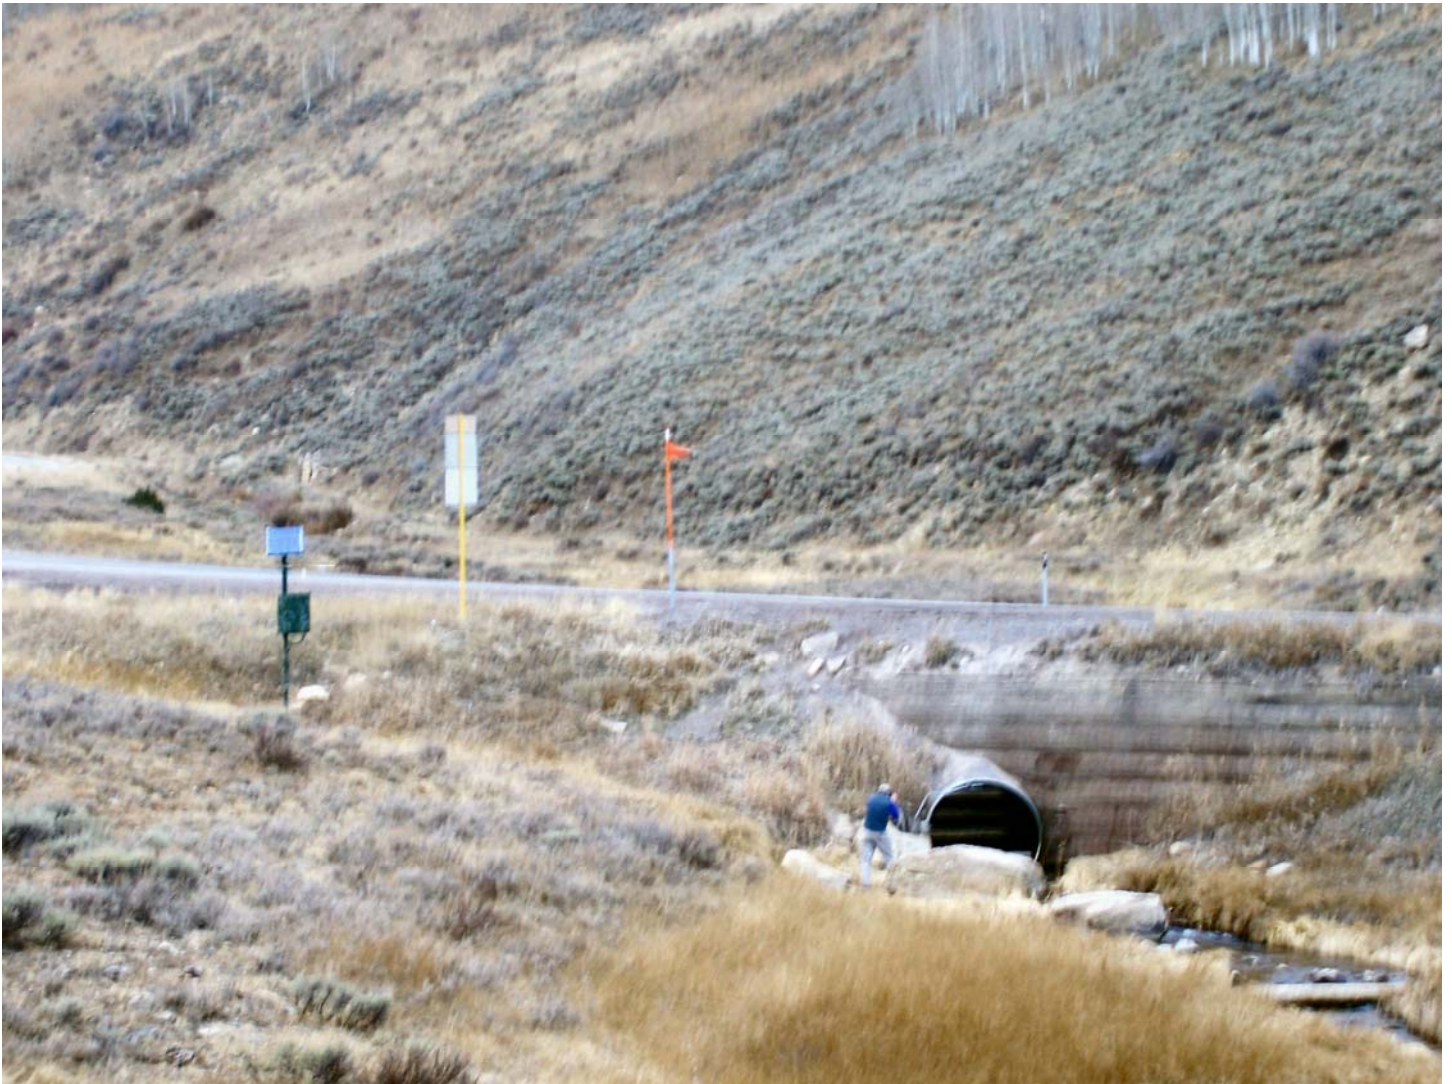
**Photo 32: Boulger Creek, tributary to Electric Lake. Gage is in culvert under State Route 264.
William Reed, November 12, 2009**

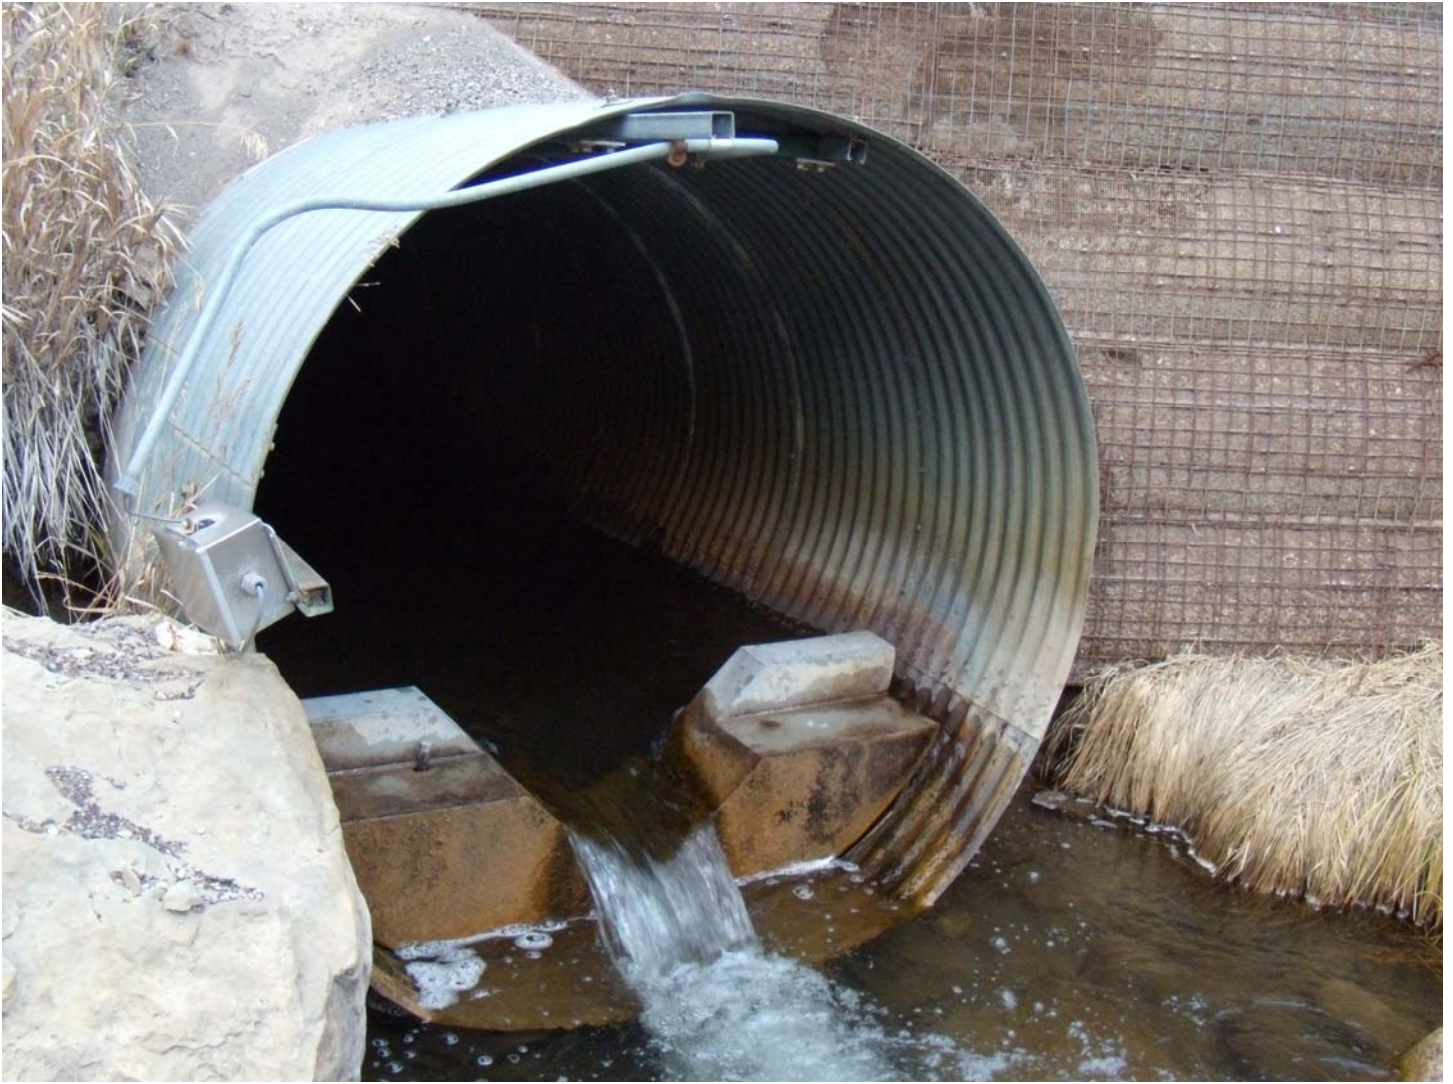
**Photo 33: Boulger Creek, tributary to Electric Lake. Gage is in culvert under State Route 264.
Tim Bardsley, November 12, 2009**

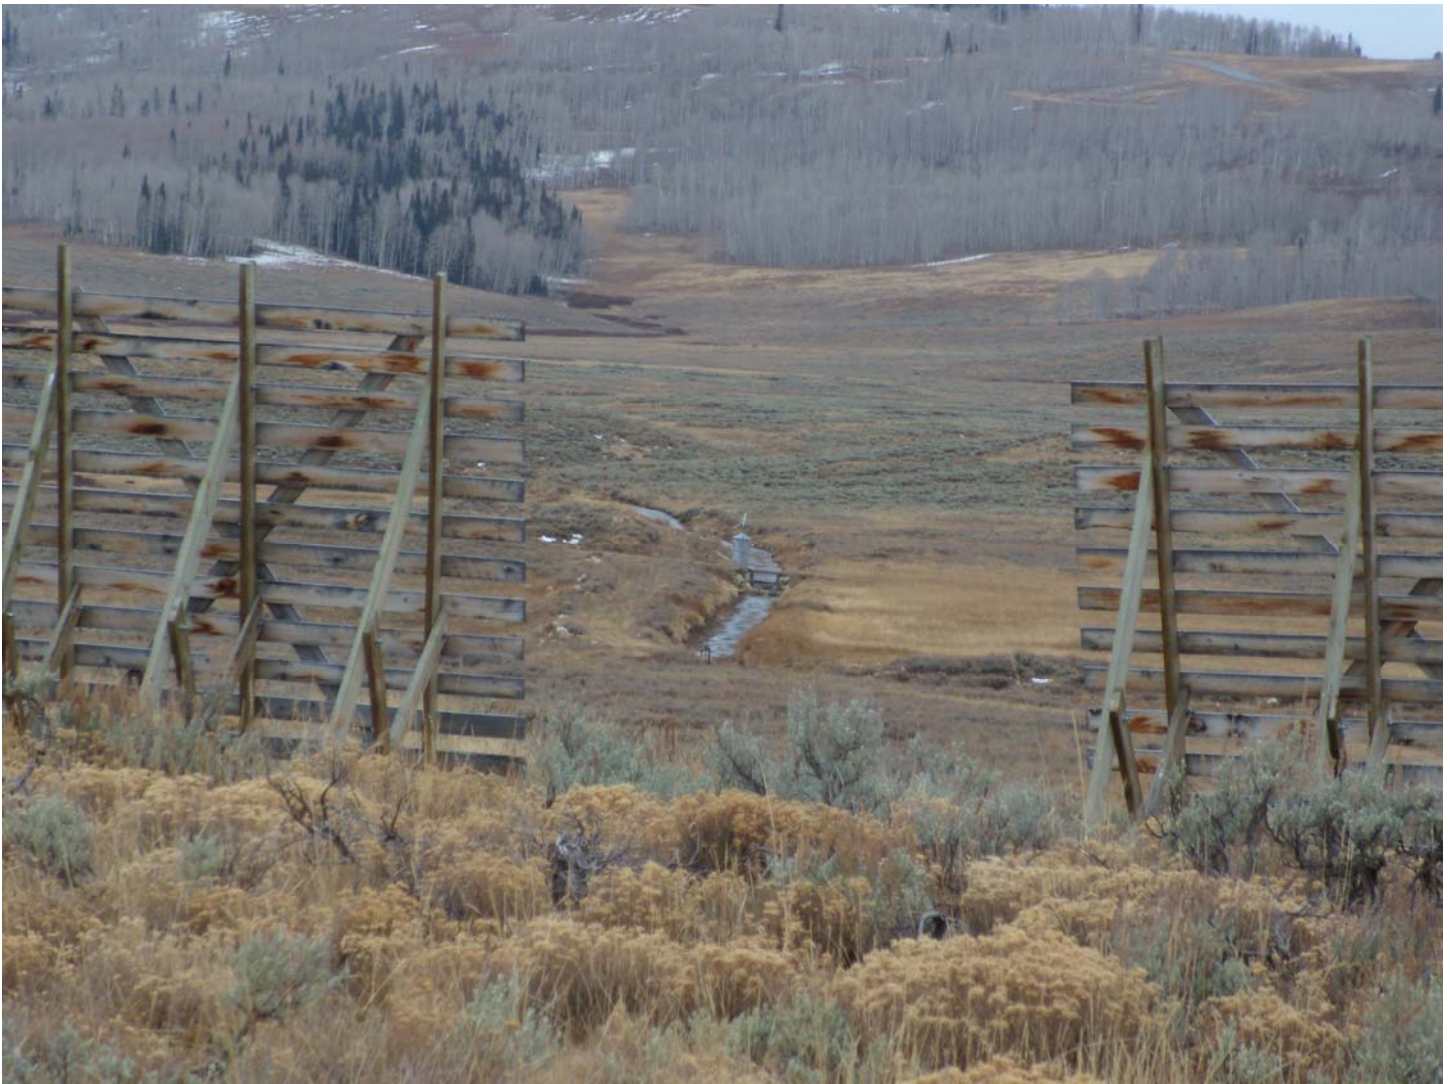
Photo 36: USGS 09309600 Fairview Tunnel near Fairview, UT. Latitude 39°40'03", Longitude 111°18'41". Drainage area: 0.01 square miles.

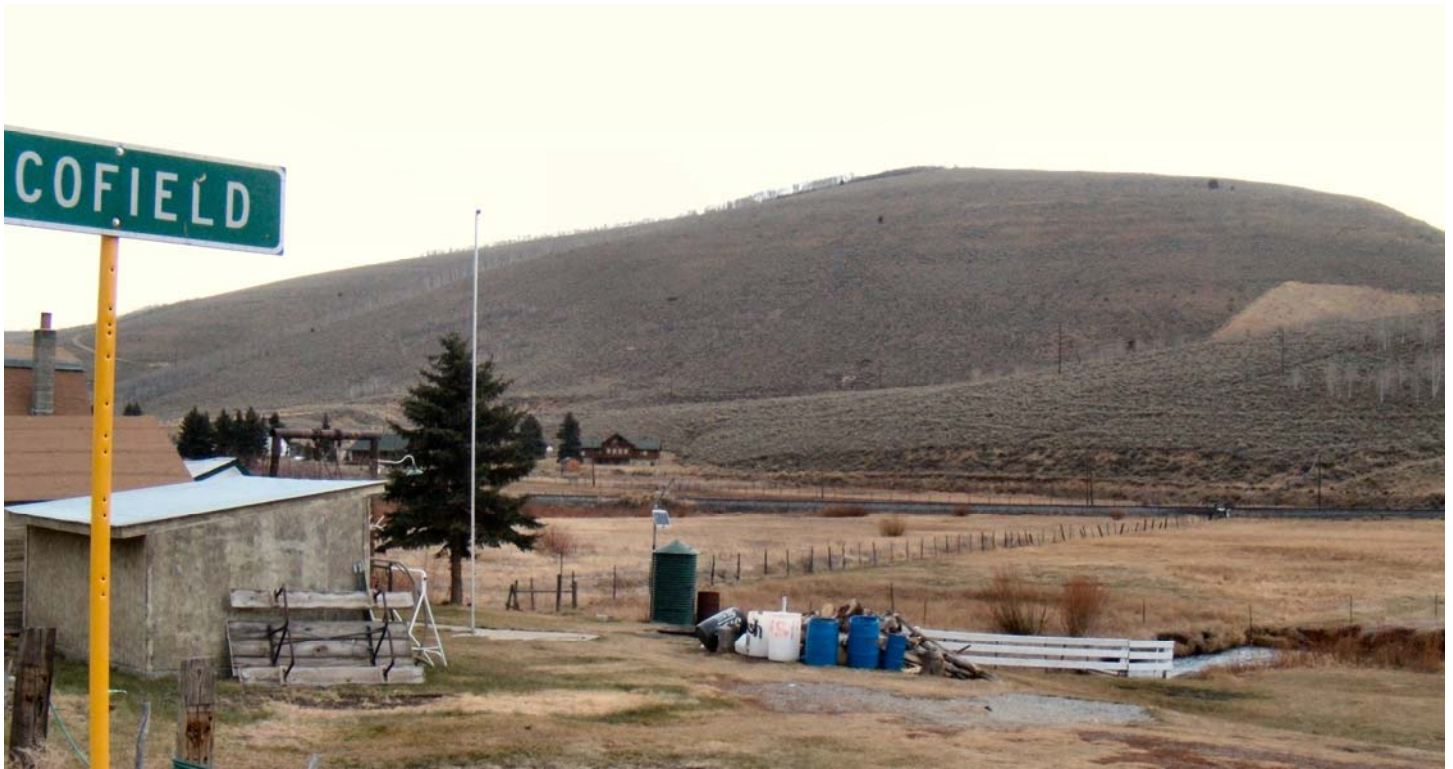
Photo 37: USGS 09310700 Mud Creek below Winter Quarters Canyon at Scofield, UT. Latitude 39°43'18", Longitude 111°09'38". Drainage area: 29.1 square miles. Sign reads: SCOFIELD. Tim Bardsley, November 12, 2009

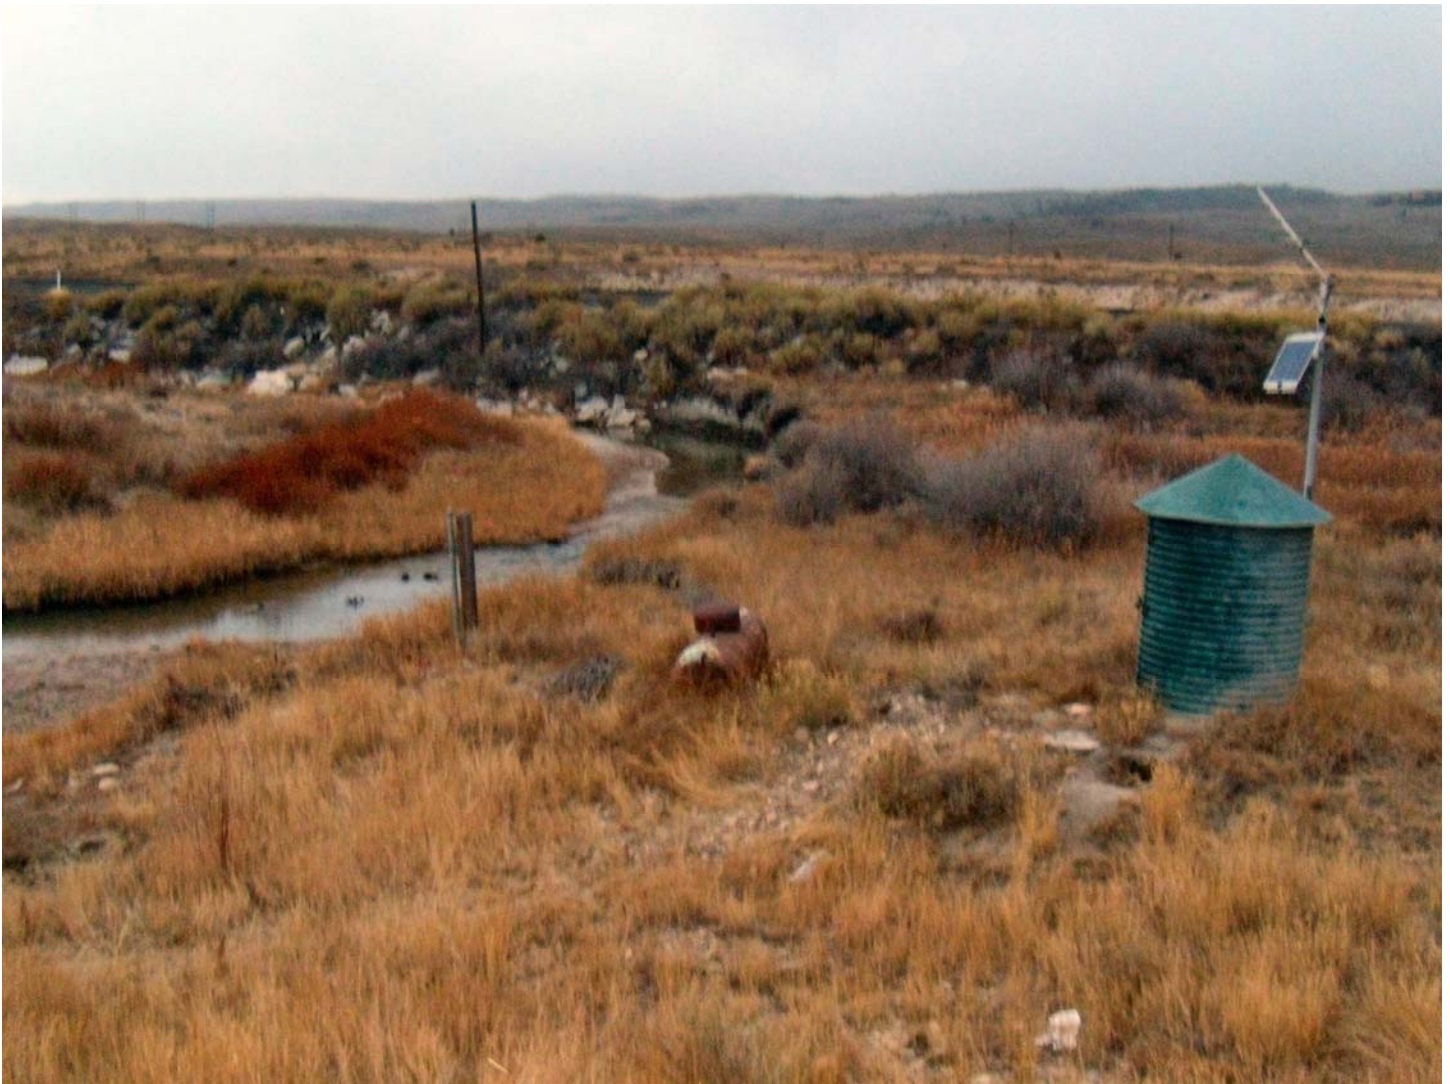
Photo 39: USGS 09312600 White River below Tabbyune Creek near Soldier Summit, UT. Latitude 39°52'33", Longitude 111°02'12". Drainage area: 75.6 square miles.
