Trip Report for Travel to Arizona the Week of January 23rd, 2006.

William B. Reed, Senior Hydrologist, NOAA's NWS Colorado Basin River Forecast Center

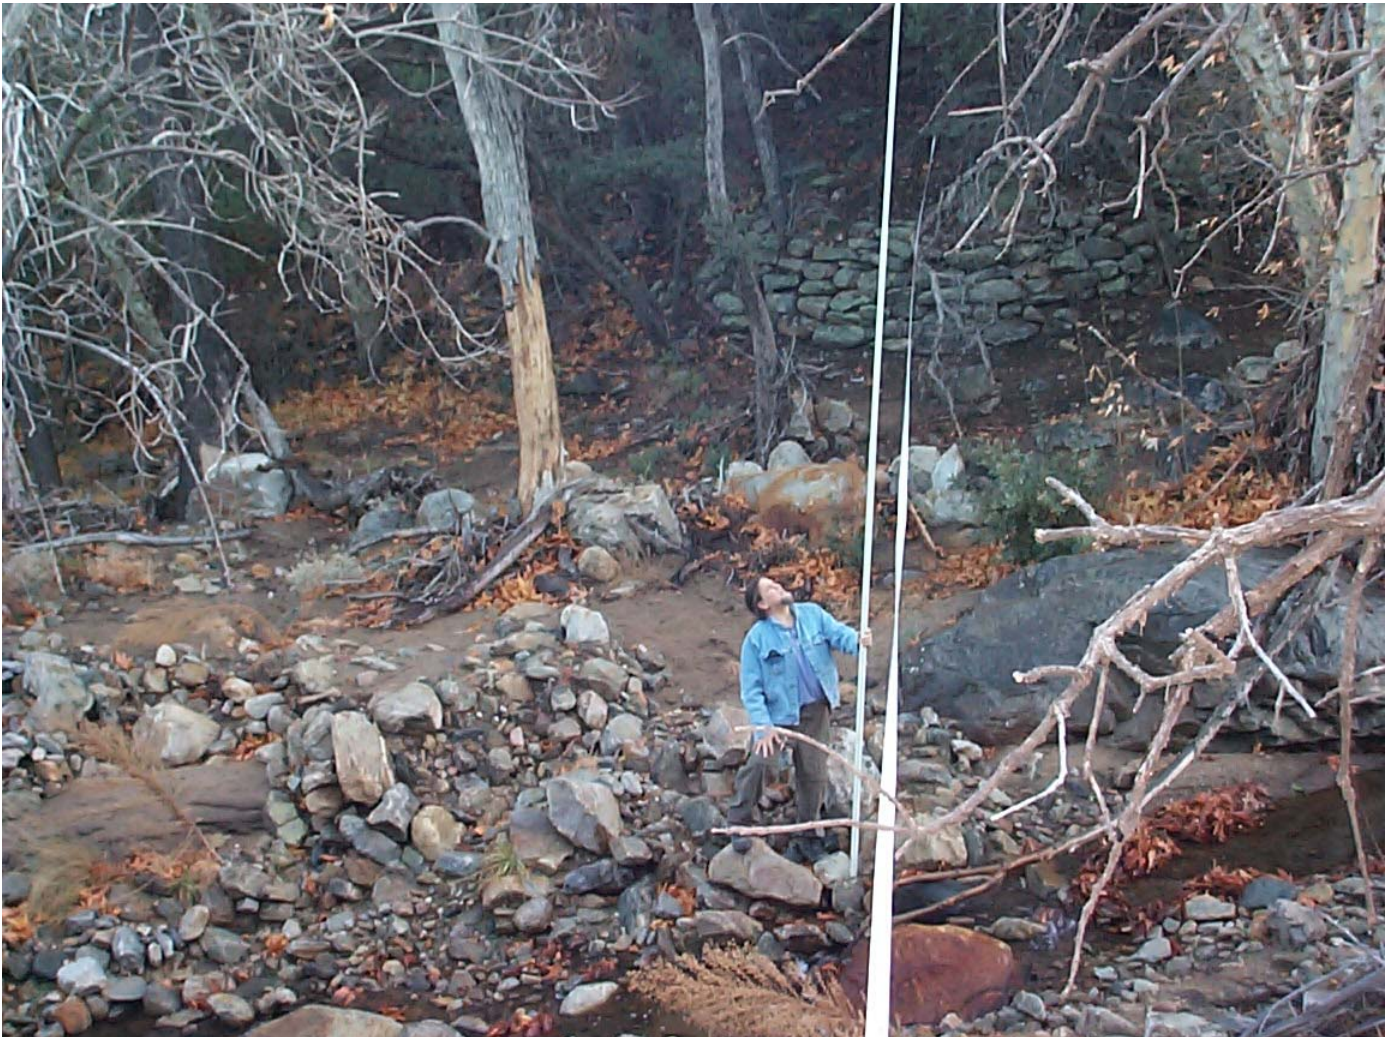
Noon Creek. Photo by Mike Schaffner (January 2006).

Noon Creek: Noon Creek is a 3.00 square mile watershed in the Pinaleno Mountains. On August 17, 2004, 0.94 inches fell in about 25 minutes. The basin average precipitation frequency for Noon Creek event was about a 2-year event. On January 25, 2006, we conducted a field survey of the high water mark and associated channel geometry for Noon Creek about 1,000 feet upstream of Highway 366. The high water mark was 10.5 feet above the channel thalweg. The cross section perpendicular to the direction of the flood flow was triangular with a top width of 110 feet and an unobstructed area of about 75% resulting in a cross sectional area of 433 square feet. Channel slope through this cross section was determined from topographic coverage of the area to be 0.18 feet/foot. Manning's "n" was estimated at 0.25. The velocity of the peak flow was calculated to be 6.20 feet/sec. The peak flow was calculated as 2,684 cfs +/- 10 percent. Such a flow would be in the range of an 250-year event. This is a post-burn peak discharge increase of 141 times greater than the pre-burn peak discharge. The 5-year post-burn flood is therefore estimated using this ratio to be 12,126 cfs.

- Noon Creek near Highway 366. Conducted slope-conveyance to estimate peak discharge from 2004 monsoon season off of Nuttall Burn Area. Flowing.

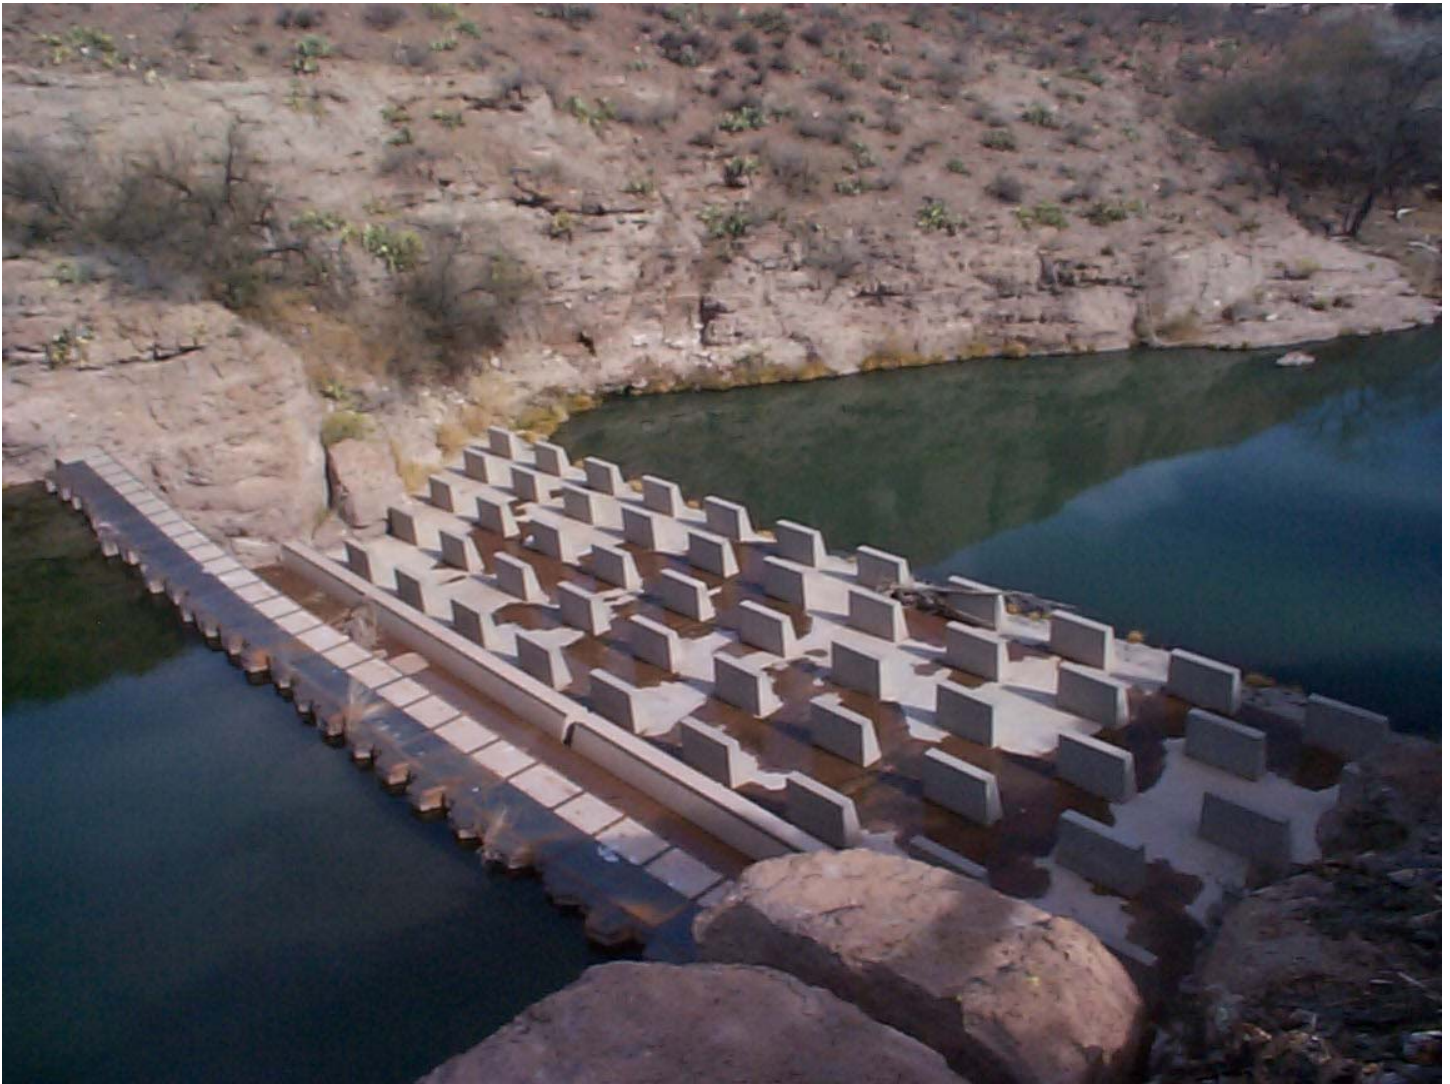
Eagle Creek. Photo by Mike Schaffner (January 2006).

Eagle Creek: The USGS gage was reporting 1.6 feet at 24 cfs. Although the flood flows for this site are above the rating curve, the extension program should work well given the site's stable geometry and channel control. (See picture below: Looking downstream to right edge of photo. Control is a small "feeder" dam.)

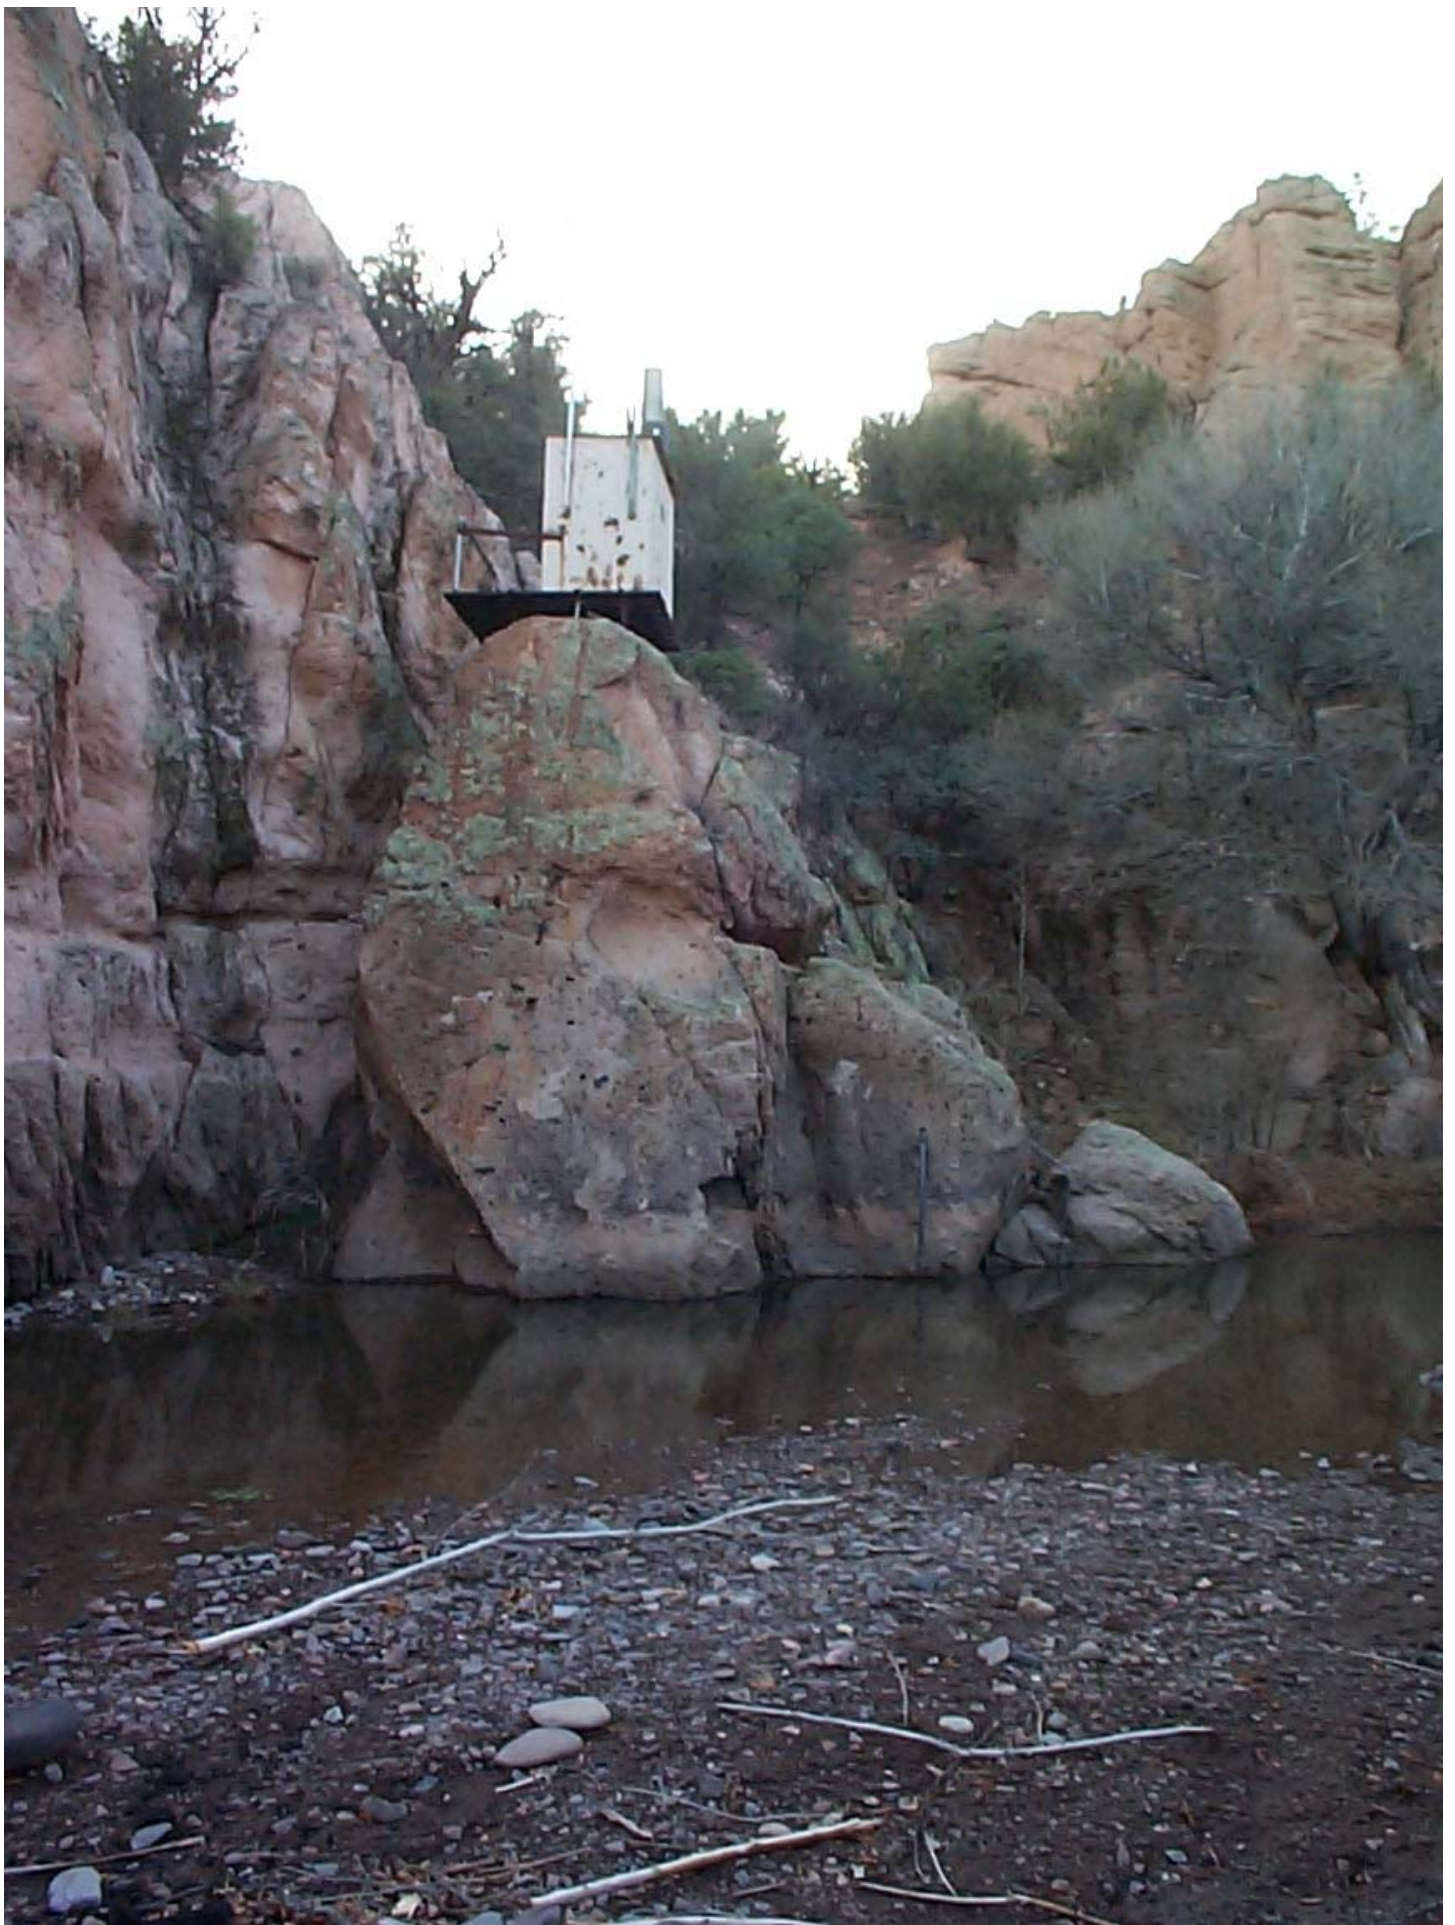
Blue River. Photo by Mike Schaffner (January 2006).

Blue River: The USGS gage was reporting 4.19 feet at 11 cfs. At this site high flows may temporarily bypass gage, possibly giving the appearance of a steady flow or drop when actually the flood flow is still increasing. (See picture next page: Looking upstream to right edge of photo.)

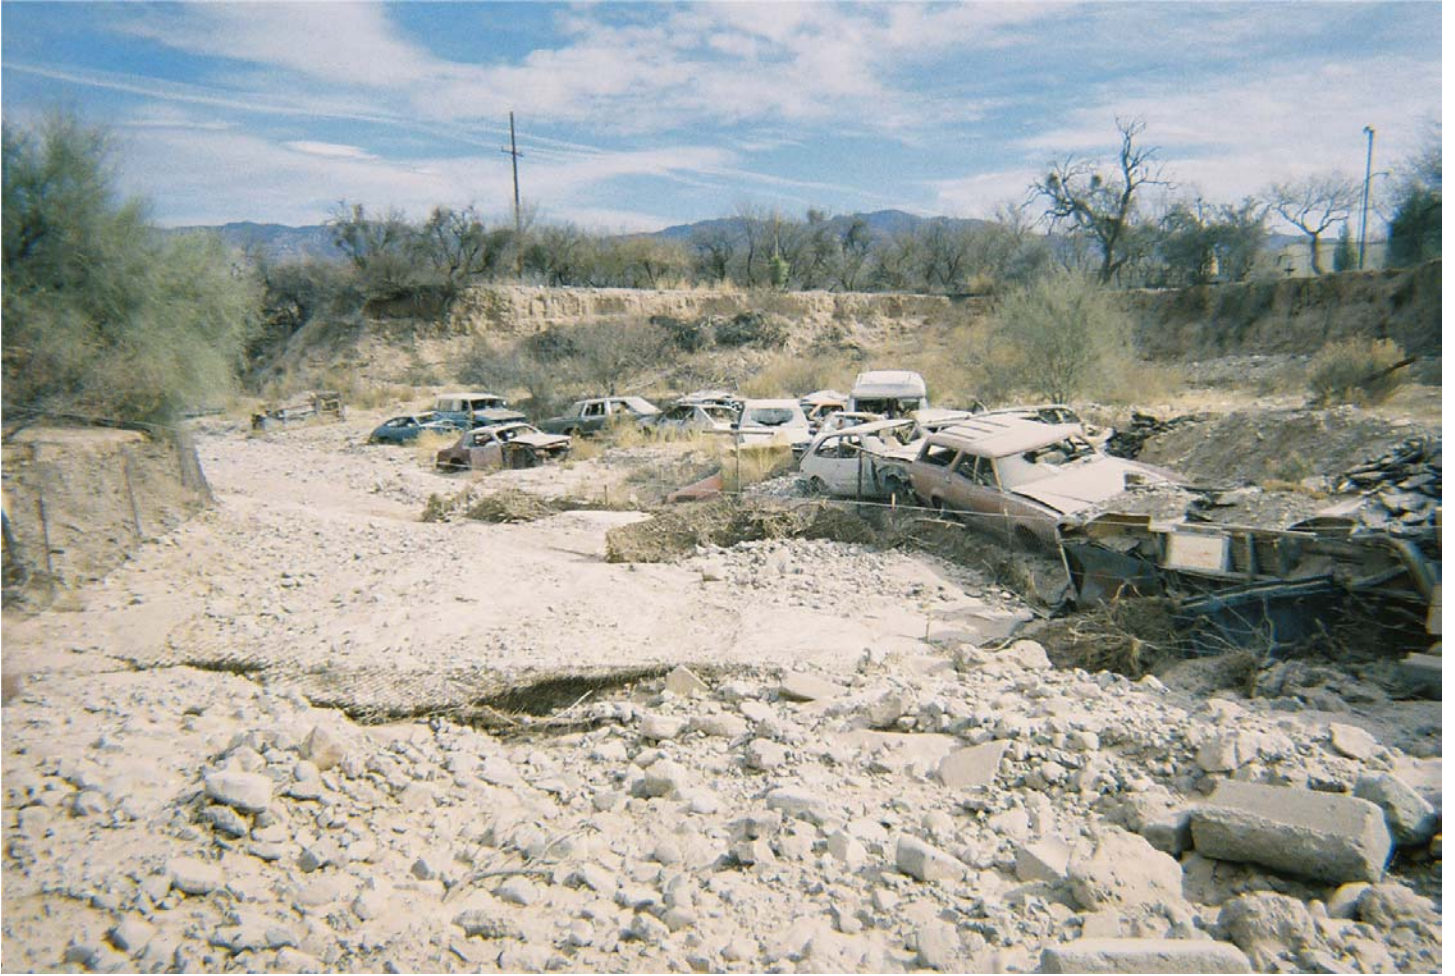
Alder Wash (abandoned cars as riprap). Photo by Bill Reed (January 2006).

- ❑ Alder Canyon at Redington Road. Observed junk cars that have been placed in the channel as riprap. Dry.
- ❑ Campo Bonito near Oracle slope-area reach (burned basin). Site visited and high water marks observed. Dry.

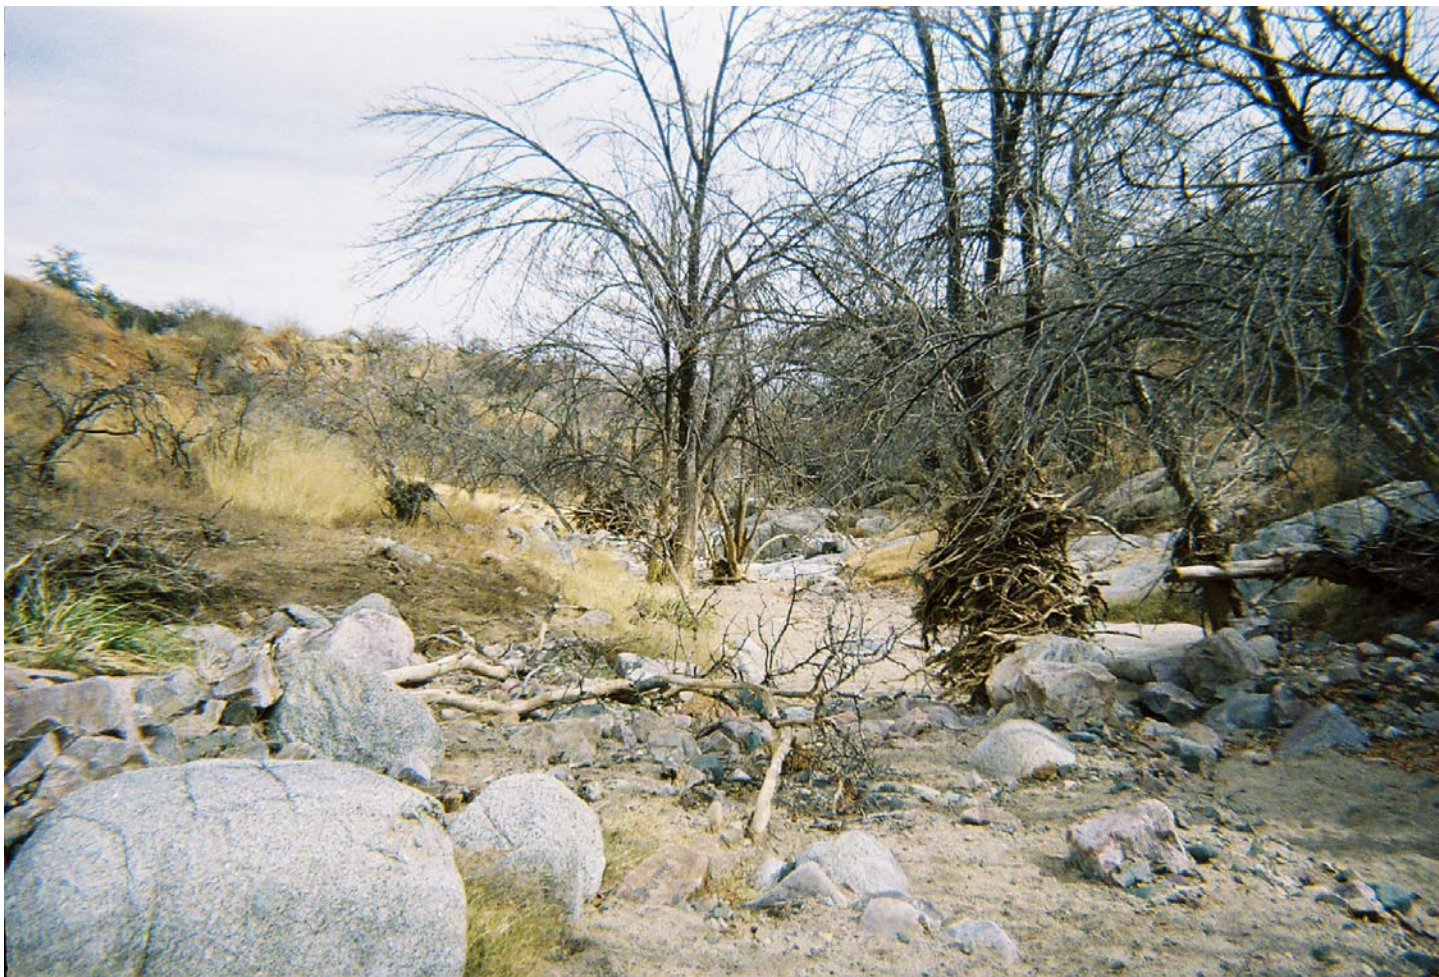
Upper Campo Bonito (high water marks still clearly visible). Photo by Bill Reed (January 2006).

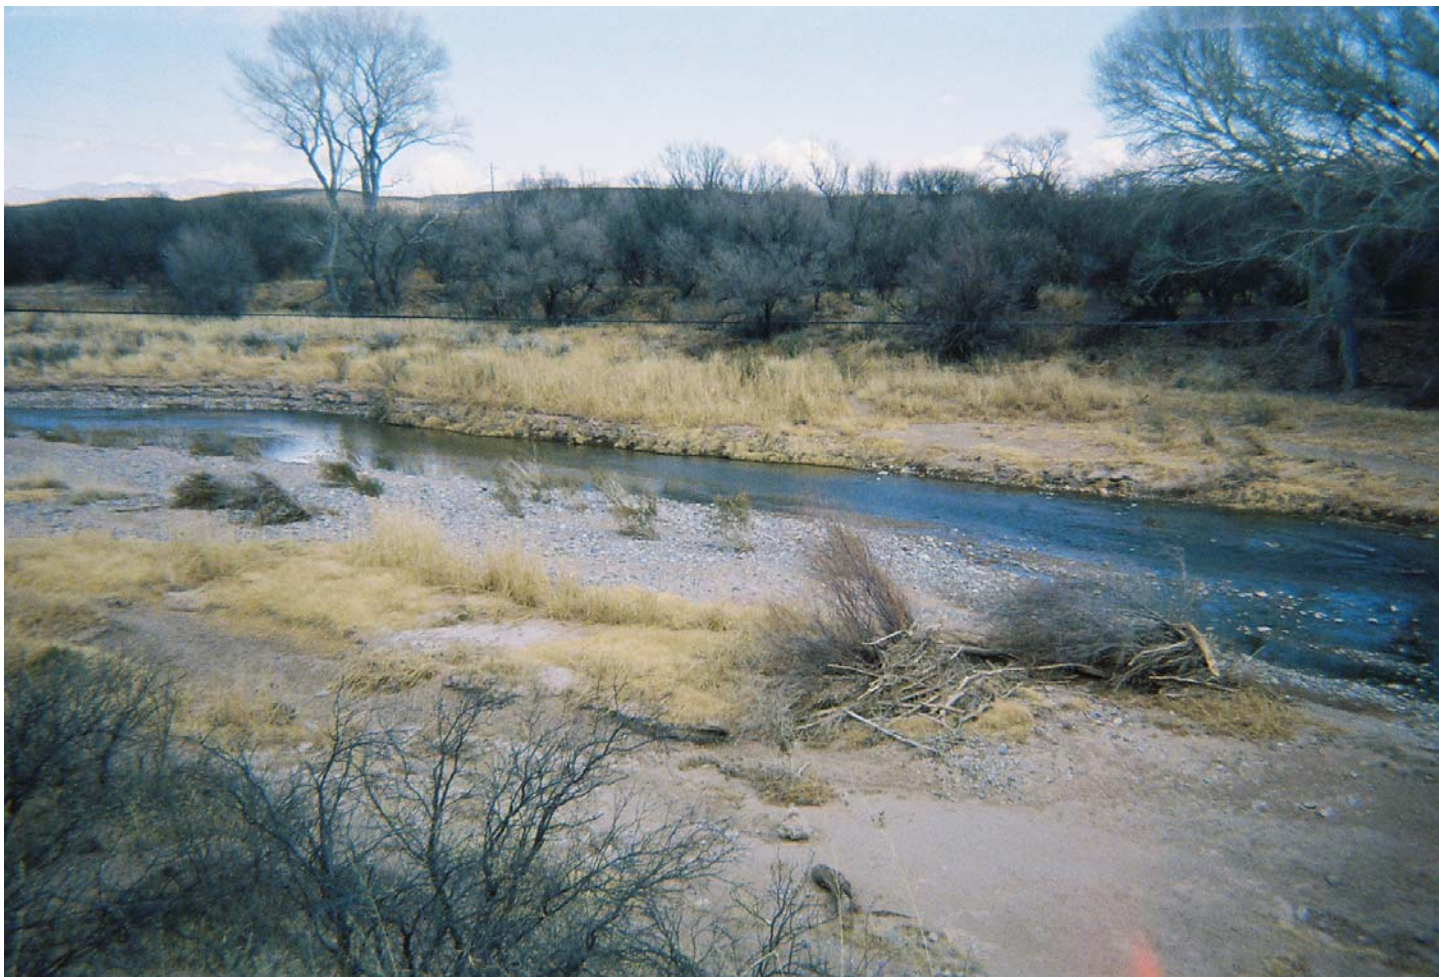
San Pedro River at Fairbank (flowing). Photo by Bill Reed (January 2006).

San Pedro River: From the Mexico border the San Pedro River flows northwest to its confluence with the Gila River near Hayden. The San Pedro River was flowing upstream at Fairbank and near Saint David. The mid-reach around Redington and Mammoth was dry. The reach at Dudleyville was flowing due to Arivaipa Creek's contribution. At the time of our visits to the upstream sites, the USGS gage at Charleston was reporting 14 cfs and we estimated the stream flow at Fairbank to be about 15 cfs. At the time of our visit to Arivaipa Creek, the USGS gage was reporting a stage of 1.40 feet at 12 cfs. At Dudleyville we estimated the flow to be about 3-4 cfs.

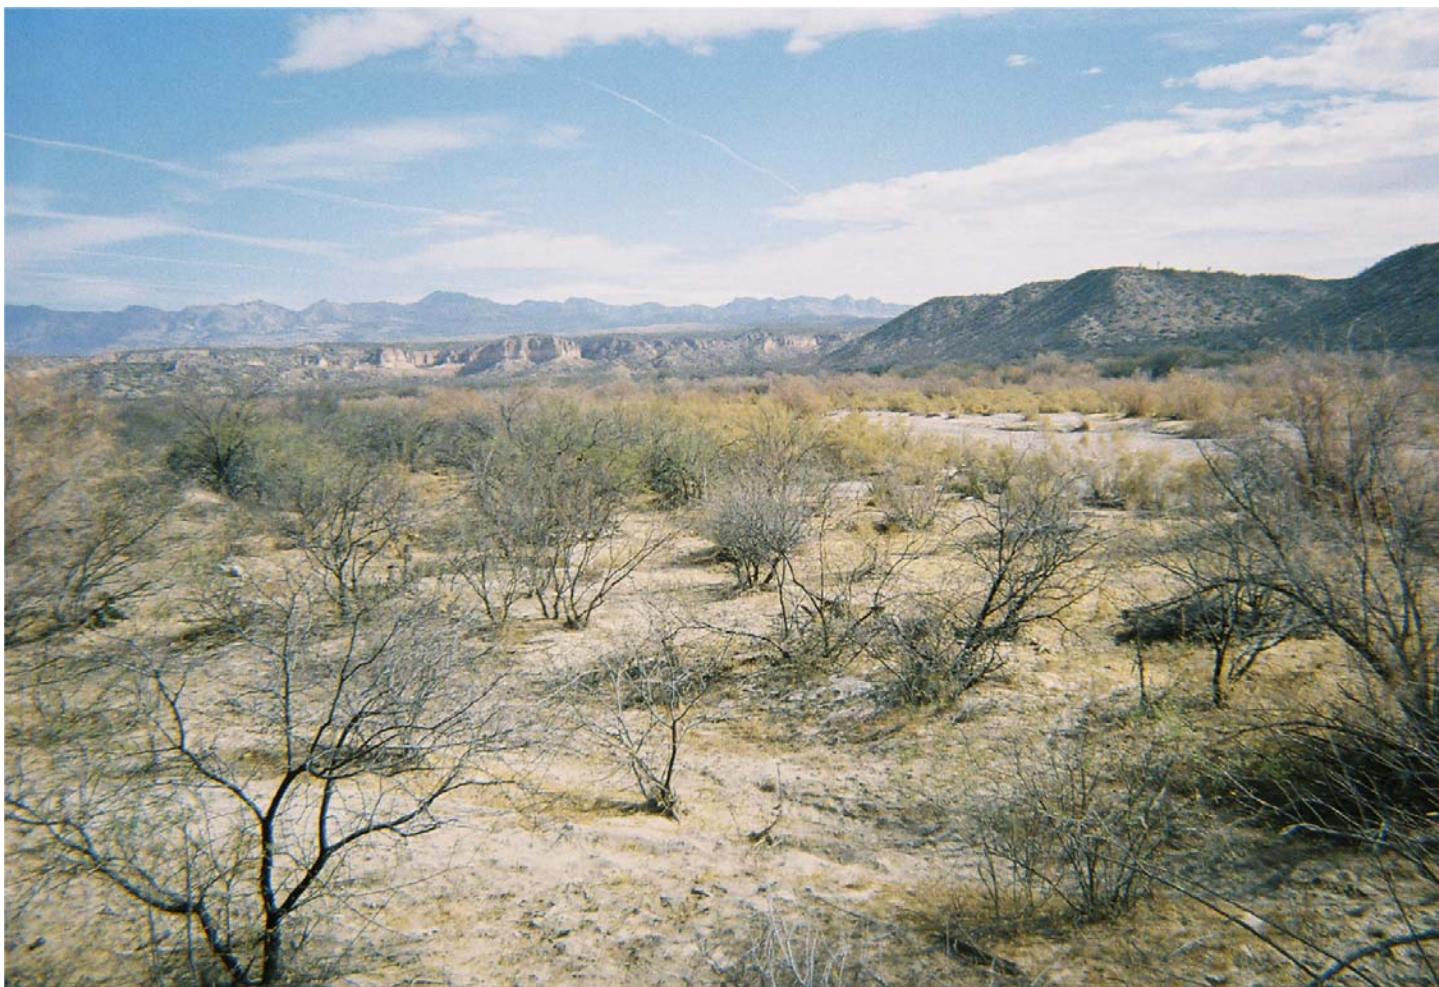
San Pedro River near Redington (looking downstream of bridge, dry). Photo by Bill Reed (January 2006).

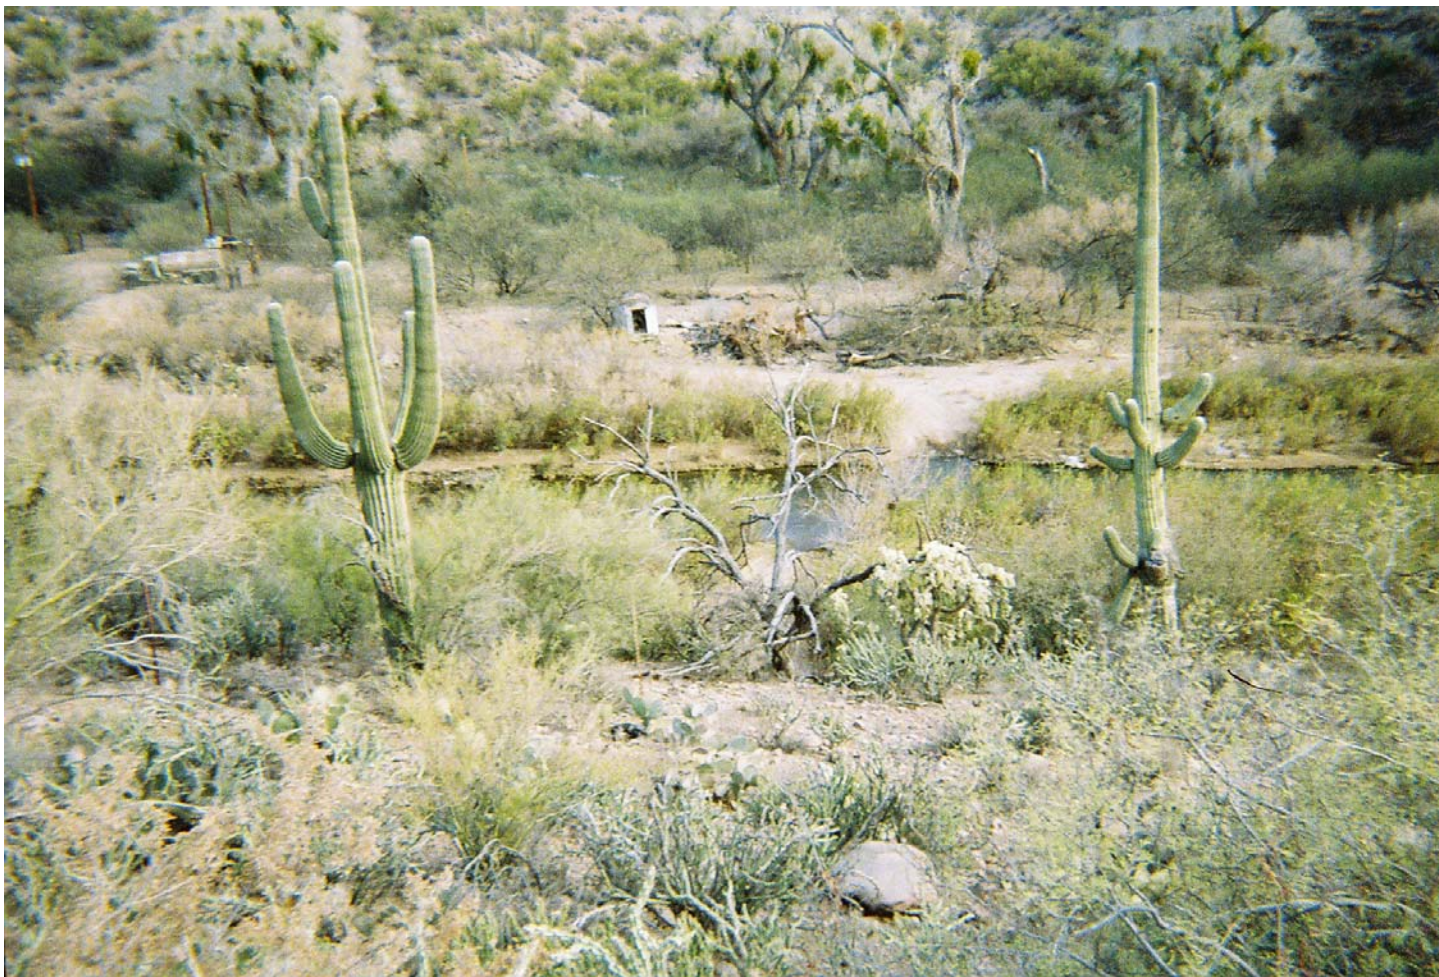
Aravaipa Creek (looking from near gage on right bank to left bank, flowing). Photo by Bill Reed (January 2006).

- ❑ San Pedro River at Mammoth. No gage at site. Visually inspected channel and compared to flood flows from Redington gage. Dry.
- ❑ Aravaipa Creek near Mammoth (ARVA3). Evaluated for flood stages / forecast point. Flowing. Elise Moore departs.

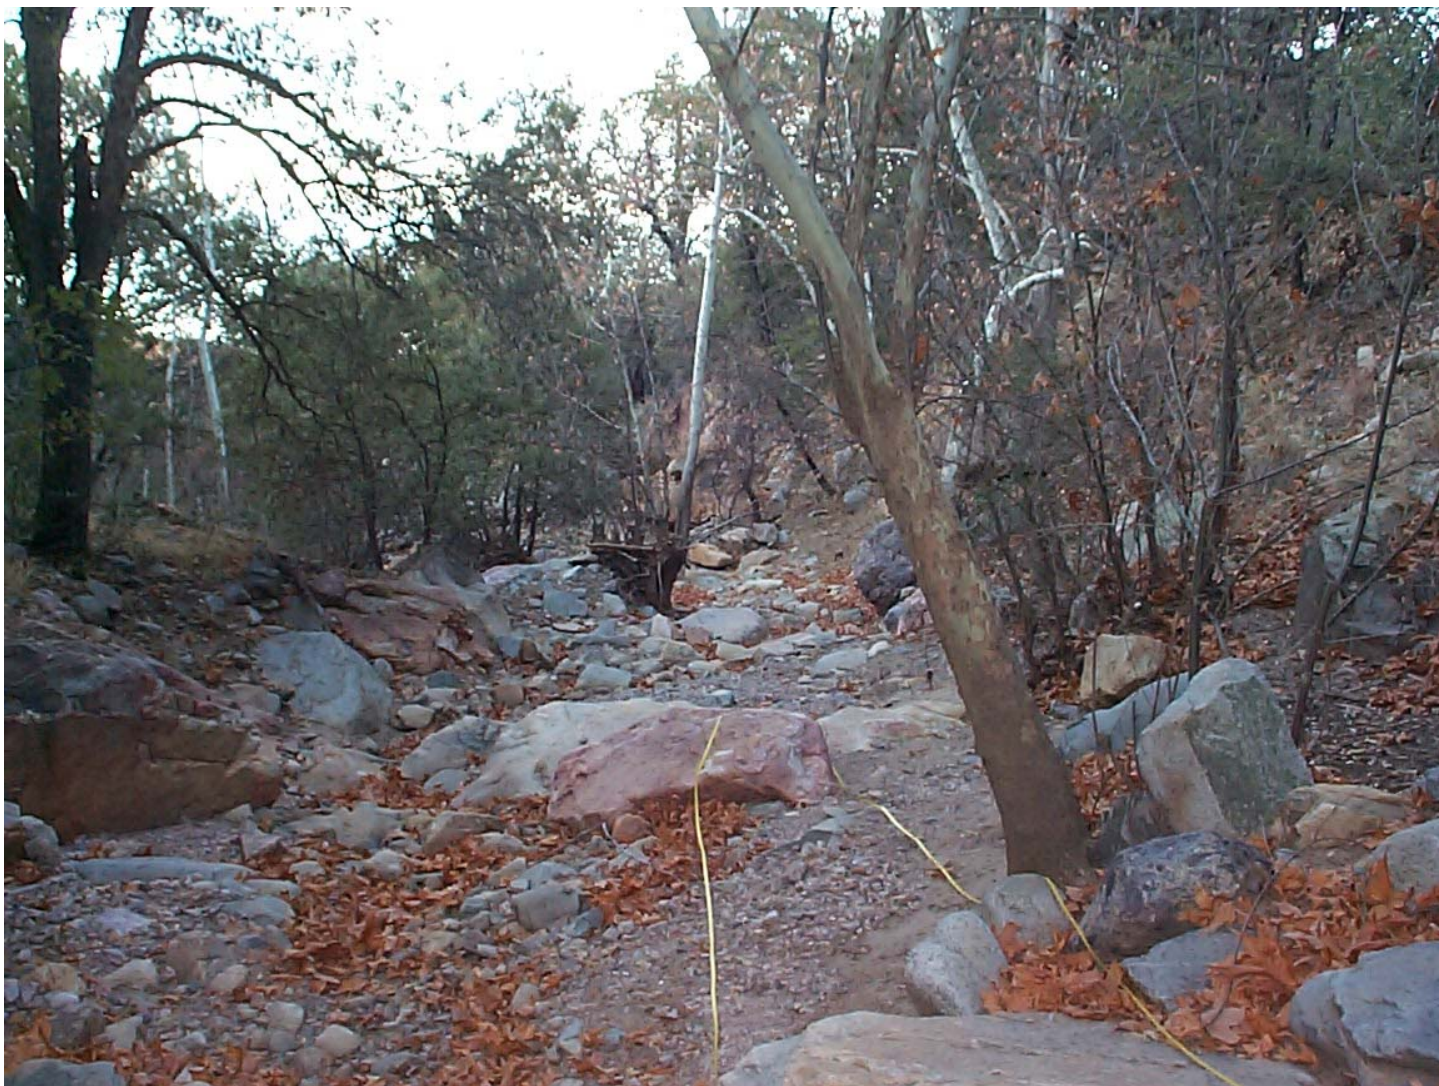
Madera Canyon (looking downstream). Photo by Mike Schaffner (January 2006).

Madera Canyon: Madera Canyon is a 4.00 square mile watershed in the Santa Rita Mountains. On August 8, 2005, 0.70 inches fell in about 45 minutes. The basin average precipitation frequency for Madera Canyon event was less than a 2-year event. On January 23, 2006, we conducted a field survey of the high water mark and associated channel geometry for Madera Creek near the U.S. Forest Service amphitheater. The high water mark was 7 feet above the channel thalweg. The cross section perpendicular to the direction of the flood flow was trapezoidal with a top width of 38.2 feet and a base of 15 feet resulting in a cross sectional area of 186.2 square feet. Channel slope through this cross section was 0.094 feet/foot. Manning's "n" was estimated at 0.24. The velocity of the peak flow was calculated to be 4.79 feet/sec. The peak flow was calculated as 891.8 cfs +/- 10 percent. Such a flow would be in the range of an 8-year return flow. This is a post-burn peak discharge increase of at least 3.3 times greater than pre-burn peak discharge. The 5-year post-burn flood is therefore estimated using this ratio to be greater than 2,170 cfs.

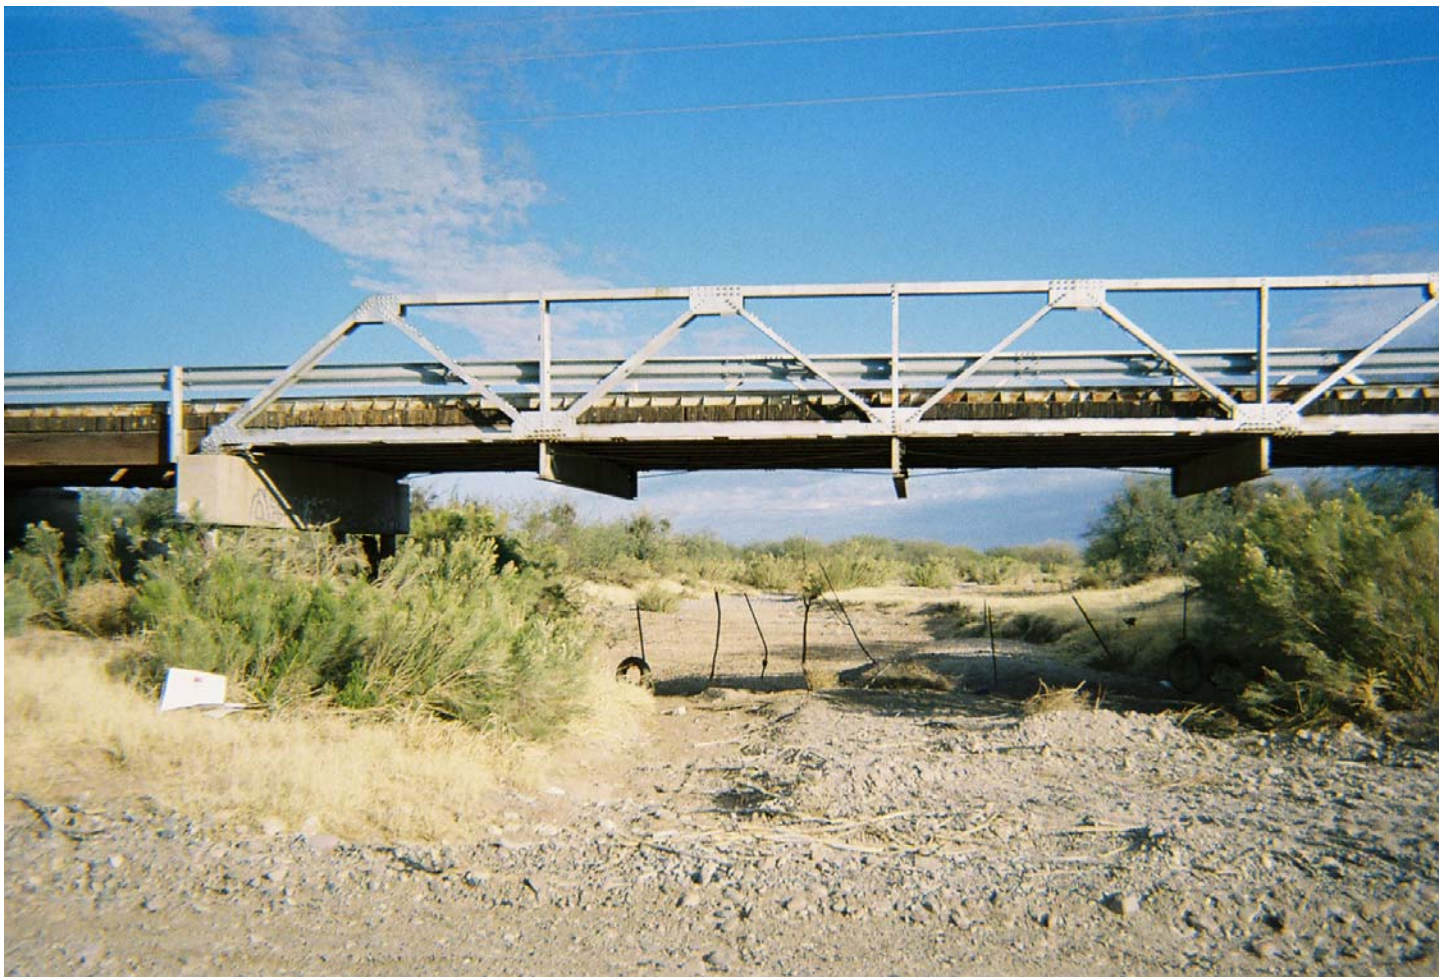
Bradley Wash at Milewide Road. Photo by Bill Reed (January 2006).

- ❑ Brawley Wash at Milewide Road (BMWA3) downstream terminus of guidance forecast reach. Site of 6,125 cfs flood from Aug 14, 2005 monsoon. Dry.
- ❑ Brawley Wash near Three Points (BWTA3) Guidance River Forecast Point. USGS gage. Site of 11,800 cfs flood from Aug 14, 2005 monsoon. Dry.
- ❑ San Pedro River near Saint David. No gage. Flowing.
- ❑ San Pedro River at Fairbank. San Pedro Riparian National Conservation Area. No gage. Flowing.
- ❑ Dragoon Wash at Sibyl Road near Saint David. Flash Flood Concern. Dry.
