Trip Report for Travel to Review Flooding in Southern Utah Within Salt Lake City HSA From May 24th to May 25th, 2005.

**William B. Reed¹, Senior Hydrologist
NOAA's Colorado Basin River Forecast Center**

PURPOSE OF TRIP:

- ❖ To review ongoing flooding in Southern Utah, Great Basin Desert (Beaver River, Sevier River, and Coal Creek); and Colorado Basin (East Fork Virgin River); also
- ❖ To estimate critical stages where needed.

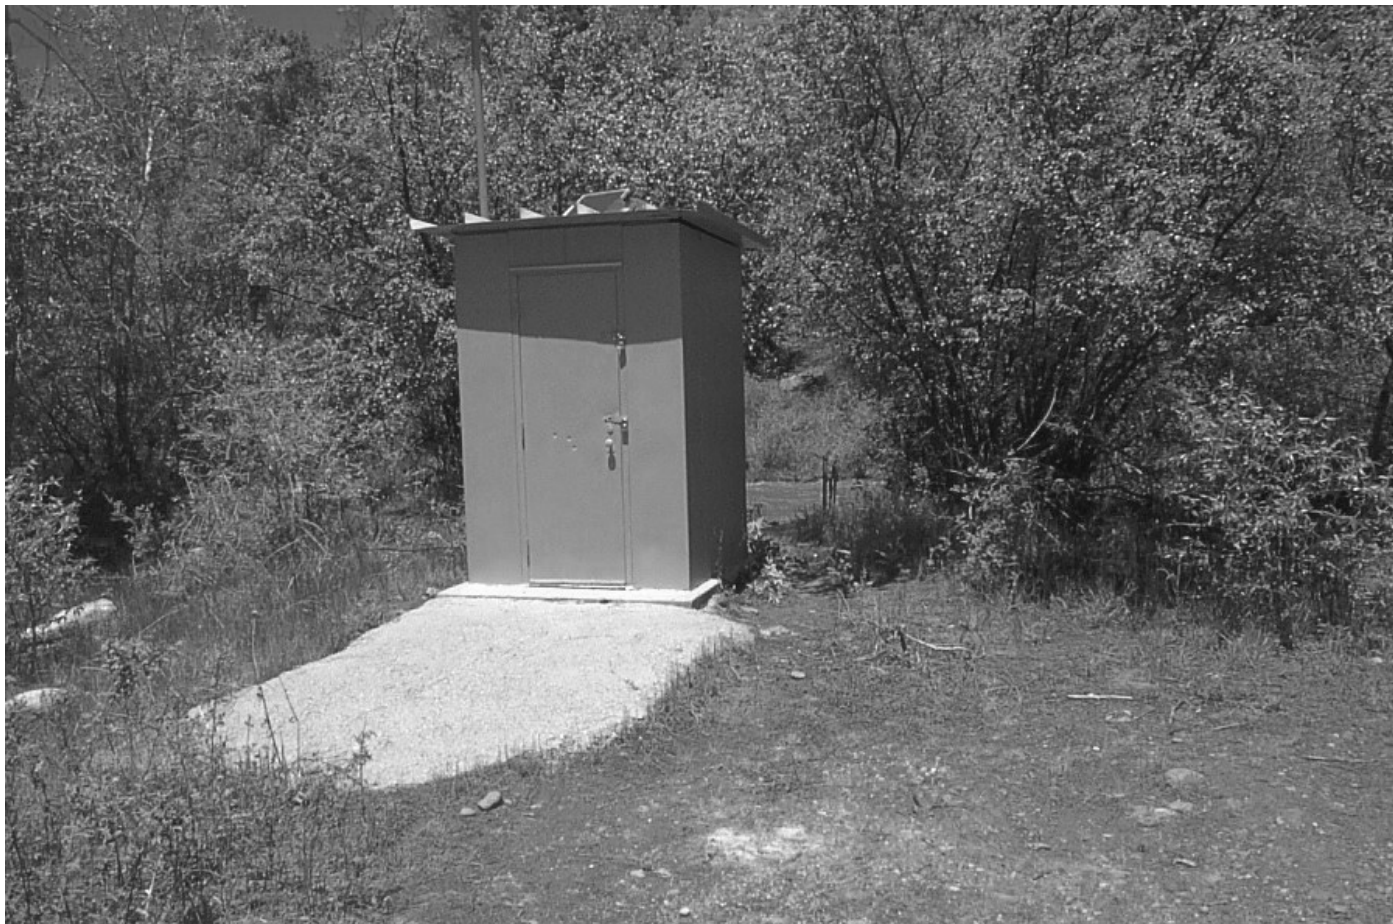
At time of visit (1305) the flow was approximately 1 foot below bank full and 1.5 feet below road surface downstream.

Gage was reading 2.57 feet on 5/24 at 1305.

BEVU1 Gage House, stream within bank. wbr 5/24/2005@1300

Suggest new bank full stage of 3.5 feet.

Suggest new minor unofficial flood stage of 4.0 feet

Suggest new moderate unofficial flood stage of 4.5 feet.

Suggest new major unofficial flood stage of 5.0 feet.

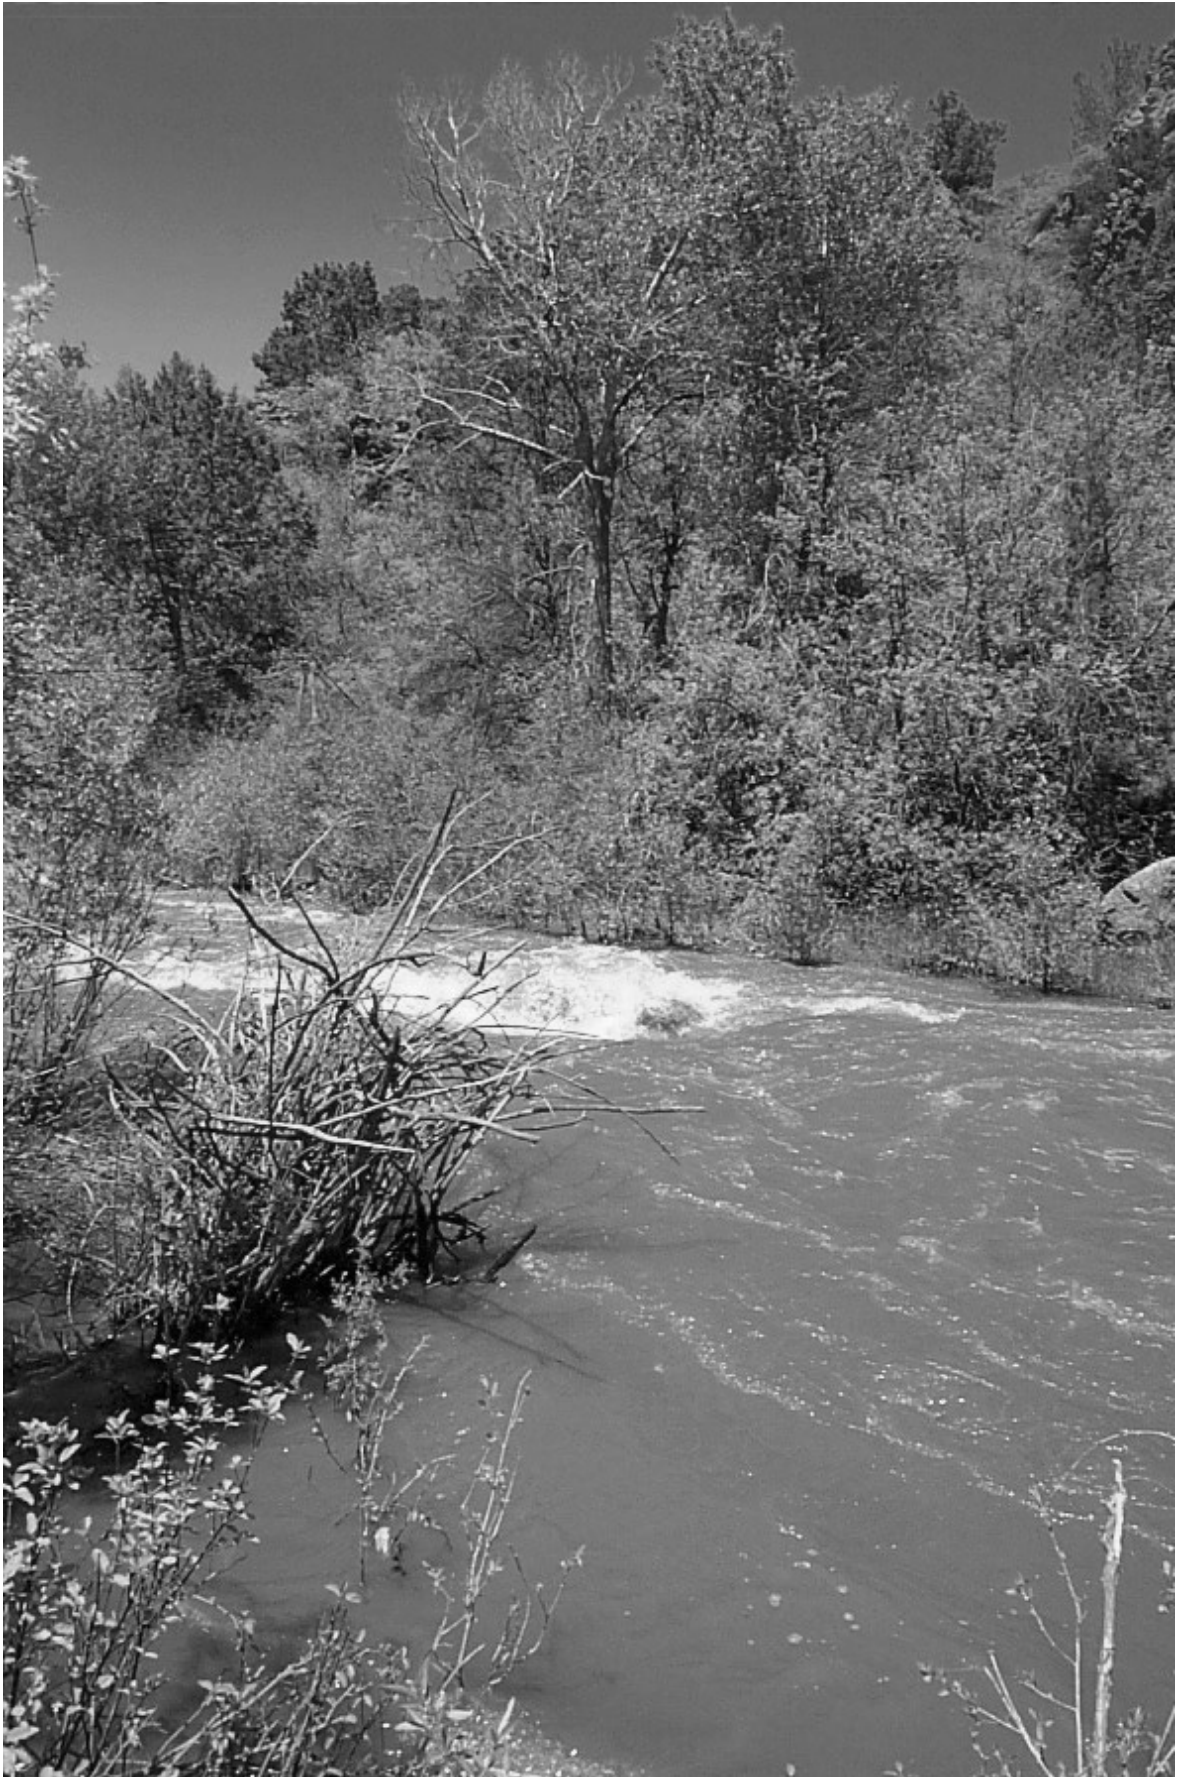
USGS Webpage reports 2.58 feet at 569 cfs for 1300.

BEVU1 Flow 569 cfs. wbr 5/24/2005@1300

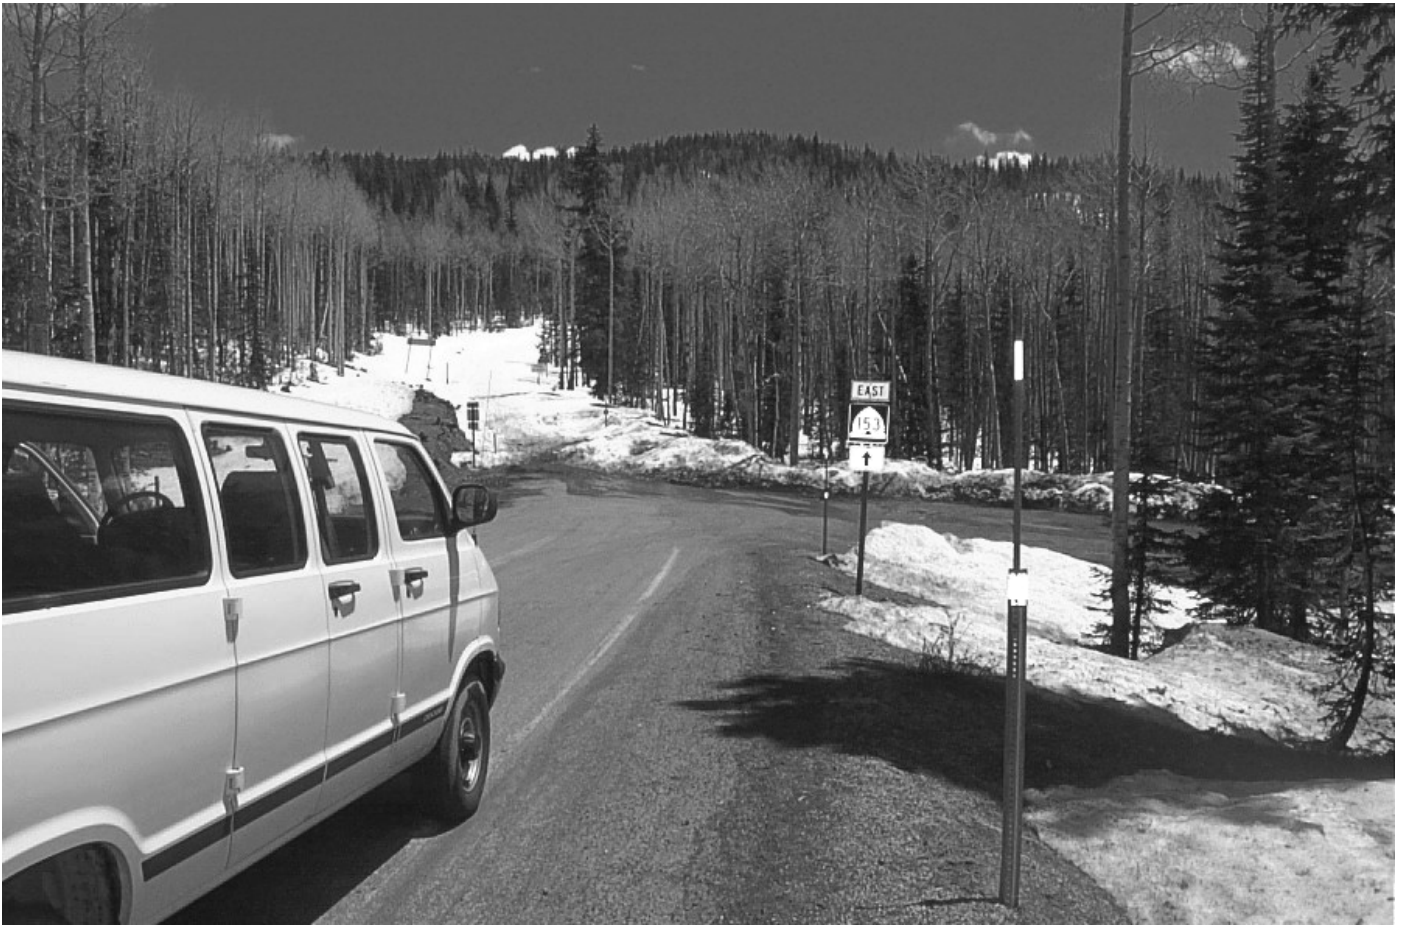
At the very top of the Beaver River watershed was a dam that could possibly become unstable. Also went to where Utah 153 was still closed 22 miles due to snow (so had to back track and take Utah 20 to US 89). When I arrived at the junction of 20 & 89 it was 1510 so decided to proceed south to Hatch.

Utah 153 closed about 22 miles beyond BEVU1. wbr 5/24/2005

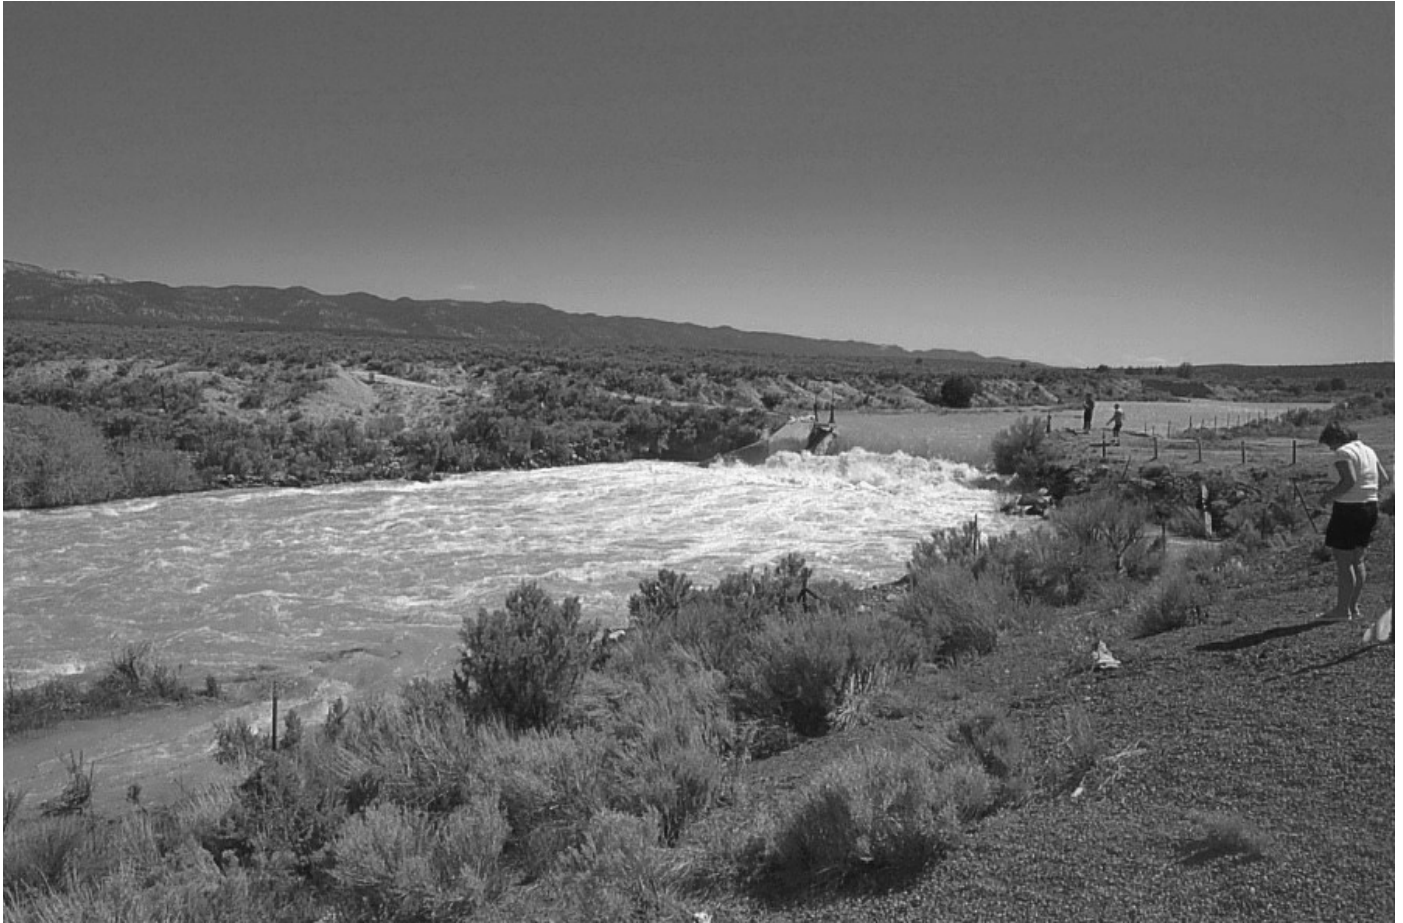
This site typified what may be referred to as “scenic flooding” and was being photographed by several tourists. See Hatch for estimate of flow.

Sevier River downstream of Hatch – flow 1600 cfs. wbr 5/24/2005

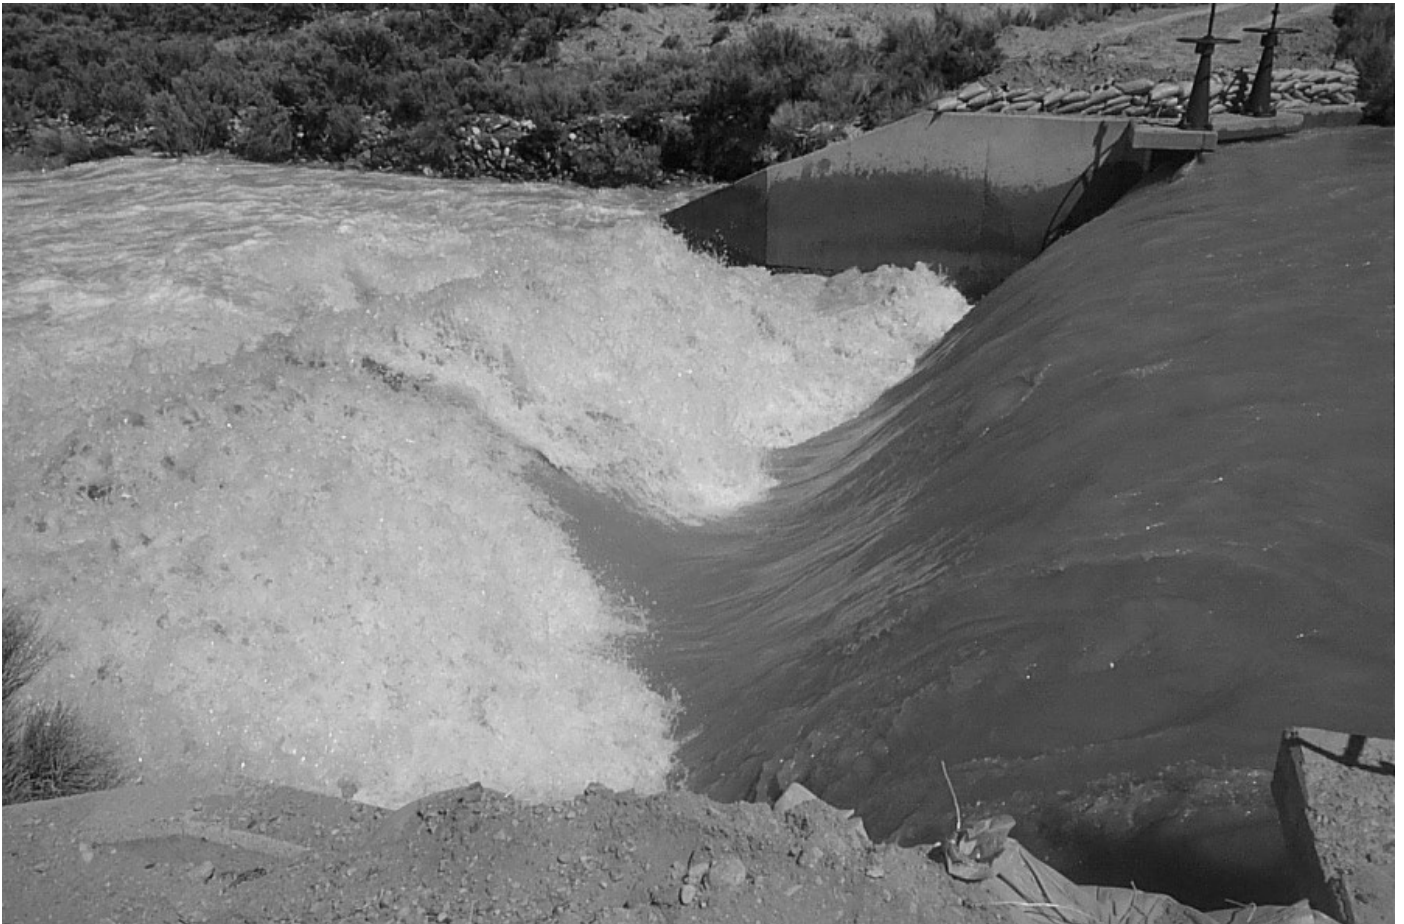
Sevier River downstream of Hatch – flow 1600 cfs. wbr 5/24/2005

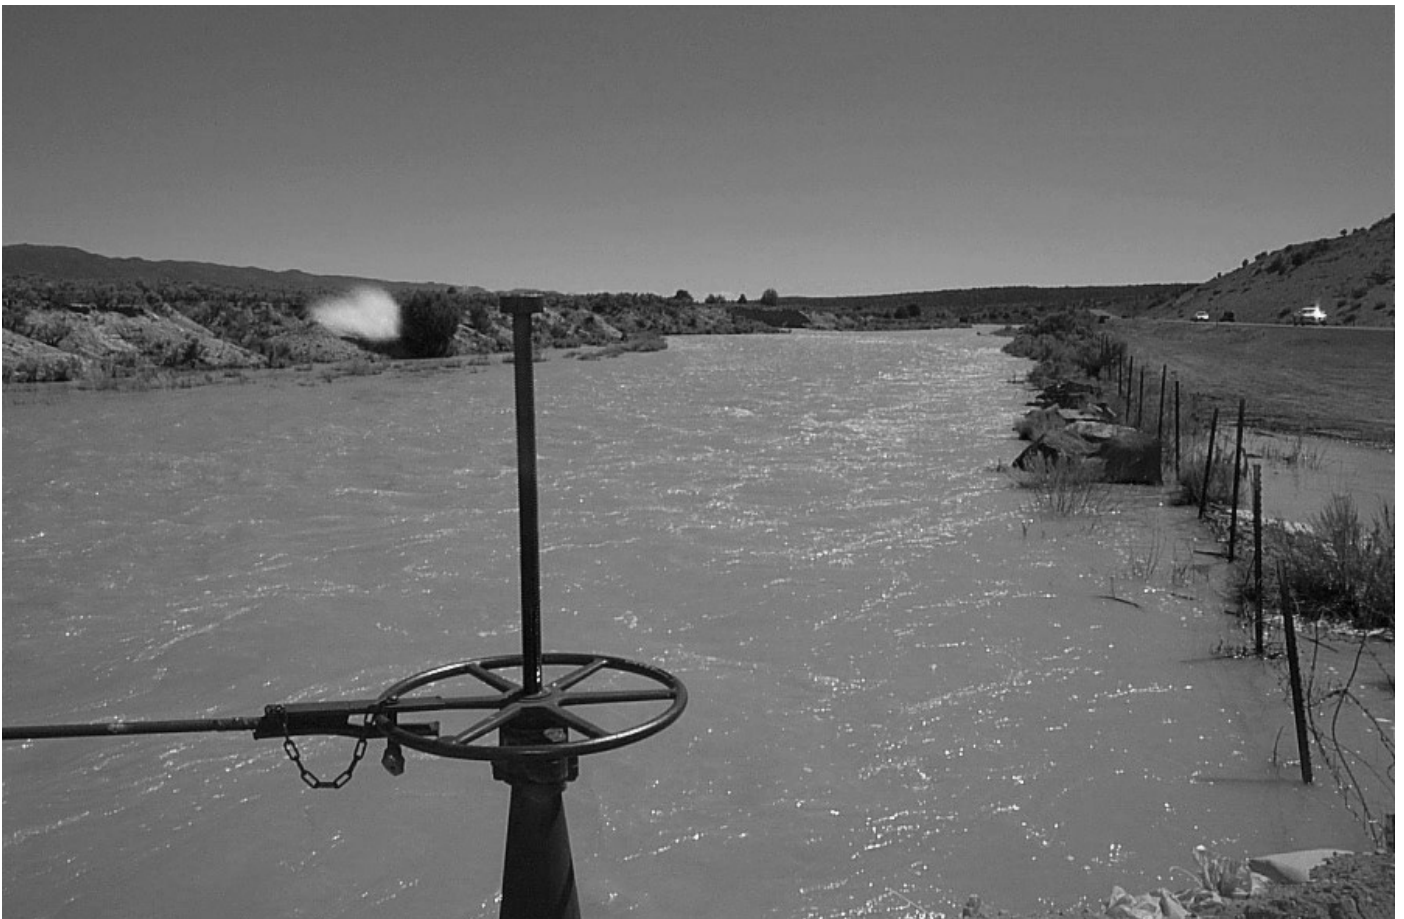
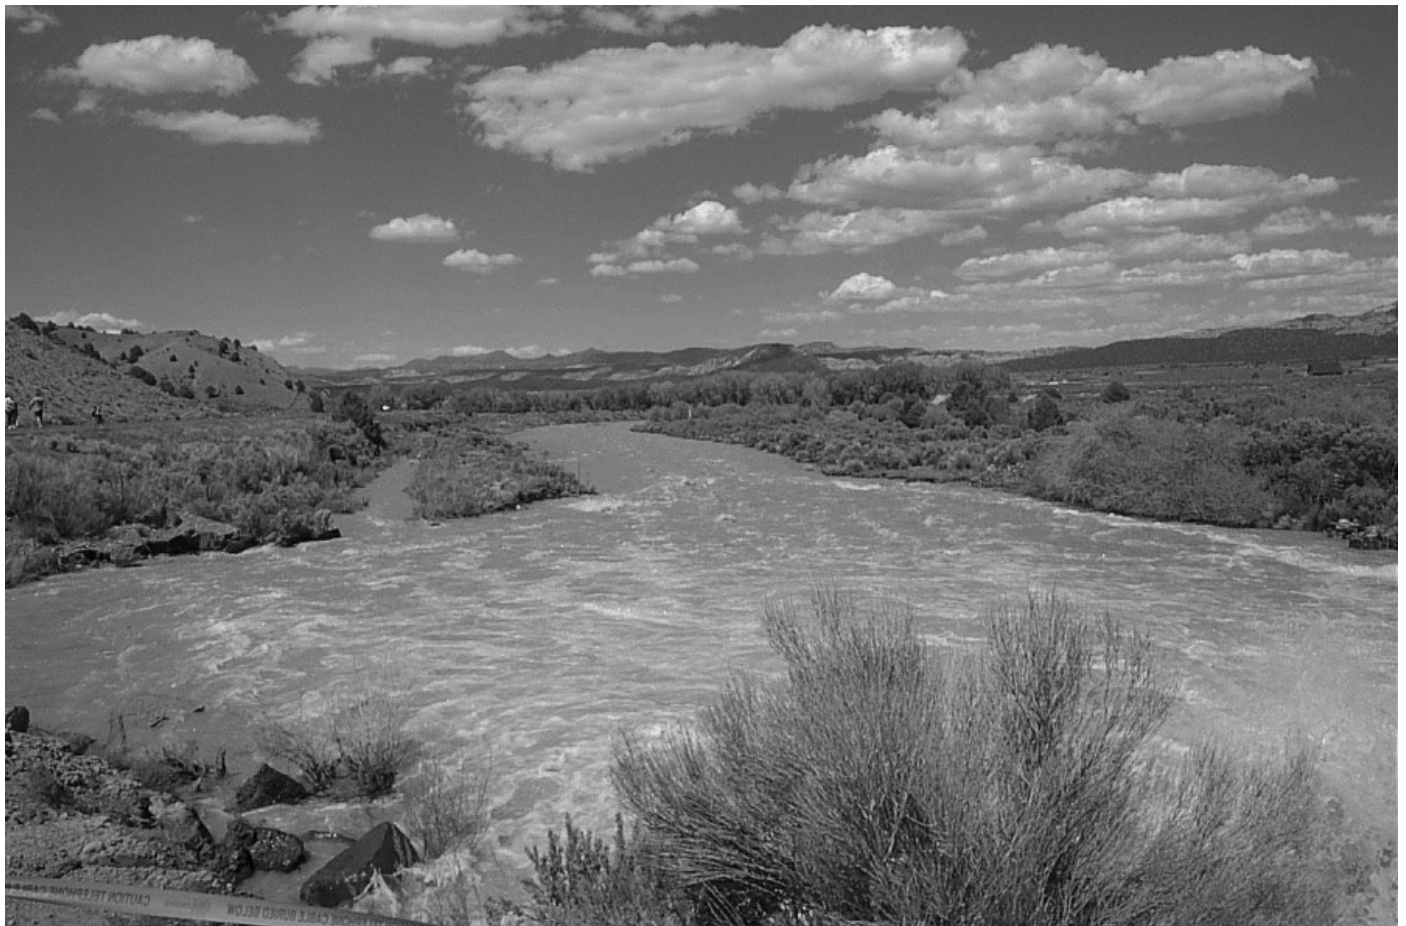
Sevier River downstream of Hatch – flow 1600 cfs. wbr 5/24/2005

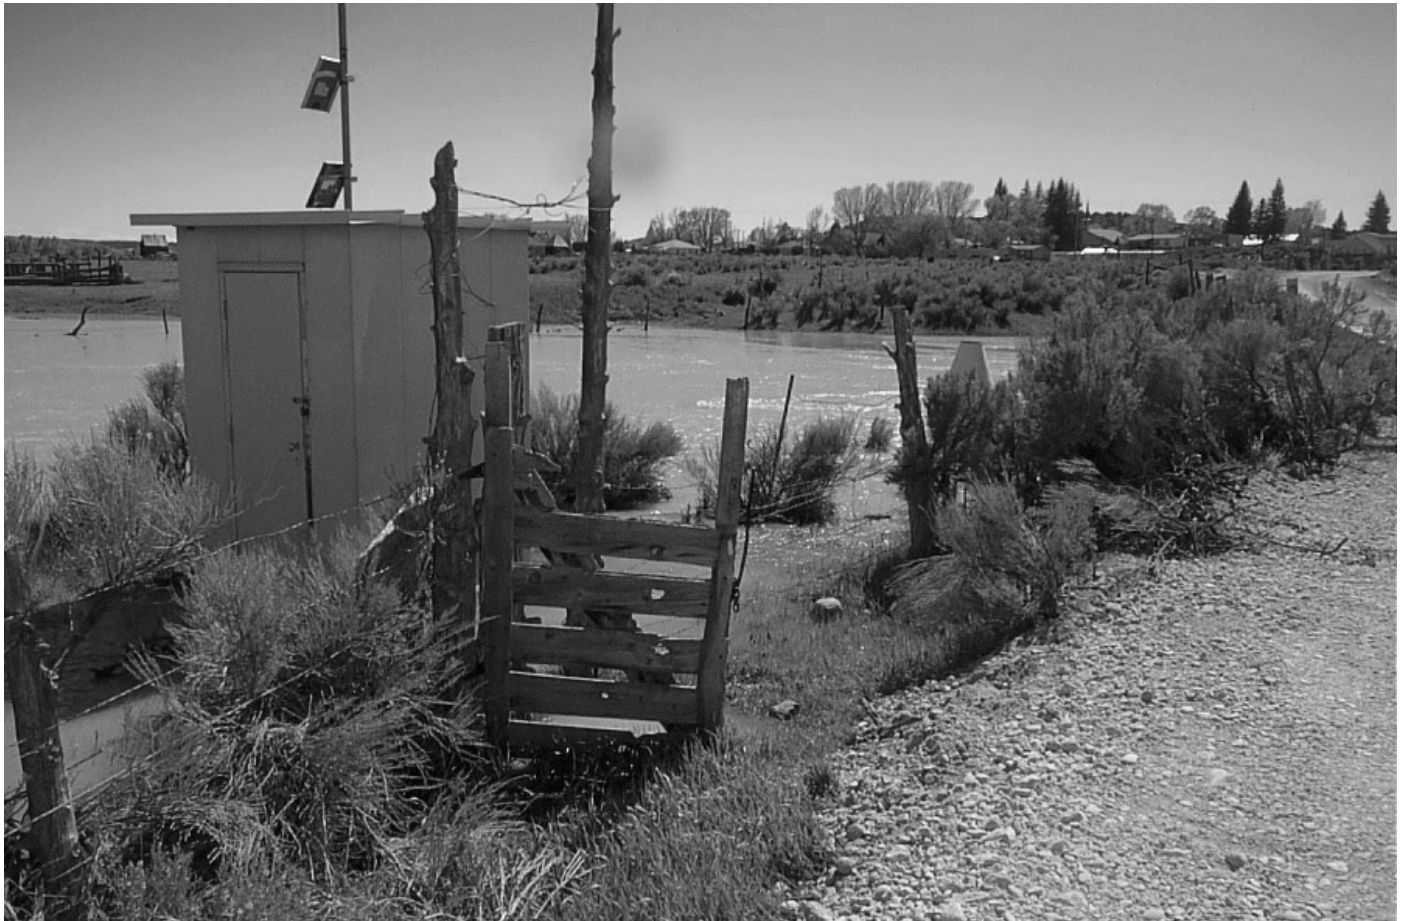
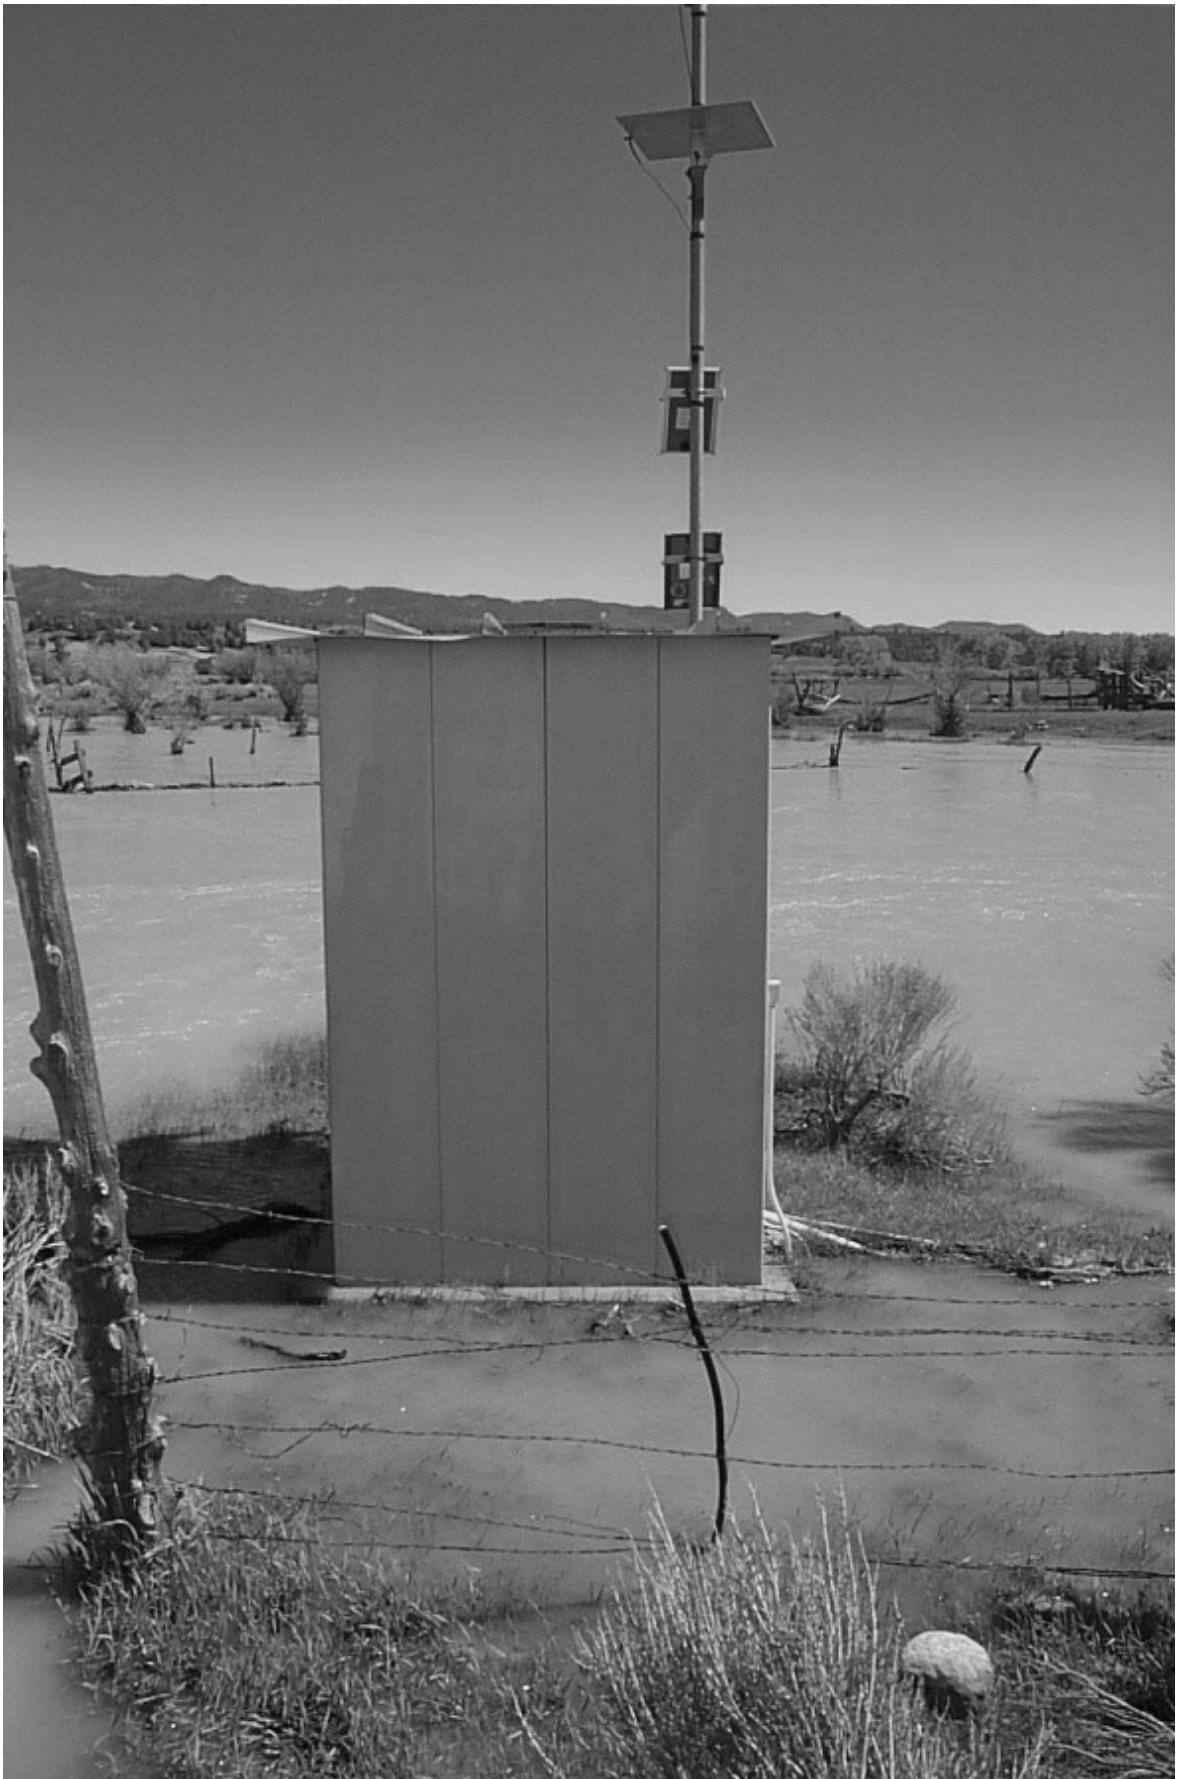
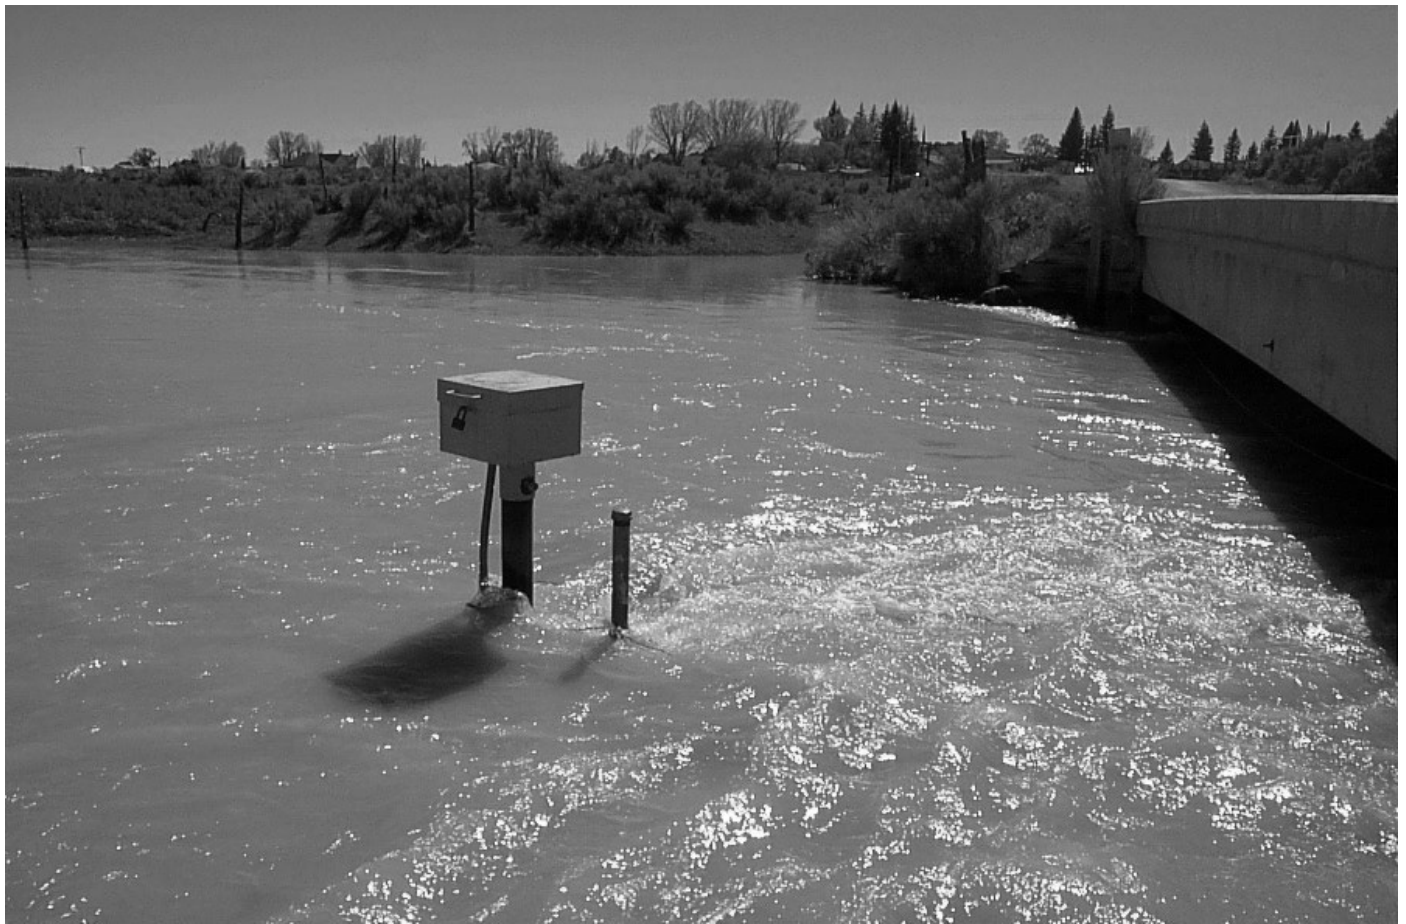
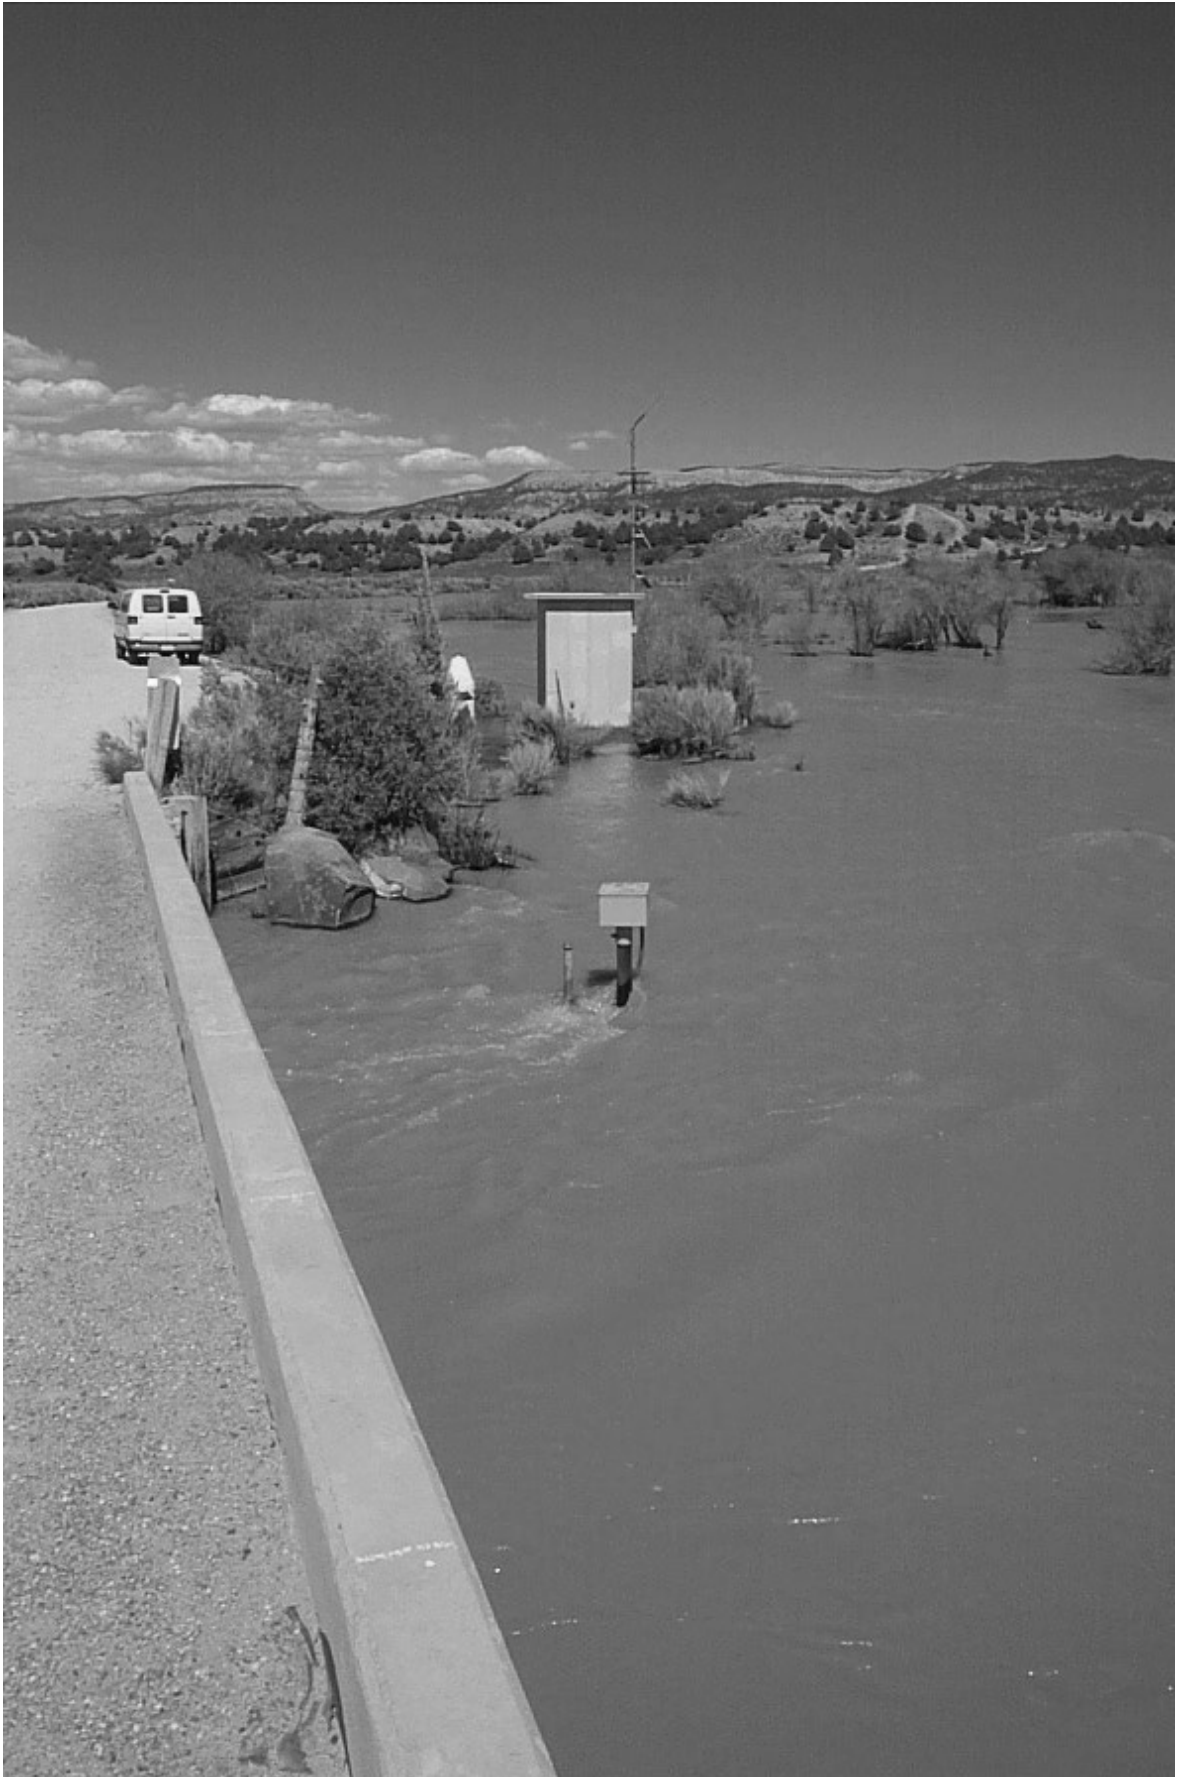
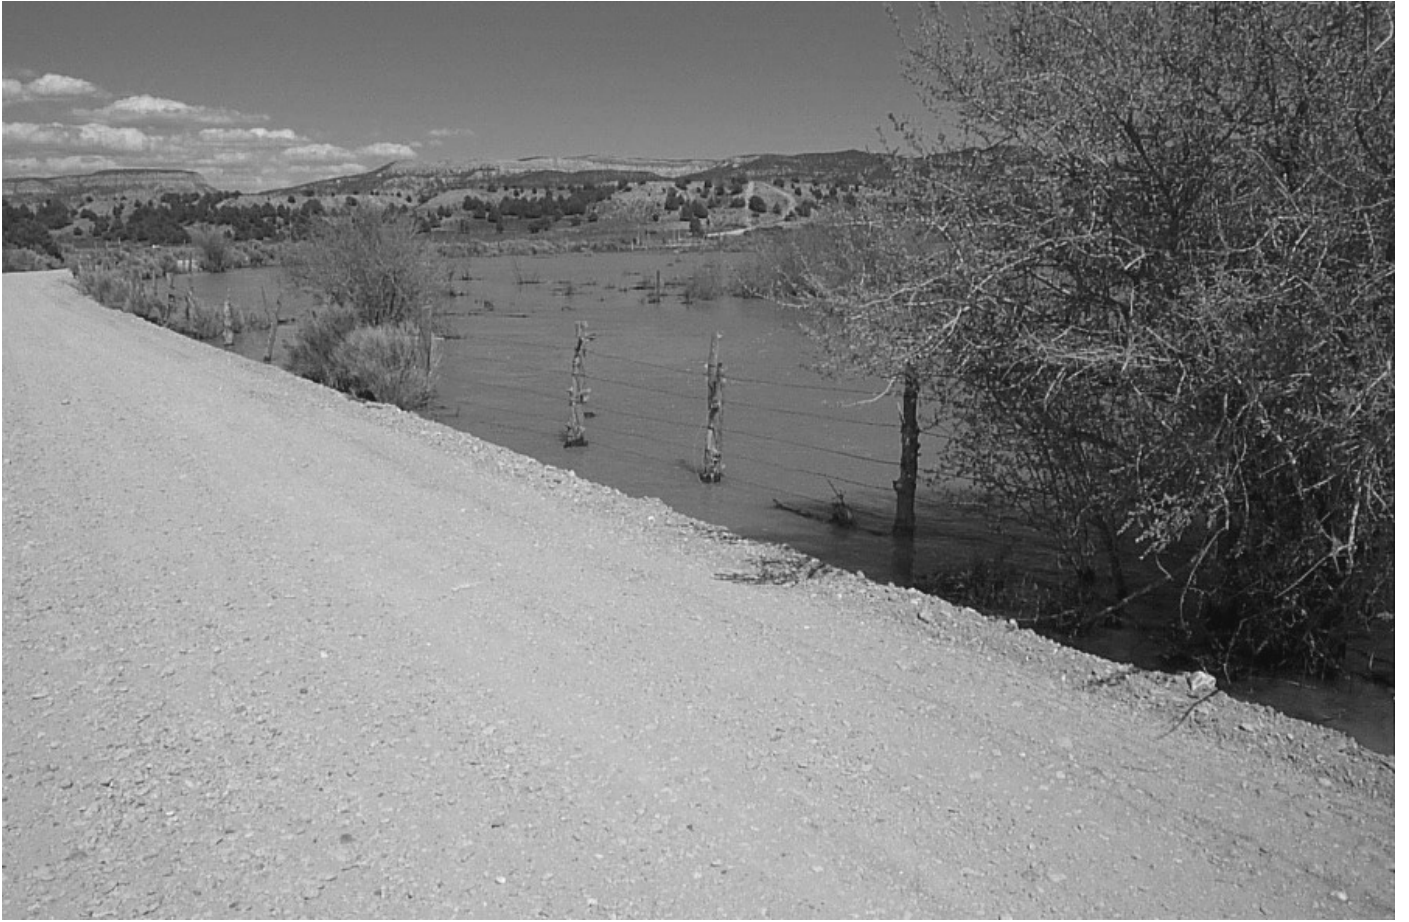
At the time of visit (1555) the gage was completely surrounded by water and flow was approximately 1.5 feet below recently graded road. Gap under bridge was 2 feet to 1.5 feet.

USGS Webpage reports 4.43 feet at 1620 cfs for 1545.

HATU1 – 1620 cfs. wbr 5/24/2005@1555

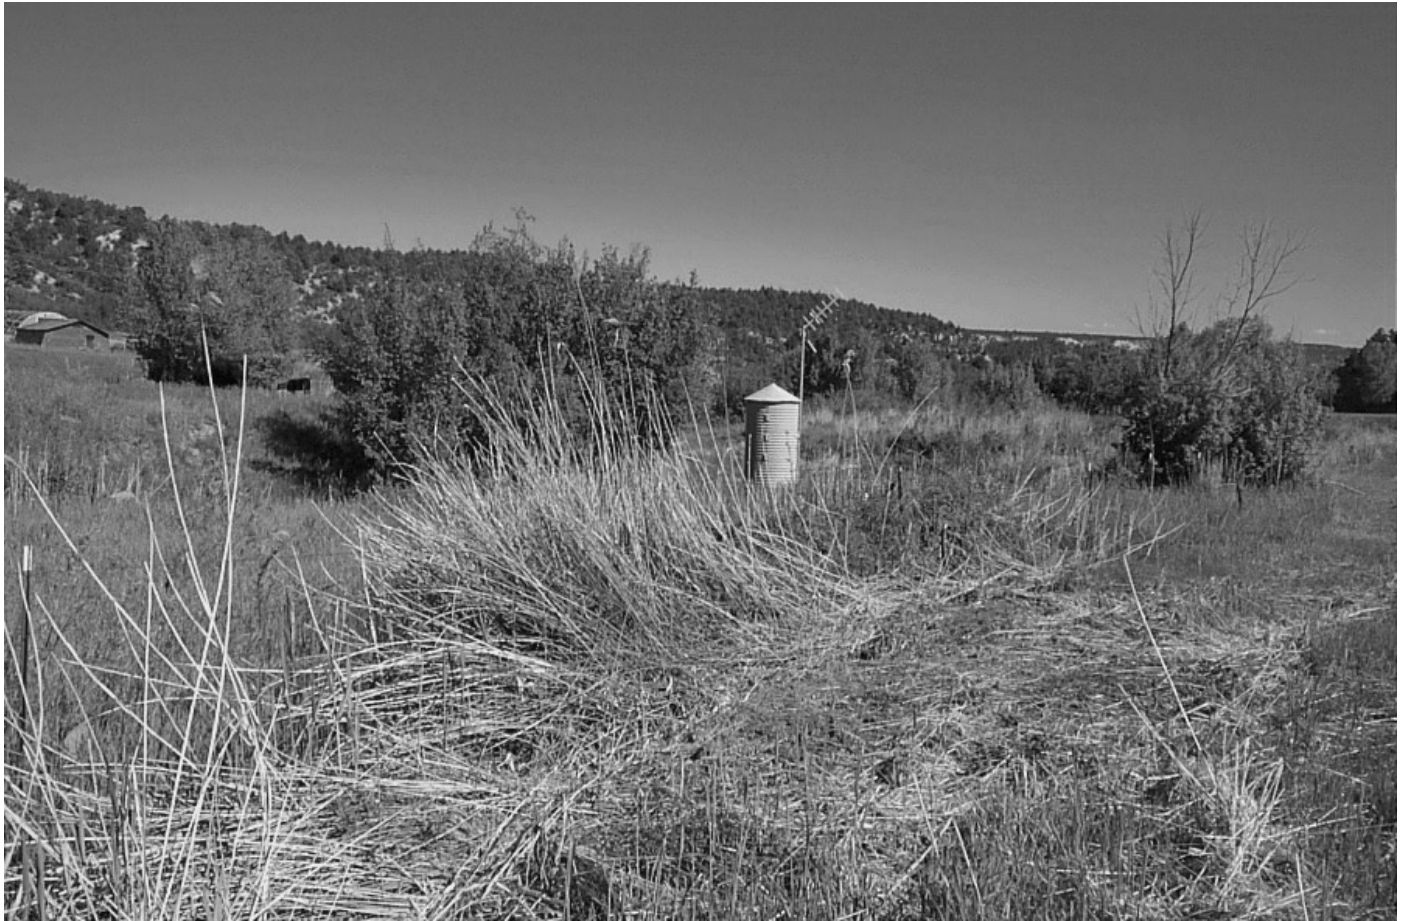
Long Valley was free of snow. At time of visit the flow was approximately 2 feet below bank full.

Gage and staff reading 1.69 feet at 1705.

EFFU1 – gage house. wbr 5/24/2005

Suggest new bank full of 3.5 feet

Suggest new minor unofficial flood stage of 4.0 feet

Suggest new moderate unofficial flood stage of 4.5 feet.

Suggest new major unofficial flood stage of 5.0 feet.

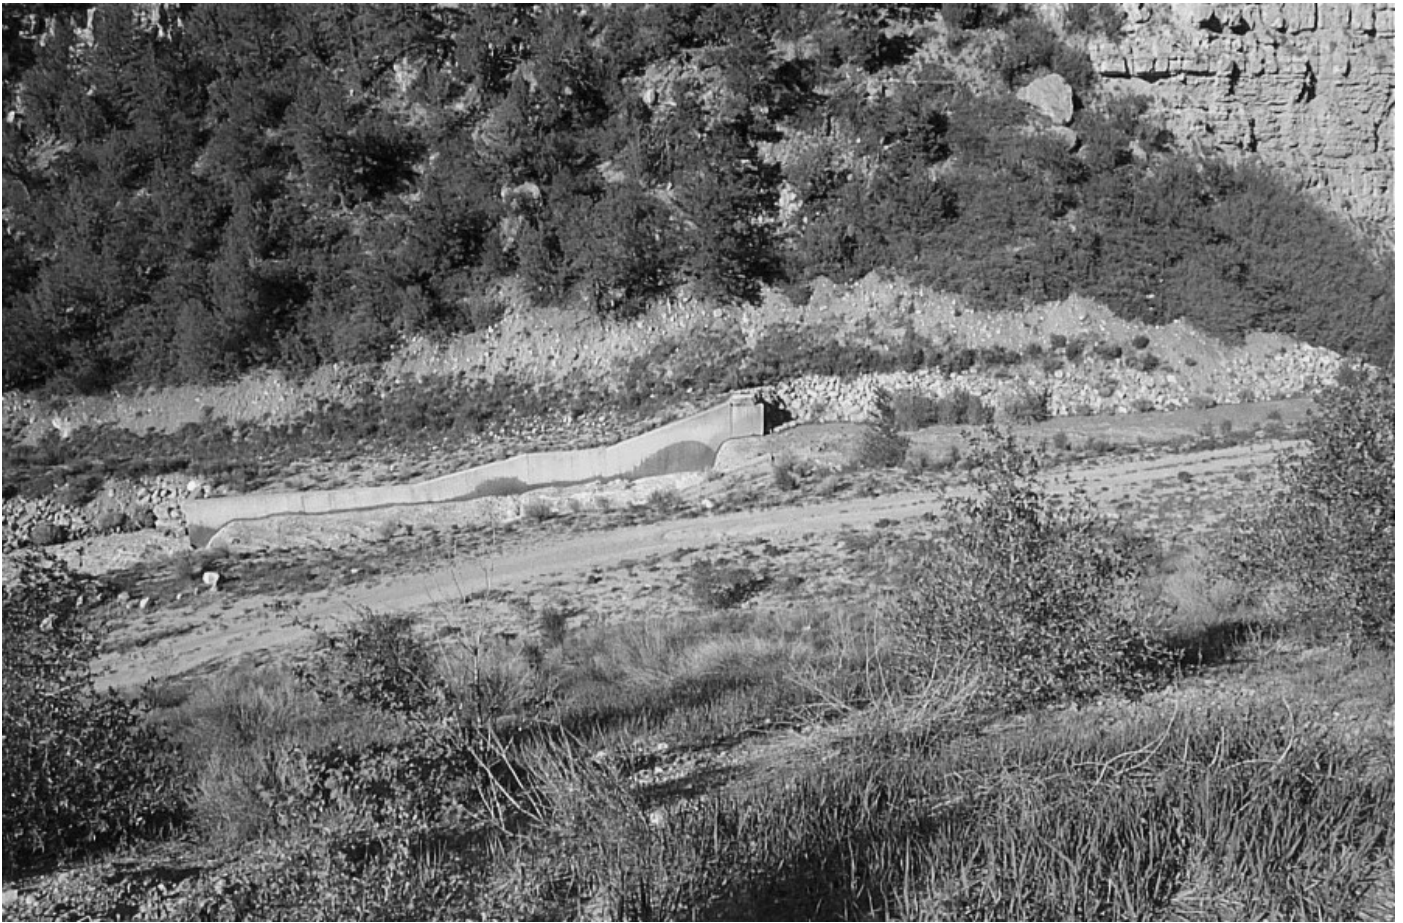
At the higher elevations, snow several feet deep was observed (this snow was in the Virgin River, Sevier River, and Coal Creek drainages). The Control Structure was observed from the Utah 14. Here Coal Creek could not only be seen but also heard roaring in the canyon below.

Coal Creek – flow thru control structure 10 miles upstream of COAU1. wbr 5/24/2005@1815
