Trip Report for Travel to Review Flooding in Southern Utah Within Salt Lake City HSA From May 24th to May 25th, 2005.

**William B. Reed¹, Senior Hydrologist
NOAA's Colorado Basin River Forecast Center**

PURPOSE OF TRIP:

- ❖ To review ongoing flooding in Southern Utah, Great Basin Desert (Beaver River, Sevier River, and Coal Creek); and Colorado Basin (East Fork Virgin River); also
- ❖ To estimate critical stages where needed.

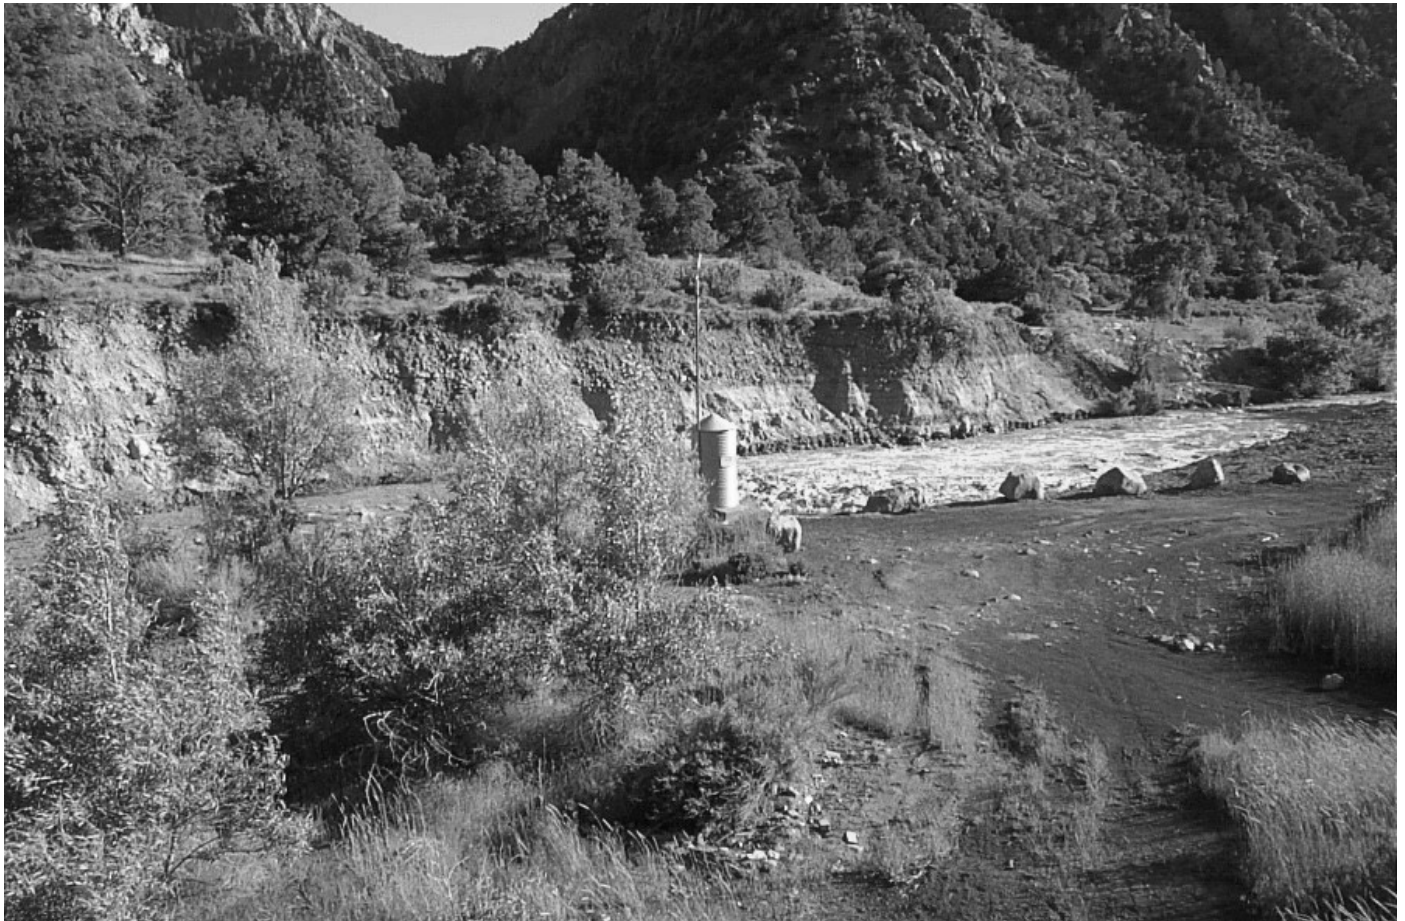
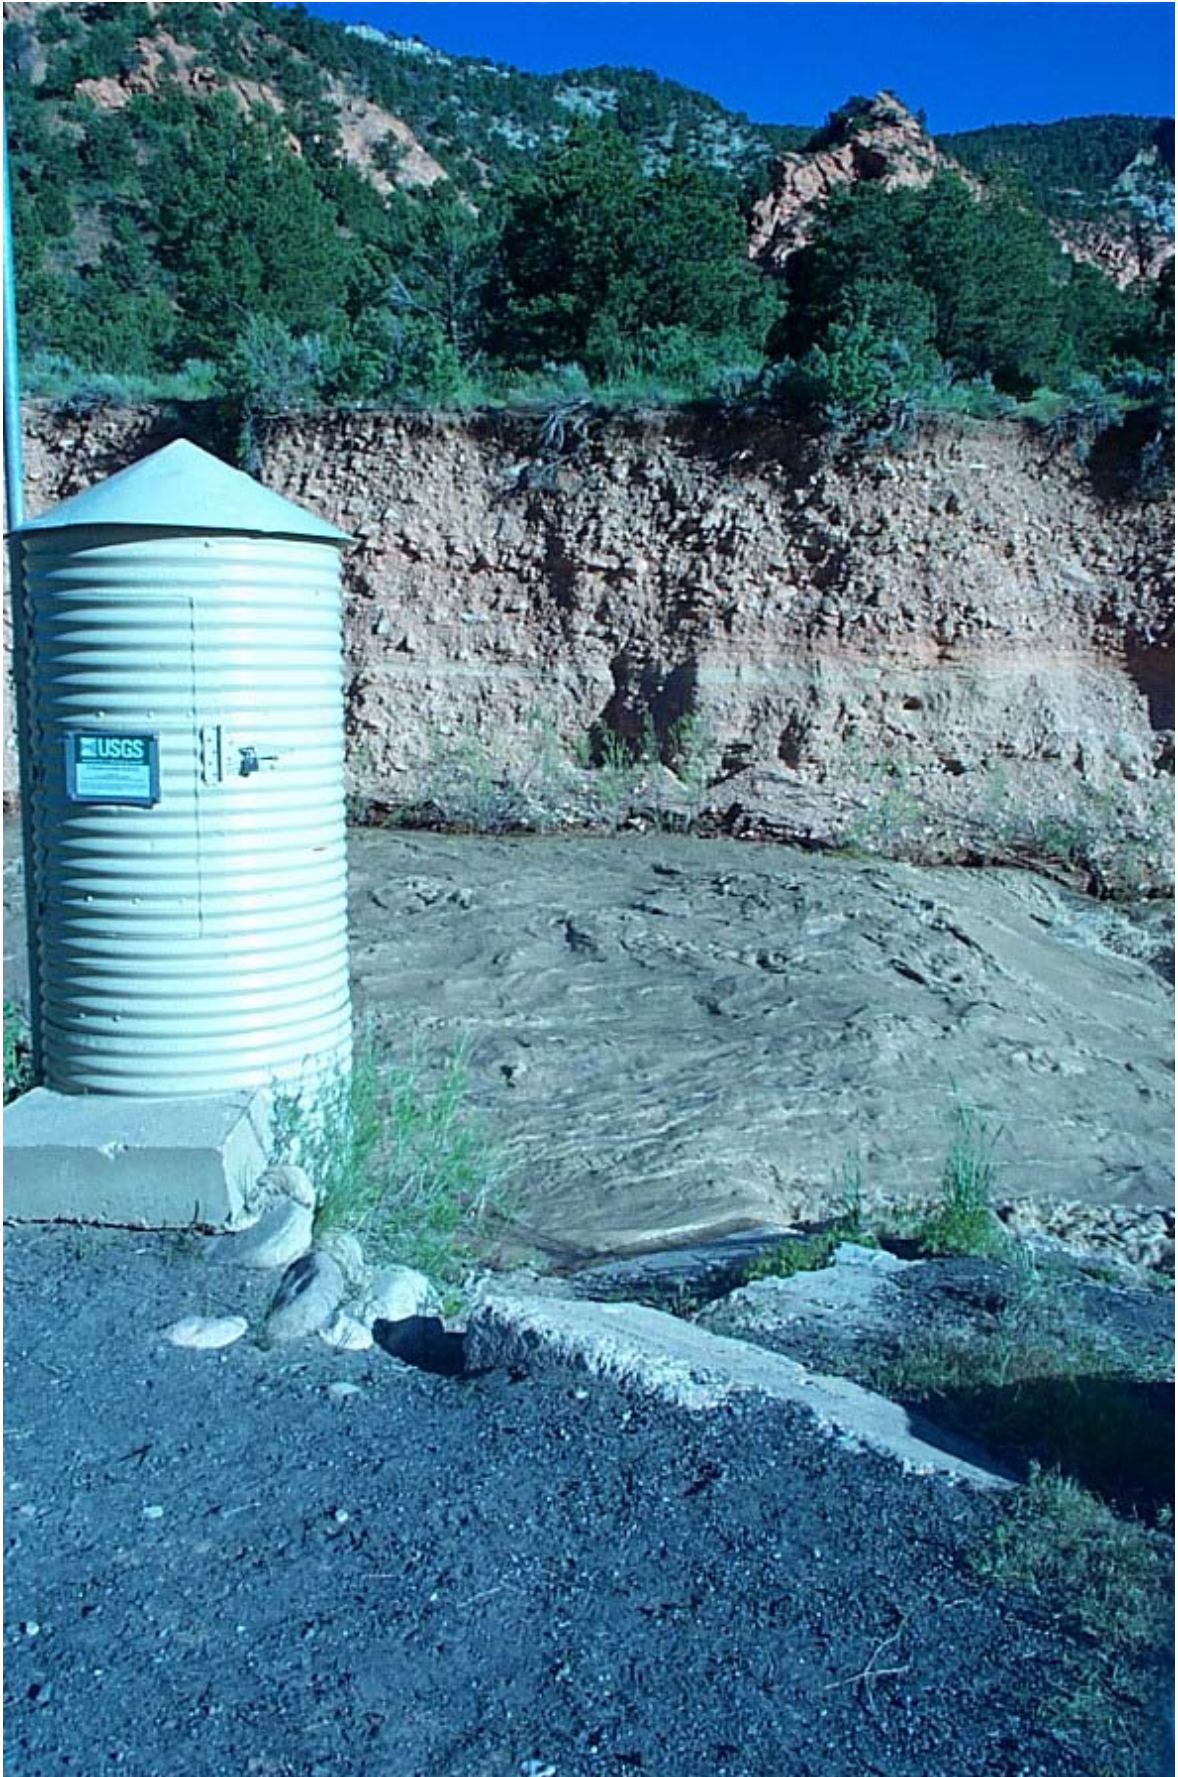
Gage was reading 7.4 feet at 1100 cfs on 5/24/2005 at 1840.

USGS Webpage reports 7.66 feet at 1220 cfs on 5/24 at 1845.

It should be noted that the City has placed temporary berms along both sides of the river thru town.

COAU1 – flow 1100 cfs. wbr 5/24/2005

Suggest new bank full and flood stage of 9.5 feet

Suggest new moderate flood stage of 10.5 feet

Suggest new major flood stage of 11.5 feet

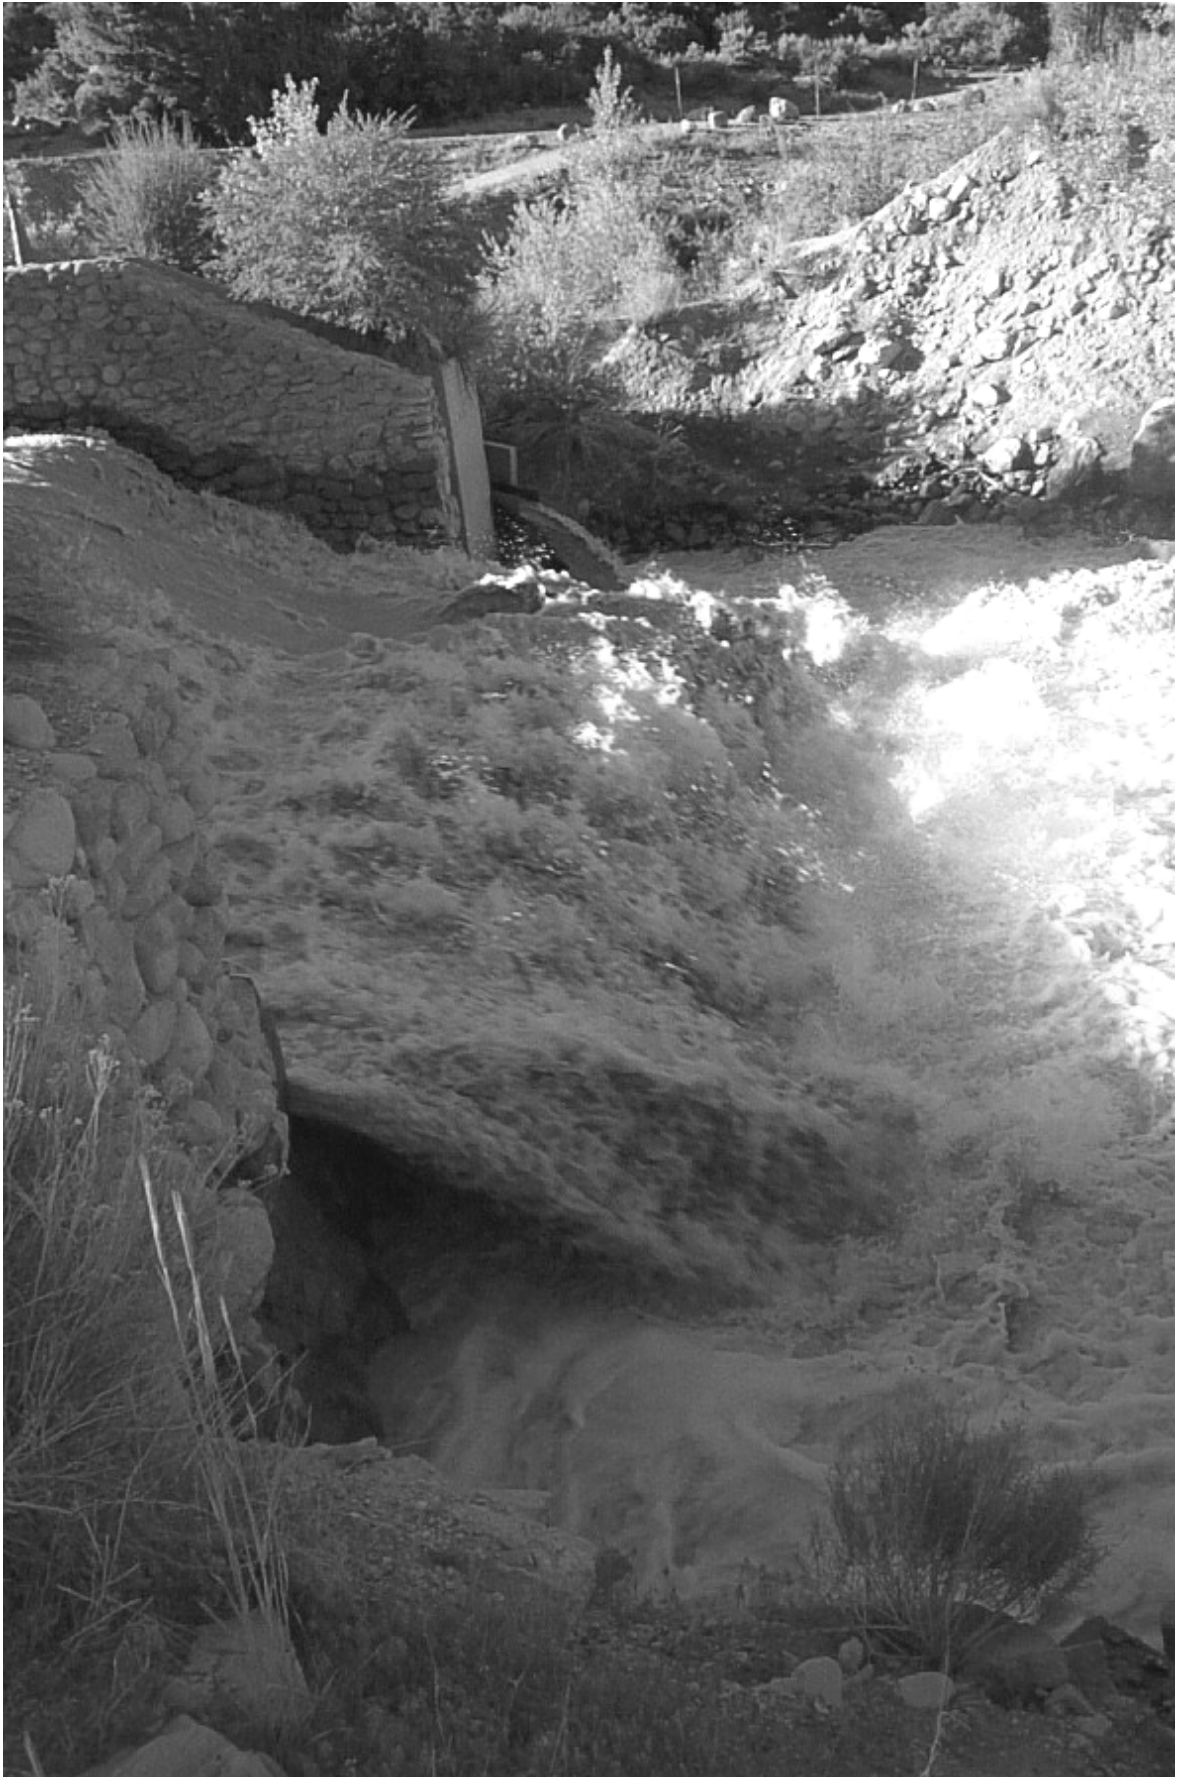
Gage was reading 7.02 feet at 913 cfs on 5/25 at 0805.

Coal Creek at diversion below gage (COAU1) – flow 913 cfs. wbr 5/25/2005@0805

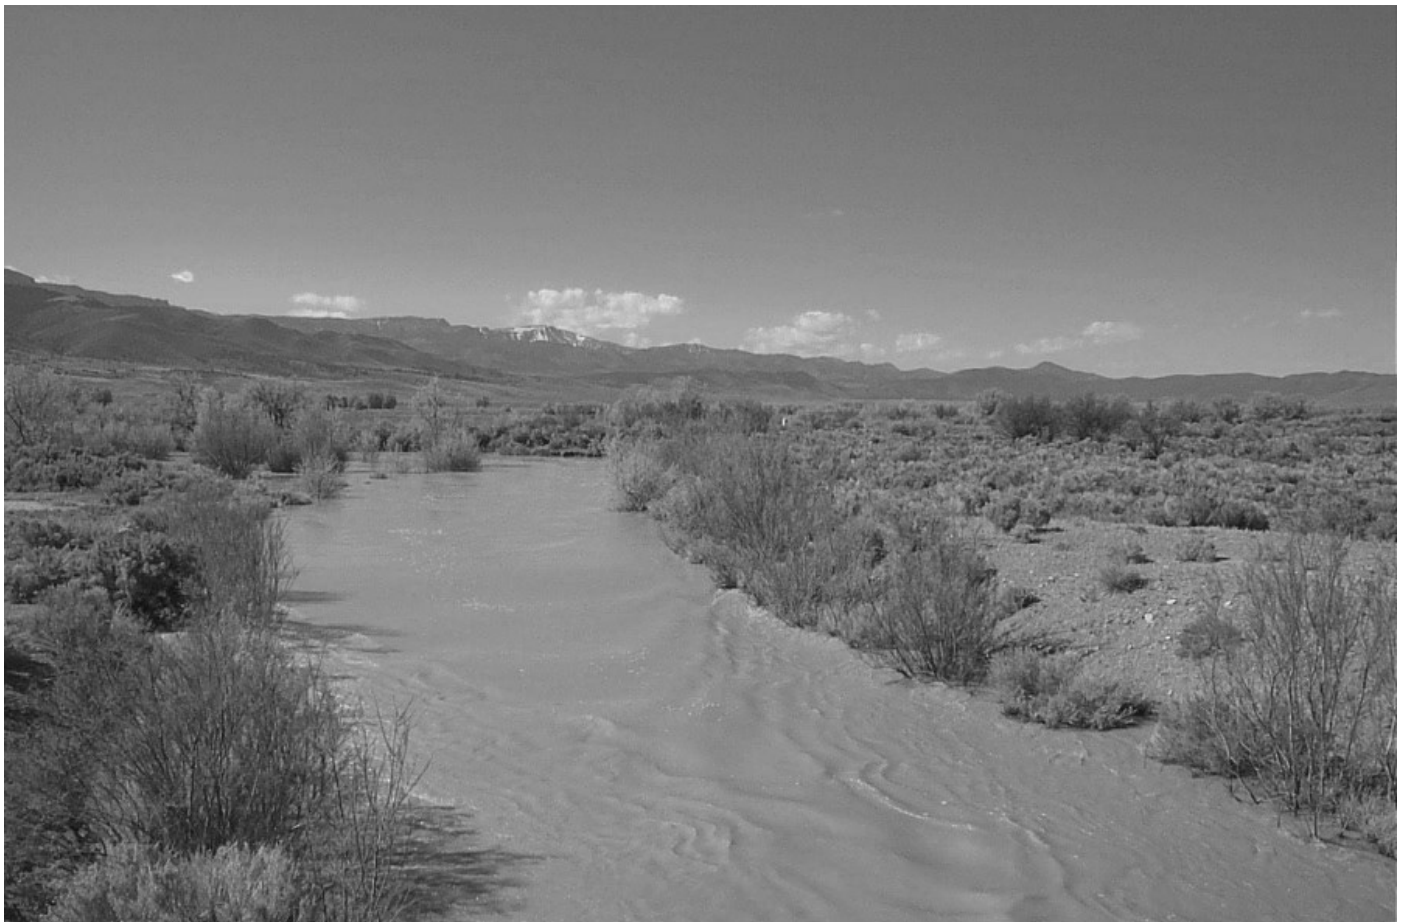
At this location the water was flowing across the field between the Utah 62 and the gage (Sevier River was over bank full stage). Therefore approximately 5 % to 15% of the flow was not being measured. Did not drive down access road to gage because conditions were such road would be damaged. Tried to walk to gage but sank to my ankles in mud.

USGS Webpage reports 4.97 feet at 1310 cfs for 5/25@1000.

SEKU1(gage near center of picture) – flow > 1310 cfs. wbr 5/25@1000

Suggest new bank full stage of 4.5 feet.

Suggest new minor unofficial flood stage of 6.0 feet

Suggest new moderate unofficial flood stage of 7.0 feet.

Suggest new major unofficial flood stage of 8.0 feet.

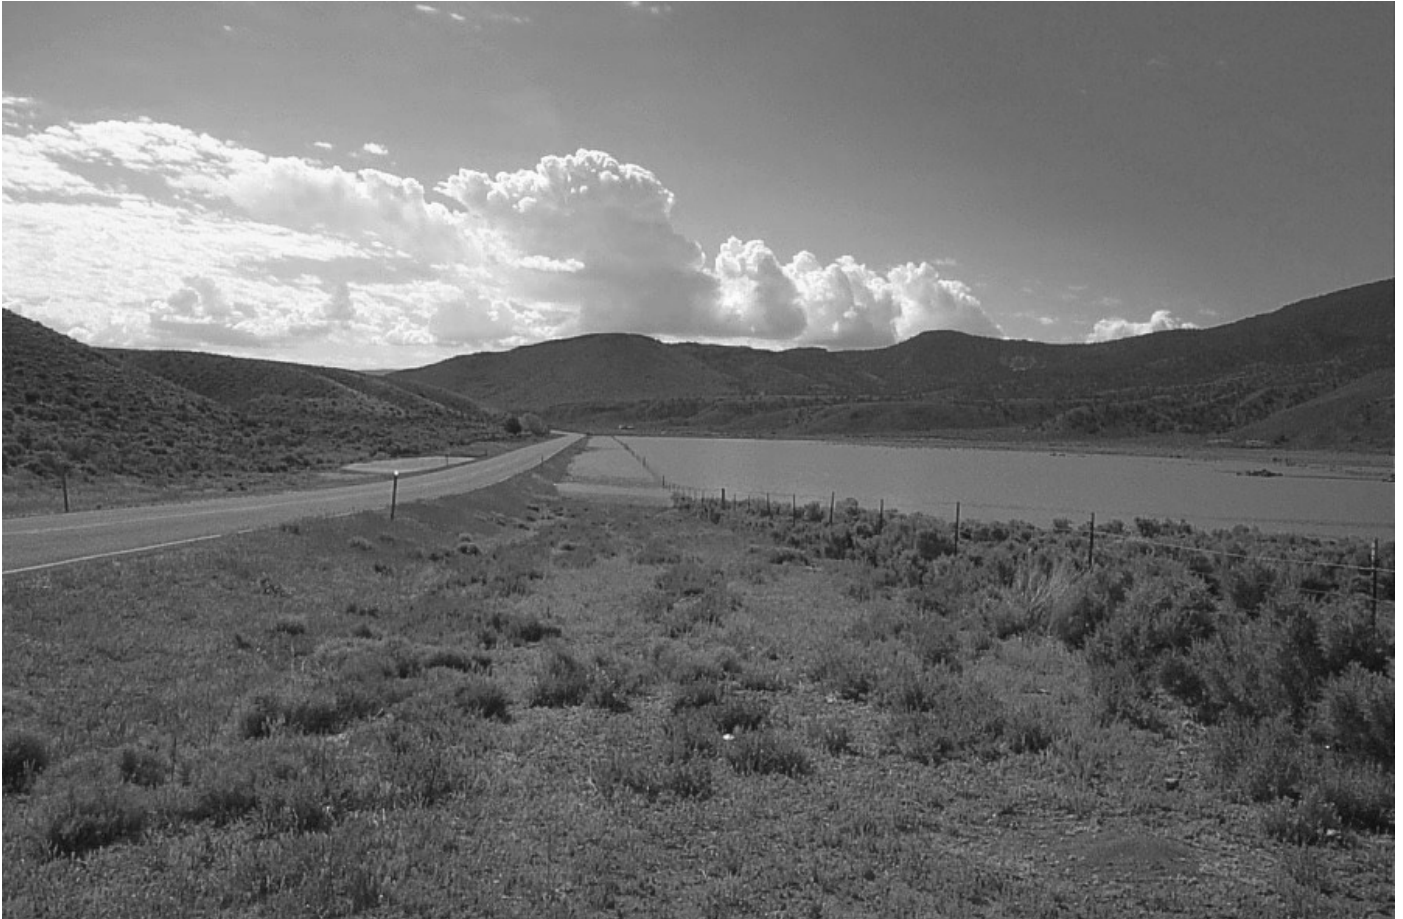
At several locations the East Fork was out of banks along Utah 62 between Kingston and Otter Creek reservoir.

East Fork of Sevier River out of its banks. wbr 5/25

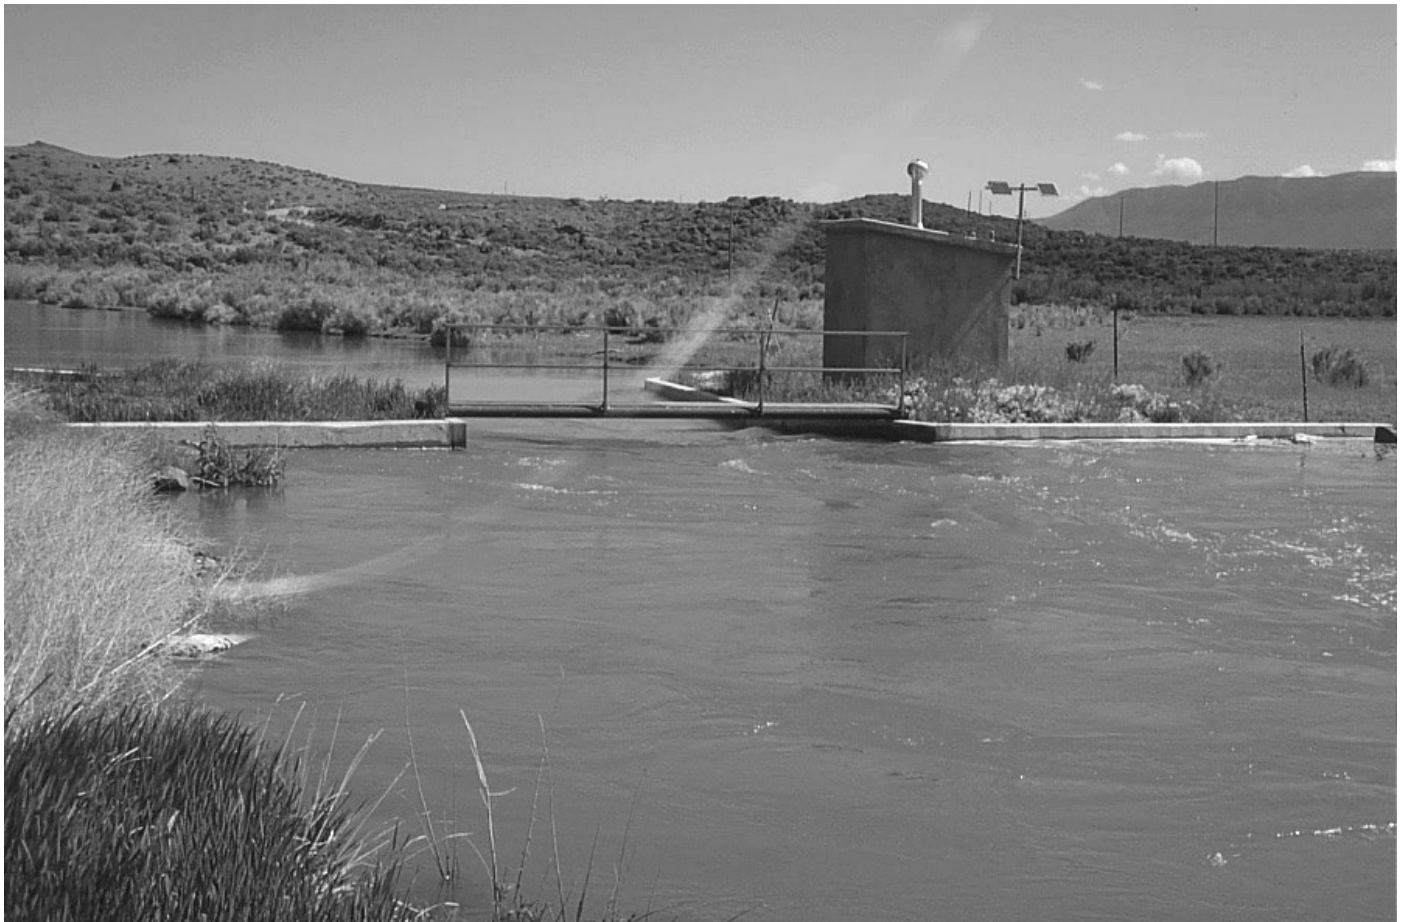
Not SRKU1 but likely dam operators measuring site for East Fork. wbr 5/25

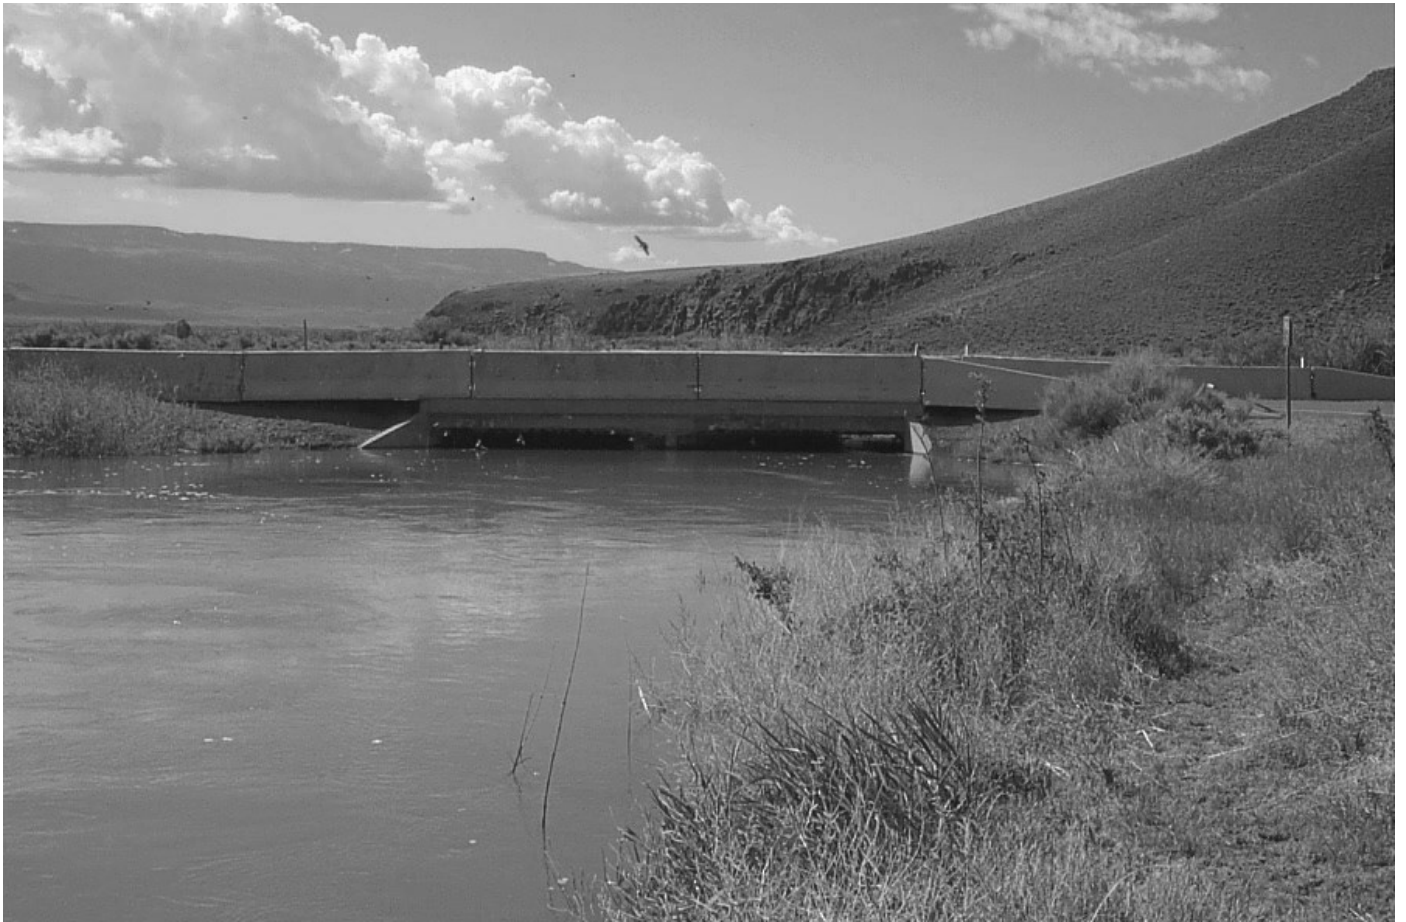
Utah 22 bridge near Utah 62 (EF Sevier).wbr 5/22

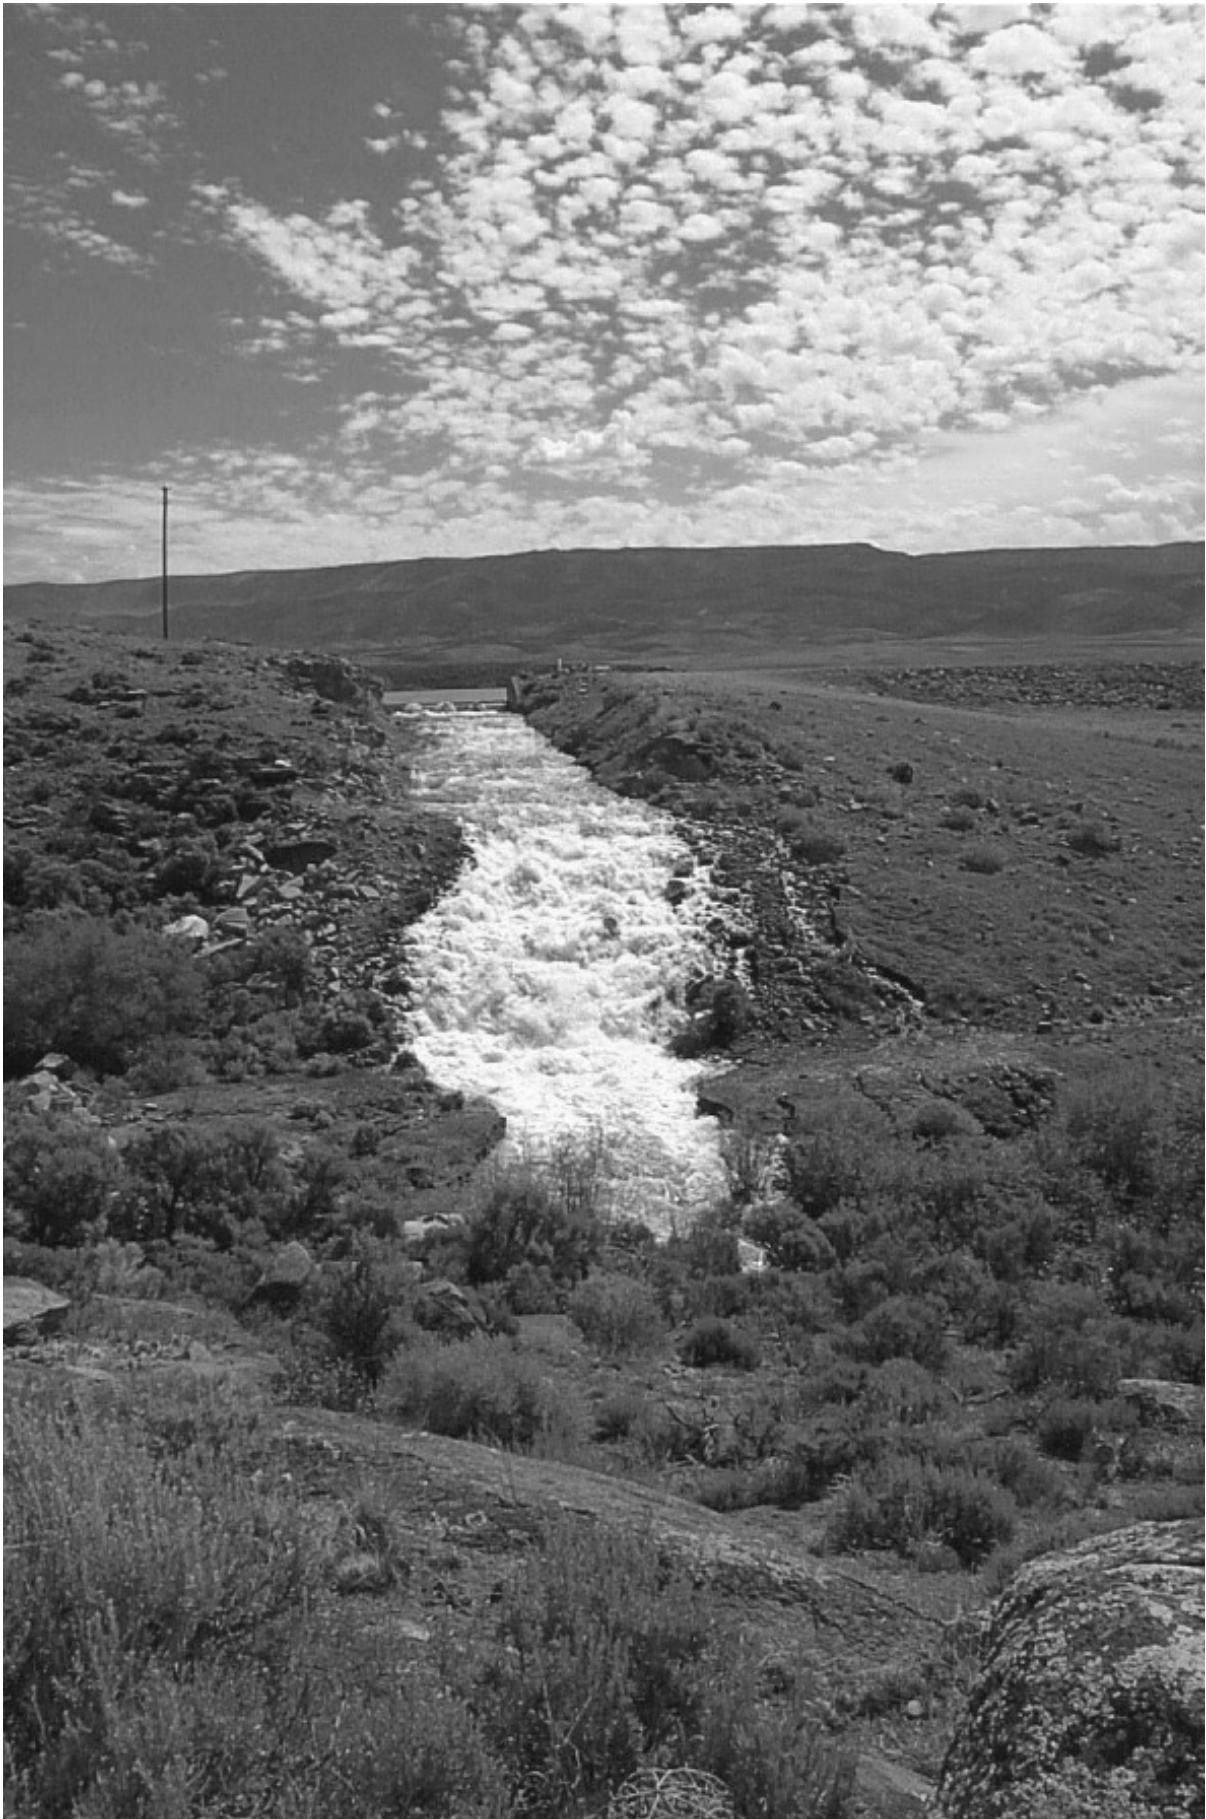
Lake level was full with water up to picnic area and trailer parking sites.

Uncontrolled spill from Otter Creek Reservoir Spillway (EF Sevier). wbr 5/25

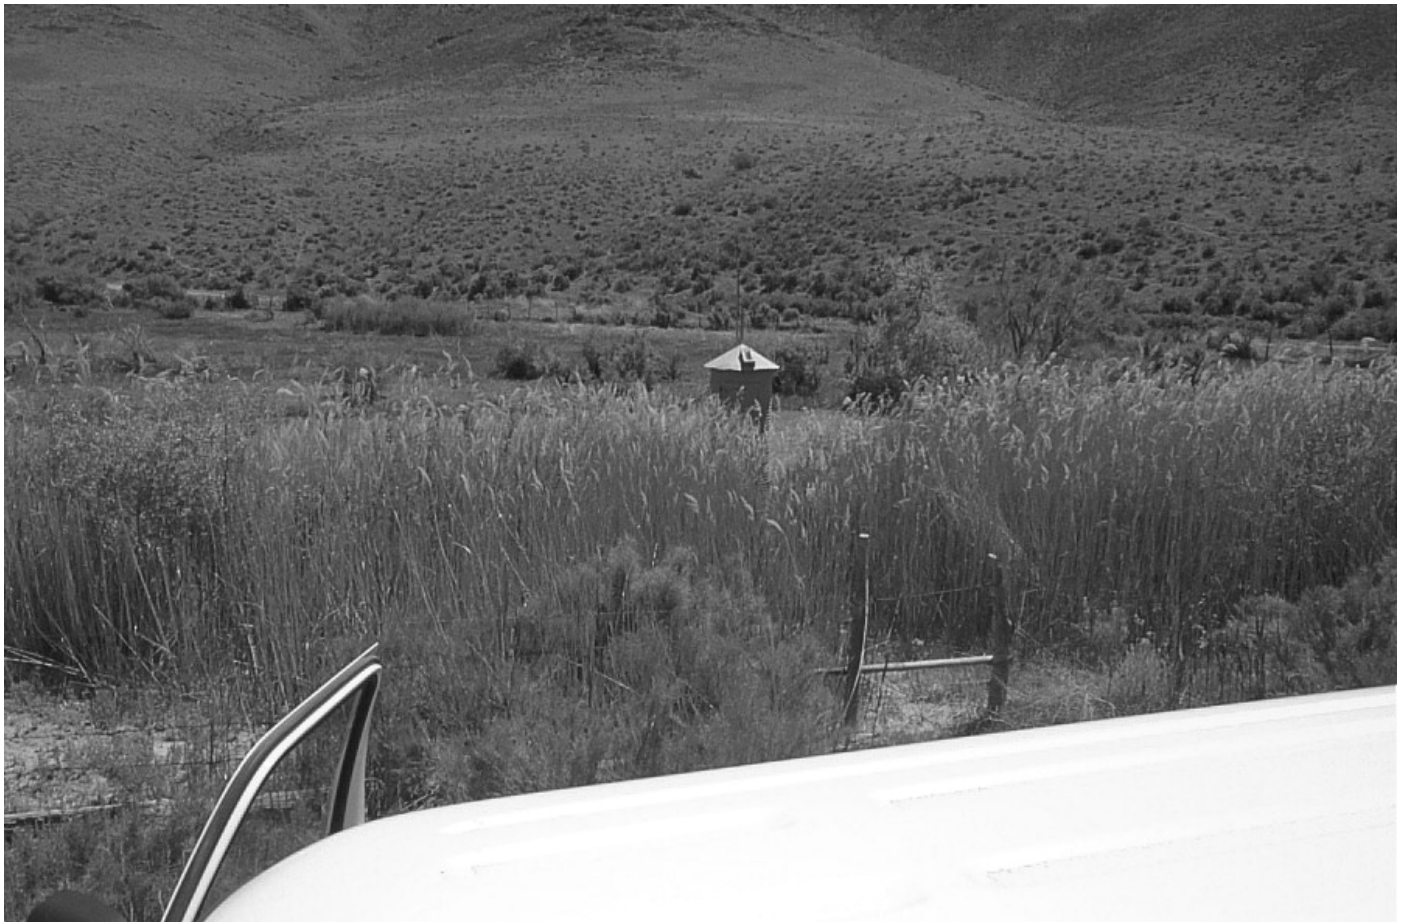
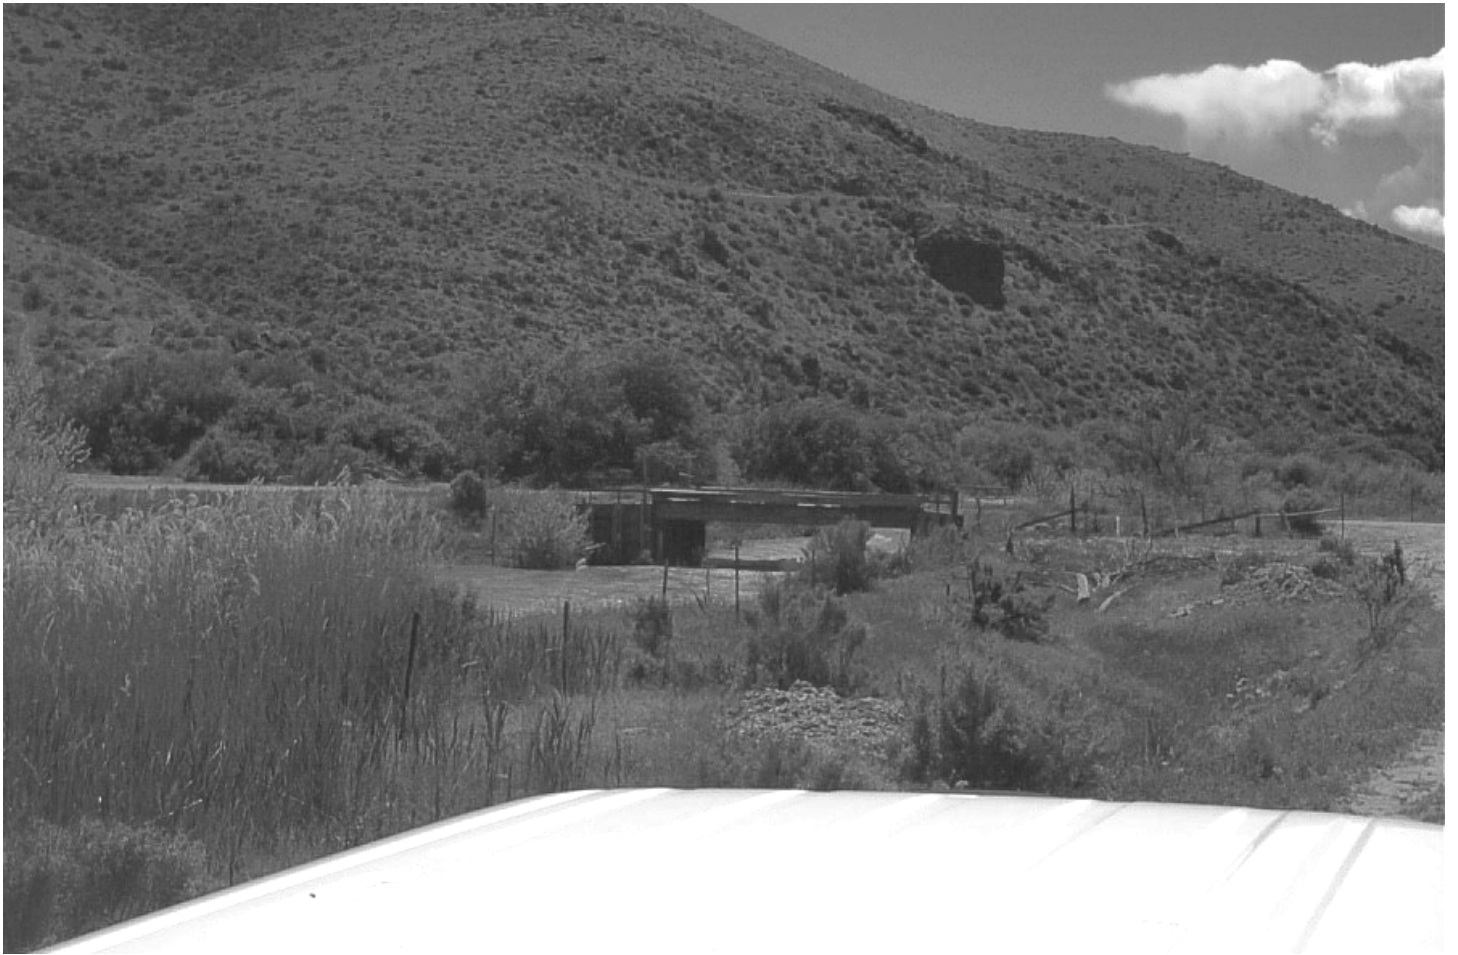
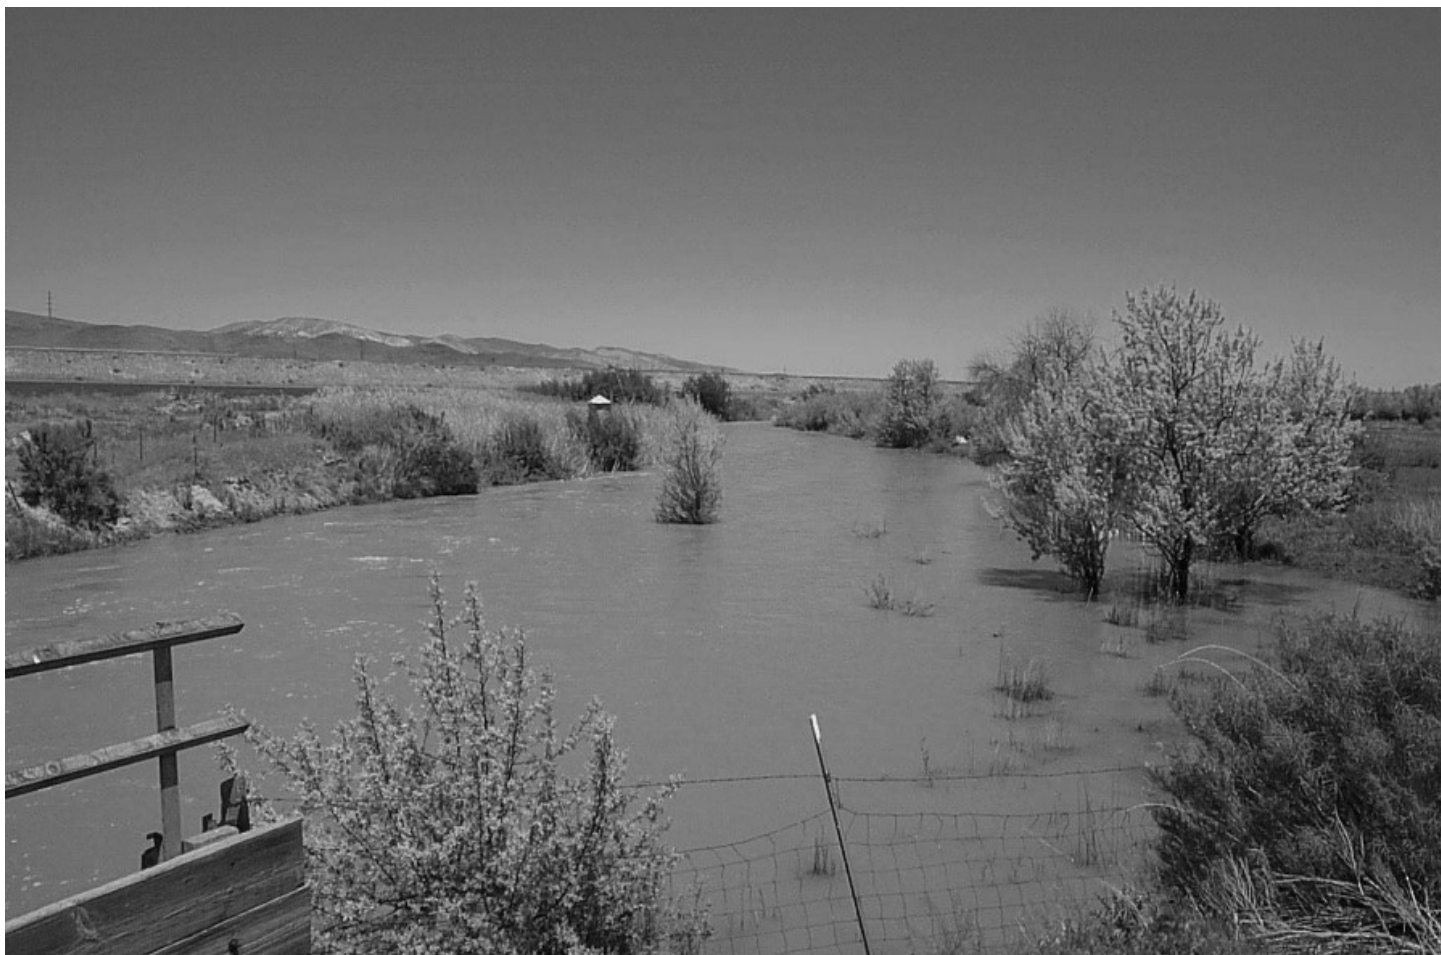
River was near bank full at time of visit 1250.

CBRFC shows observed stage and flow of 7.373 feet and 779 cfs on 5/25@1300

SGDU1 – gage house. wbr 5/25

SGDU1 – looking upstream. wbr 5/25

SGDU1 – looking downstream from bridge in previous picture. wbr 5/25

Suggest new bank full of 7.5 feet

Suggest new minor unofficial flood stage of 9.0 feet

Suggest new moderate unofficial flood stage of 10.0 feet.

Suggest new major unofficial flood stage of 11.0 feet.

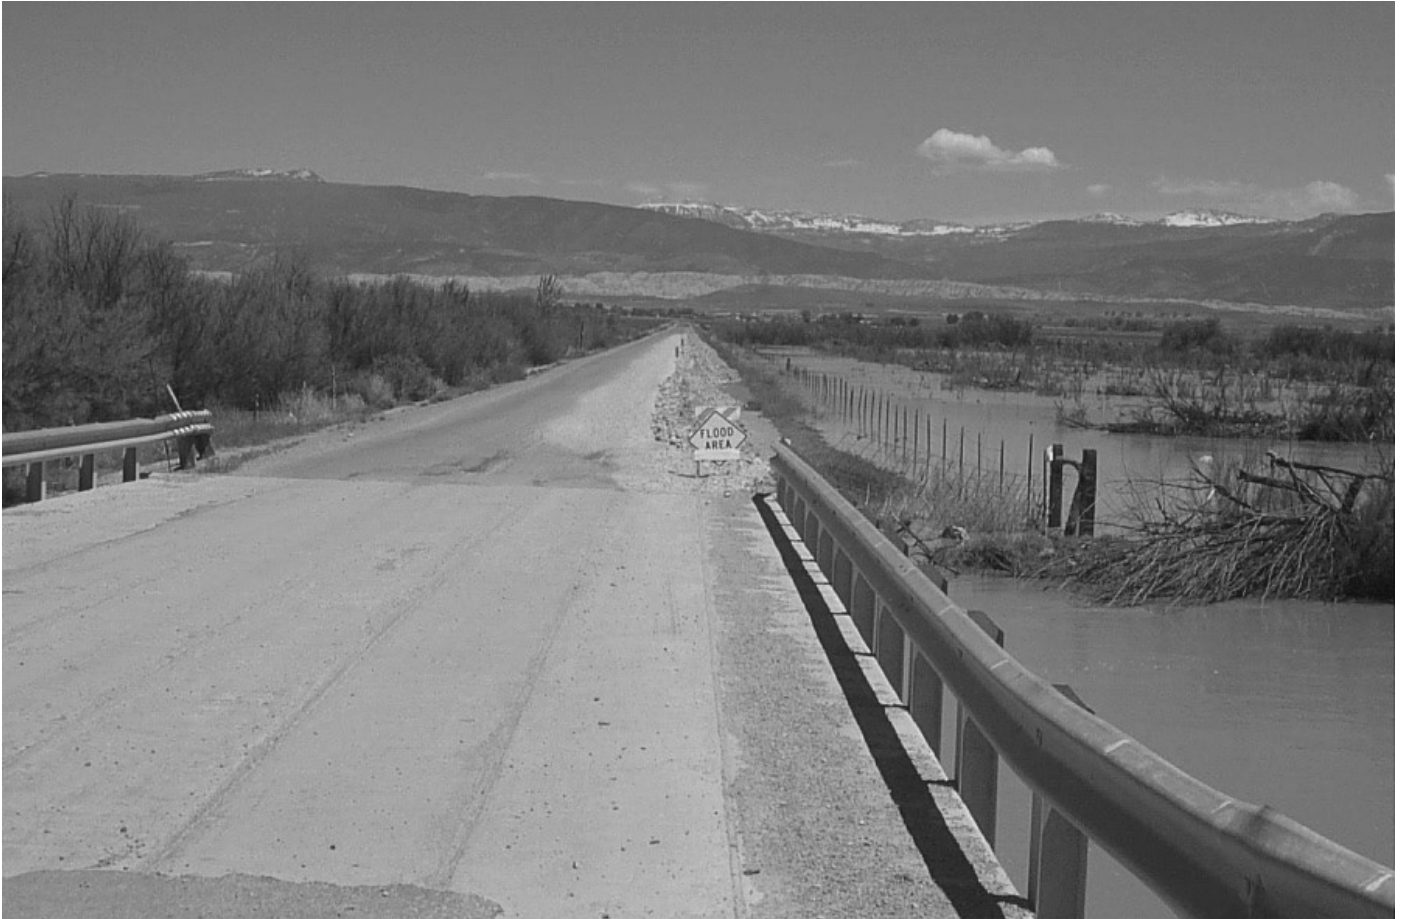
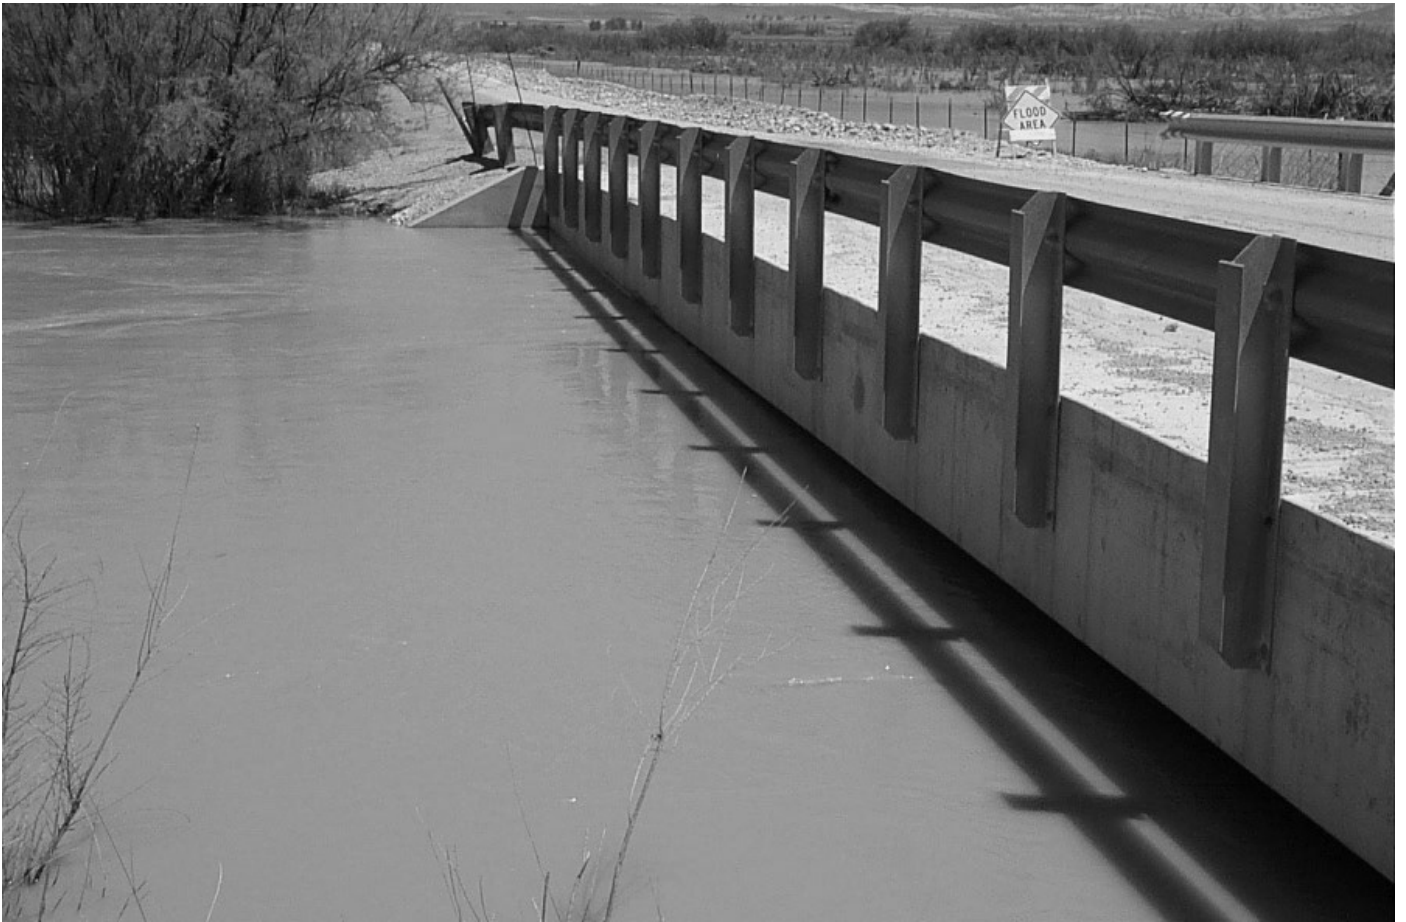
At this location the bridge and adjacent area was already signed as Flood Area. This location is above San Pitch River. SRYU1 is below San Pitch River.

Farmer's Freeway, Gunnison. wbr 5/25

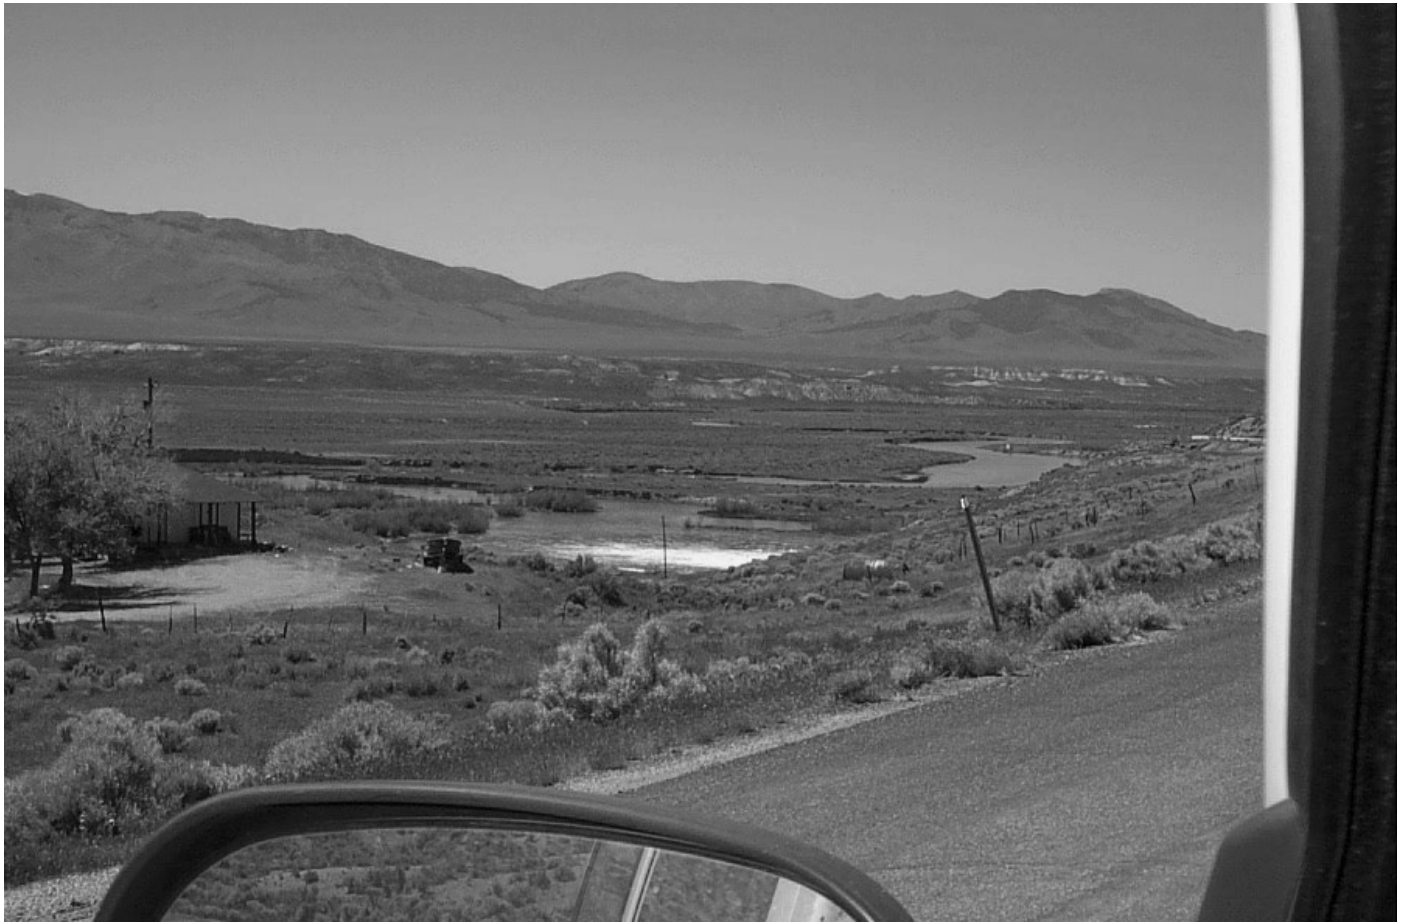
At this location it appeared that Yuba Lake had plenty of room left to hold floodwaters.

Controlled release from Yuba Lake. wbr 5/25
