# Trip Report for Travel to Arizona from April 10<sup>th</sup> to April 13<sup>th</sup> 2006: Flagstaff and Phoenix HSAs

**William B. Reed, Senior Hydrologist, NOAA's NWS Colorado Basin River Forecast Center, Salt Lake City**

**Purpose:** To visit river forecast points, meet with hydrologic customers, evaluate flood hazards at stream gages and at locations removed from the gages, and collect hydrologic data related to this season's water supply forecasts. Of special forecasting interest was a site visit to Chevlon Creek below Wildcat Canyon (CHWA3) located in an isolated area about 25 miles south of Winslow, AZ. See picture, looking downstream: gage located on right bank. Also of special hydrologic interest, was a site visit to the Grand Falls of the Little Colorado River---a discontinued USGS gaging site---to observed current drought-indicative flow conditions.

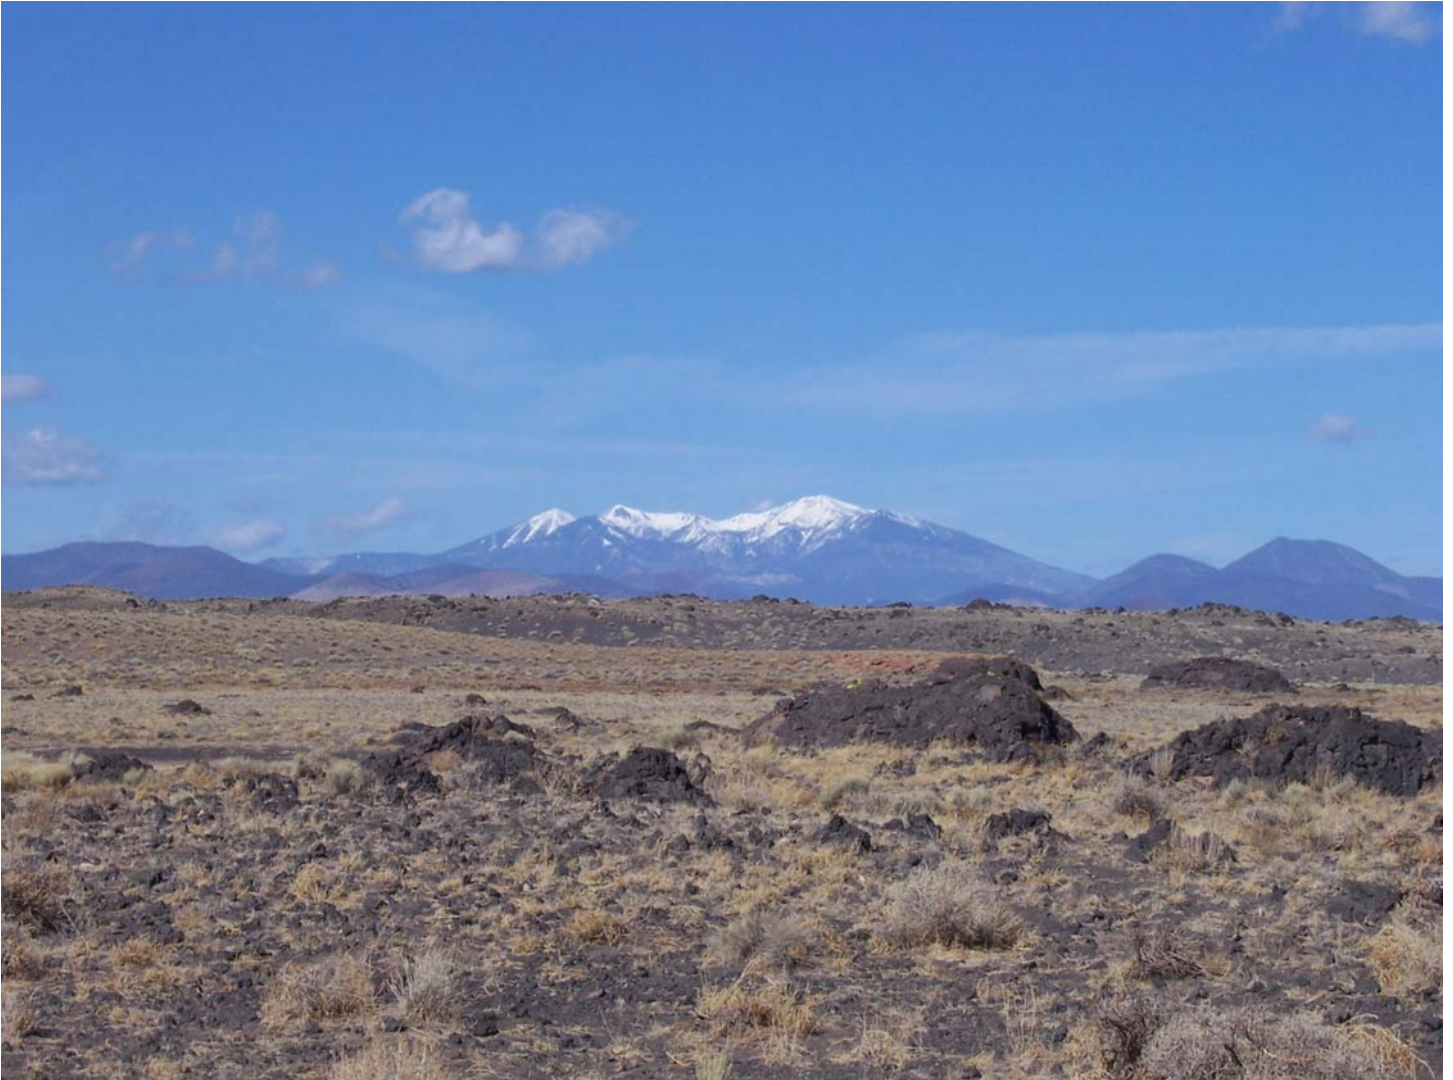
**Snow Conditions:** The bottom line for the week was there was essentially no snow to be found in Northern AZ except for on the San Francisco Peaks: Humphrey Peak (11,940 feet), Agassiz Peak (12,300 feet), and Fremont Peak (11,940 feet).

Looking Southwest towards San Francisco Peaks from near Grand Falls of the Little Colorado River.  
4/11/2006

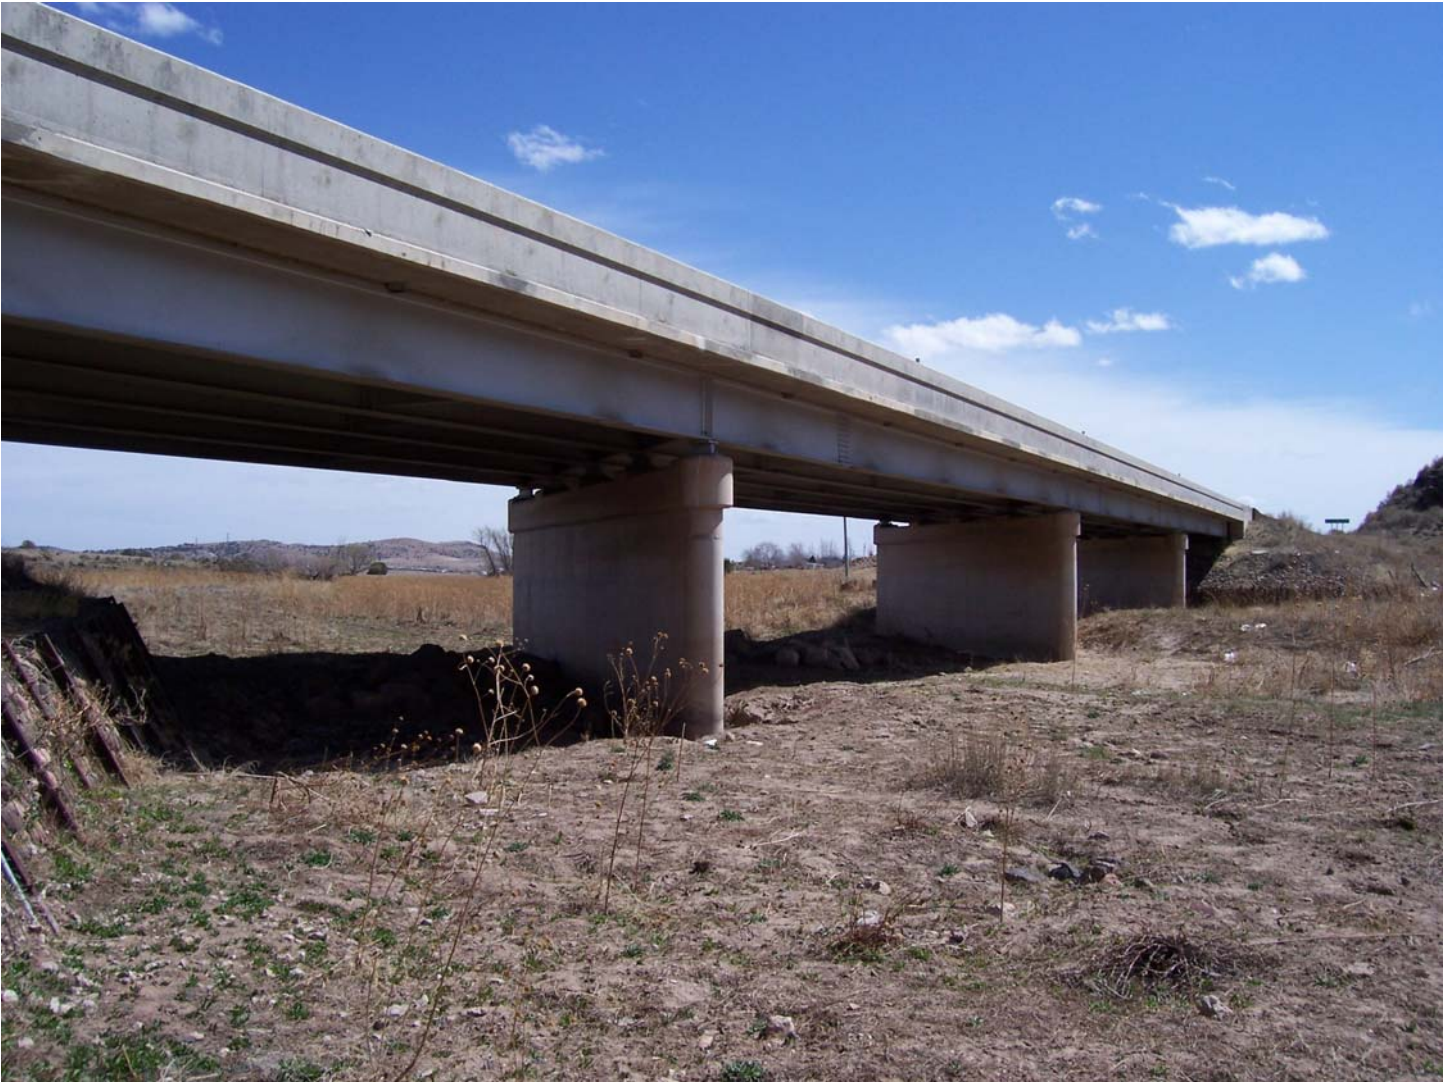
**Big Chino Wash:** New ALERT gage at State Route 89 Bridge near Paulden, AZ. Bridge is approximately 200 feet long and 15 feet high at low steel. Flow capacity of bridge estimated at 15,000 cfs. Flow at time of visit was 0 cfs. Tentative Minor, Moderate, and Major Flood Stages were determined to be 6 feet, 10 feet, and 14 feet (assuming 0 flow is 0 stage). These values should be revisited upon obtaining a rating table and Hand Book 5 ID for this site.

Big Chino Wash looking downstream. Flow is 0 cfs. 4/10/2006.

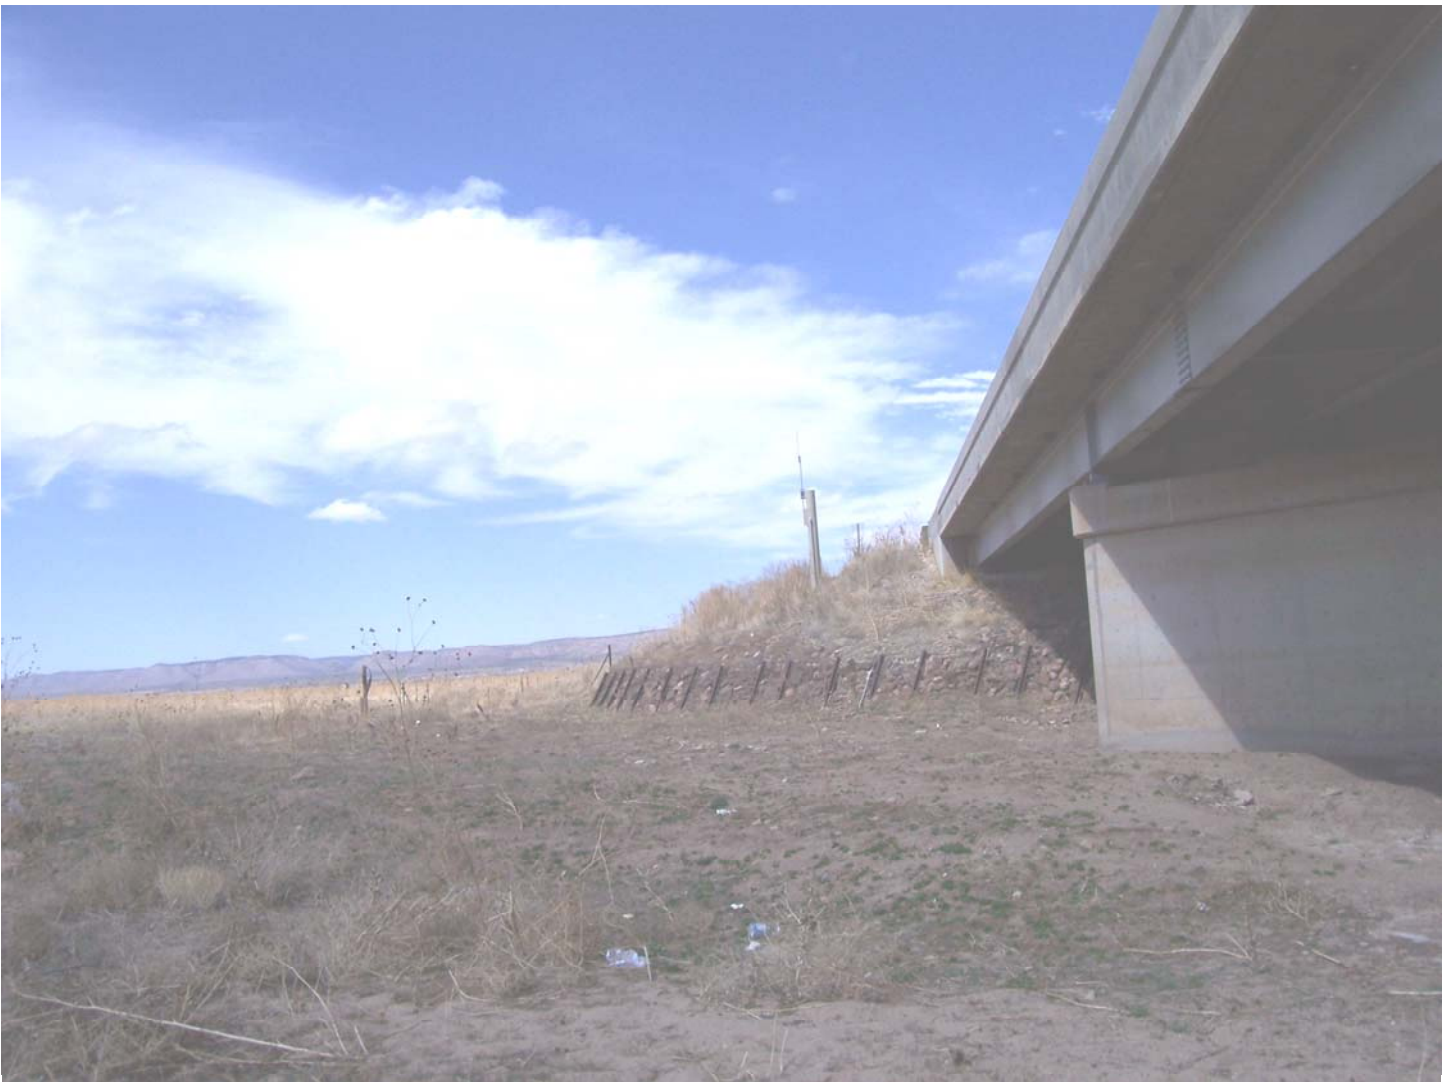
Big Chino Wash looking toward gage on left bank and upstream of bridge. 4/10/2006.

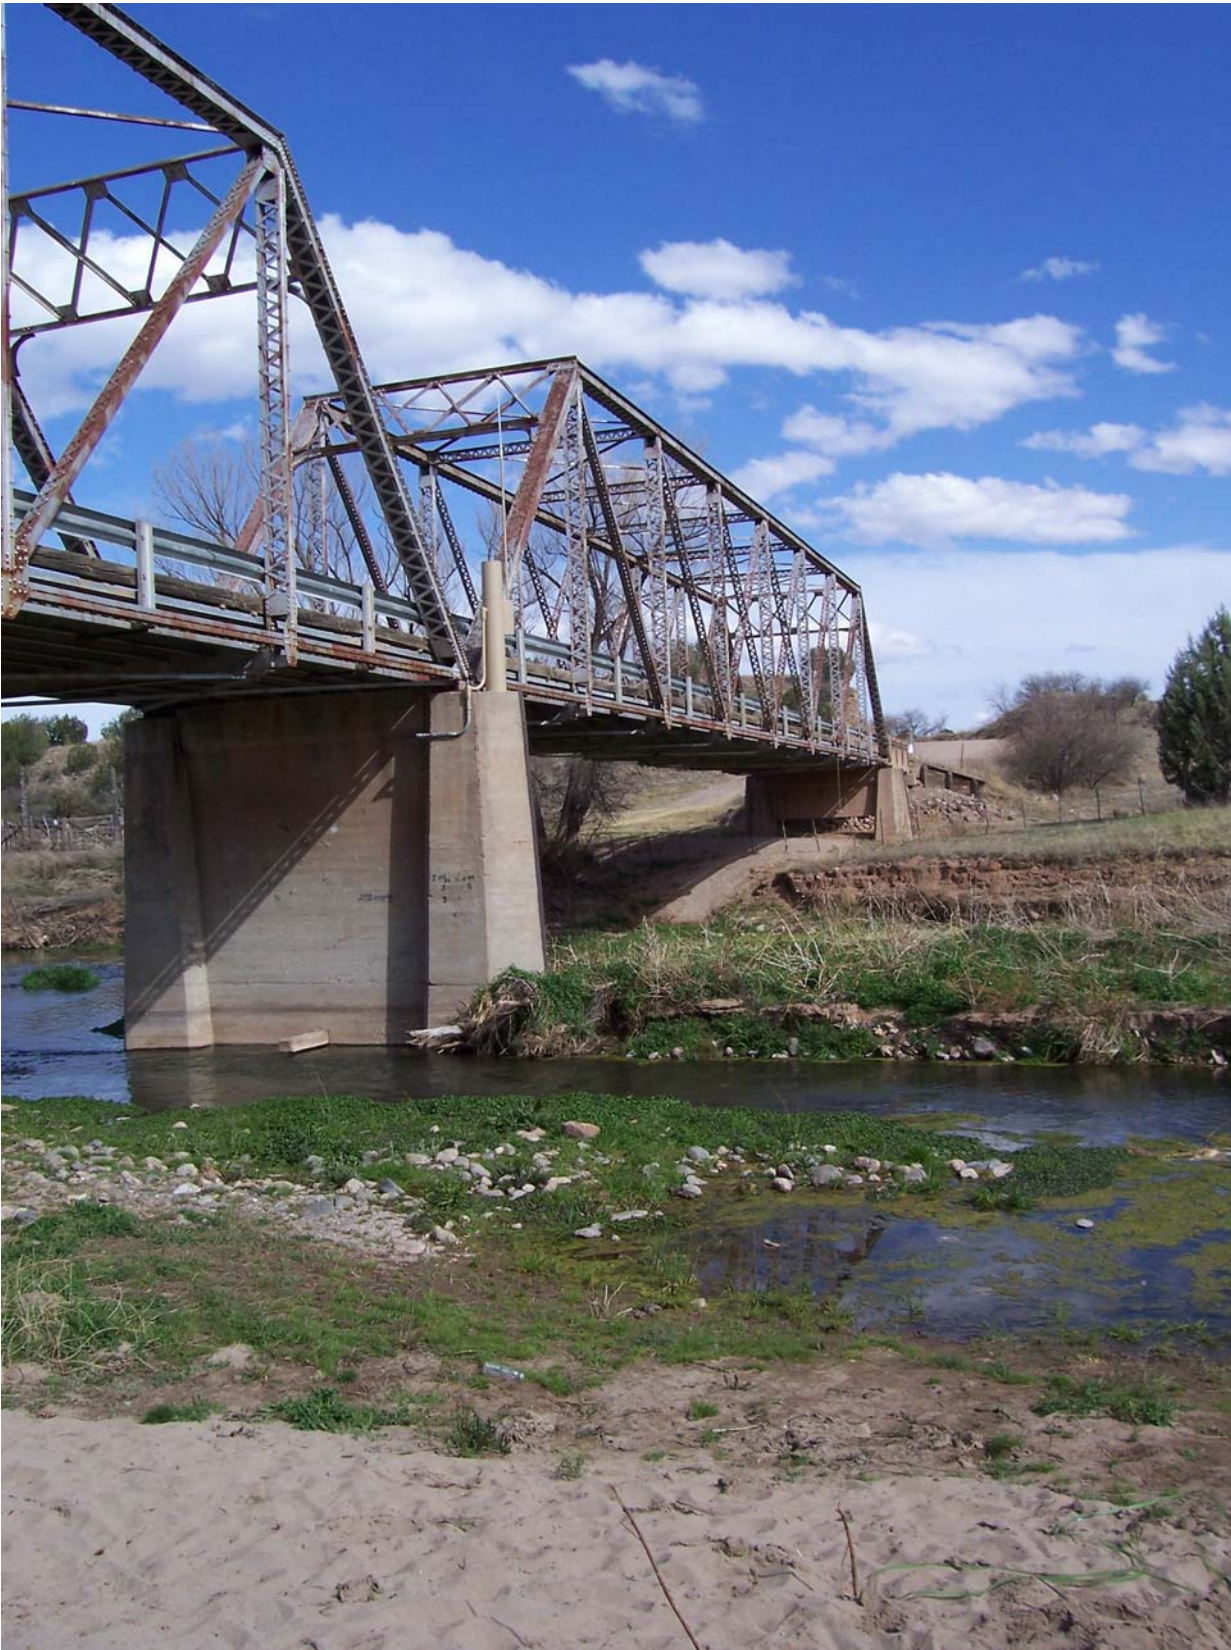
**Verde River:** ALERT gage near Perkinsville, AZ at bridge. This old bridge is approximately 400 feet long and 20 feet high. Flow at time of visit was approximately 25 cfs. Tentative Minor, Moderate, and Major Flood Stages were determined to be 6 feet, 8 feet, and 14 feet (assuming 0 flow is 0 stage). These values should be revisited upon obtaining a rating table and Hand Book 5 ID for this site.

Verde River near Perkinsville, looking towards right bank. Gage is on bridge support. Flow is approximately 25 cfs. Gage reading was 0.37 feet. 4/10/2006.

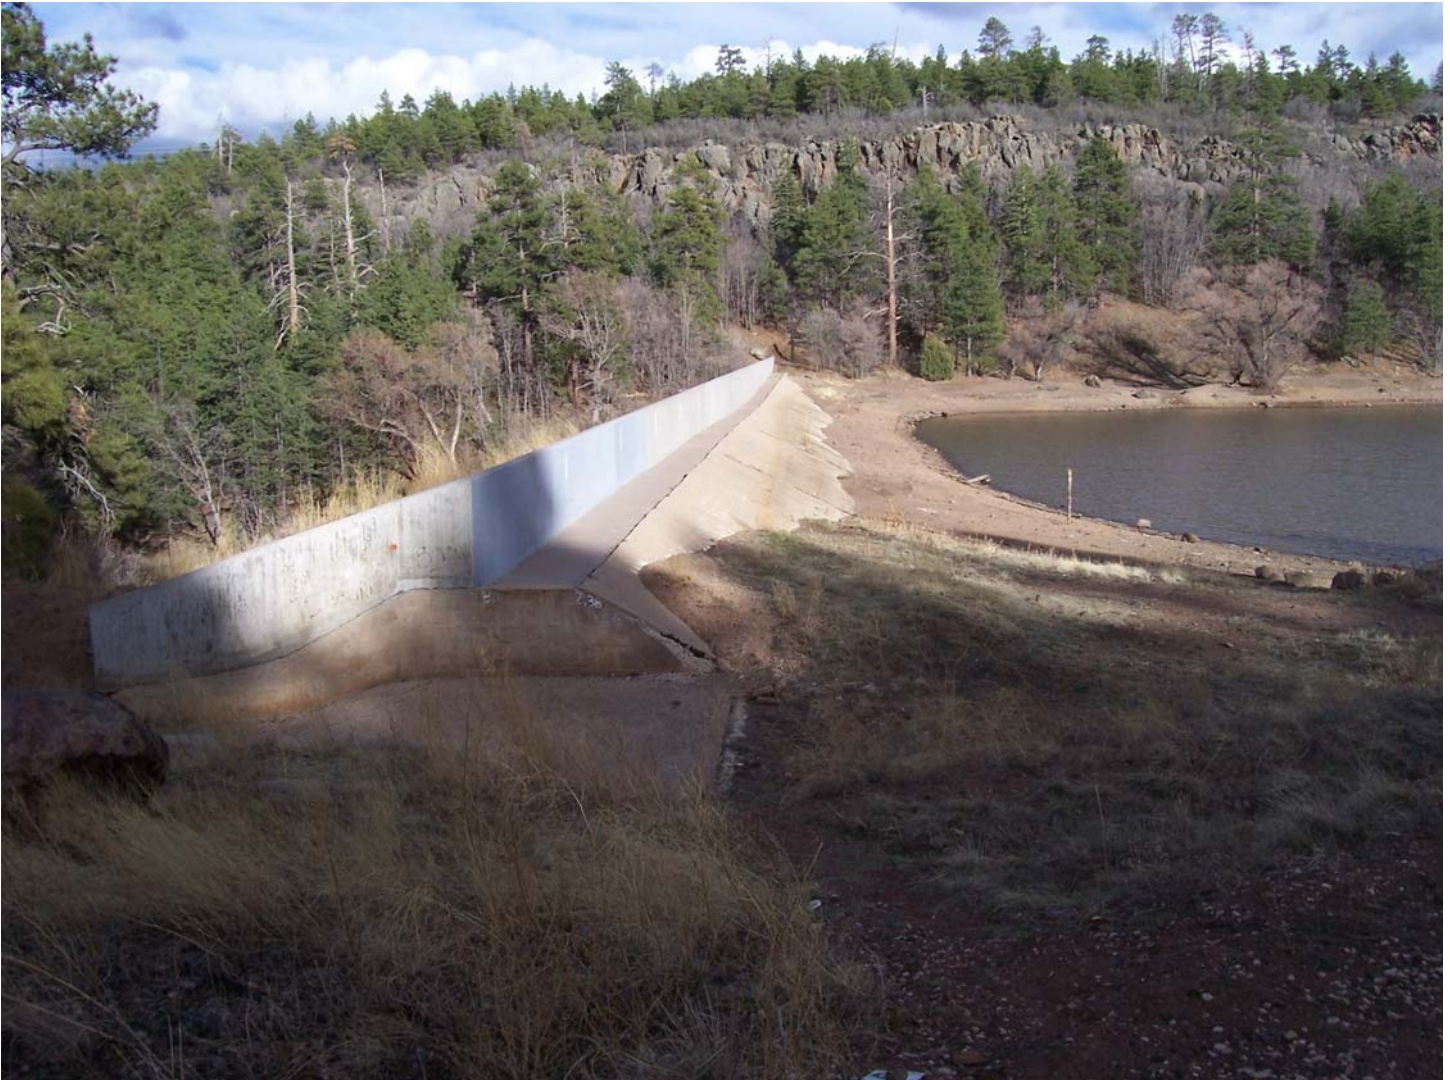
**City Dam:** This water supply dam for the City of Williams is considered unsafe and therefore, has remained essentially dewatered. The water level of the dam is monitored by an ALERT gage and current reading can be obtained from webpage: <http://hydrolynx.co.yavapai.az.us/reports.html?FN=level>. Water level at time of visit was 10.62 feet below datum (spillway).

City Dam looking at spillway and existing ponding behind dam. ALERT gage is located on far bank (right bank) and has no Hand Book 5 ID. 4/10/2006.

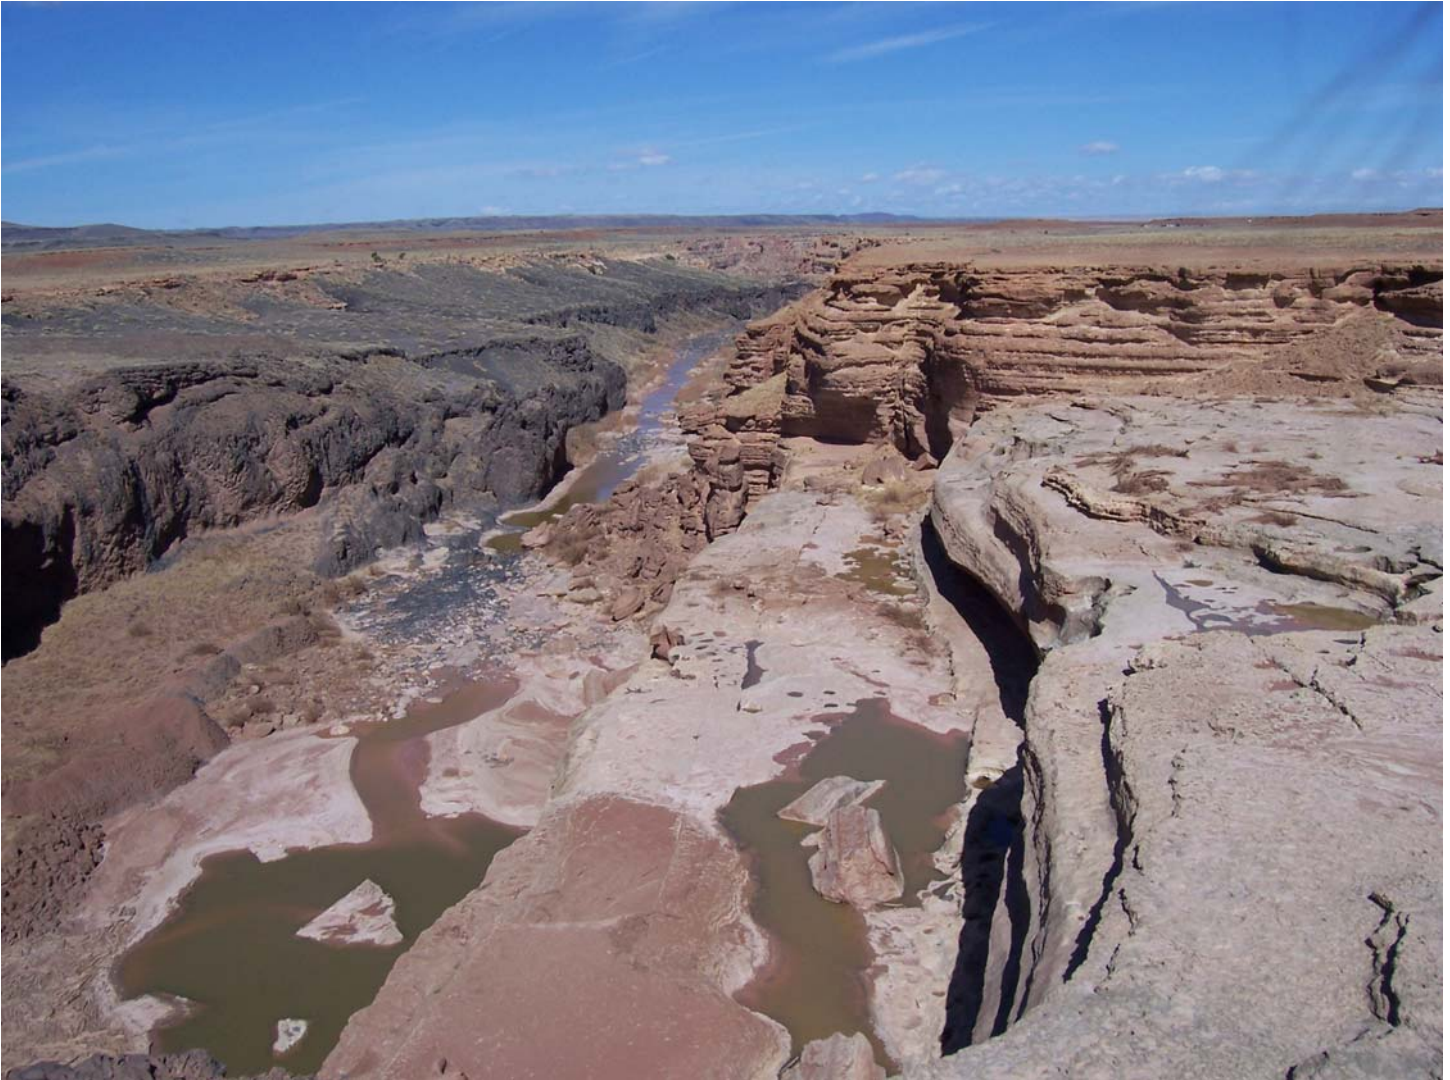
**Little Colorado:** The Grand Falls site was visited to evaluate the current Little Colorado River contribution to the local Lake Mead inflow (note: the Little Colorado River flows into the Colorado River below Lake Powell and upstream of the Grand Canyon). Flow at this site was 0 cfs. The upstream USGS gage, Little Colorado River near Winslow (LCWA3) was reporting 9.04 feet at 7.5 cfs. The downstream USGS gage, Little Colorado River near Cameron (LCCA3) was reporting 1.60 feet at 0.00 cfs. The Little Colorado River contribution to the local Lake Mead inflow for January 1 2006 to April 15 2006 has essentially been 0.0.

Grand Falls of the Little Colorado River looking from left bank to right bank. Flow was 0 cfs. When flowing, water would flow from right of picture to left of picture. Total drop is approximately 185 feet. Discontinued USGS gage located below falls (see next photo). 4/11/2006.

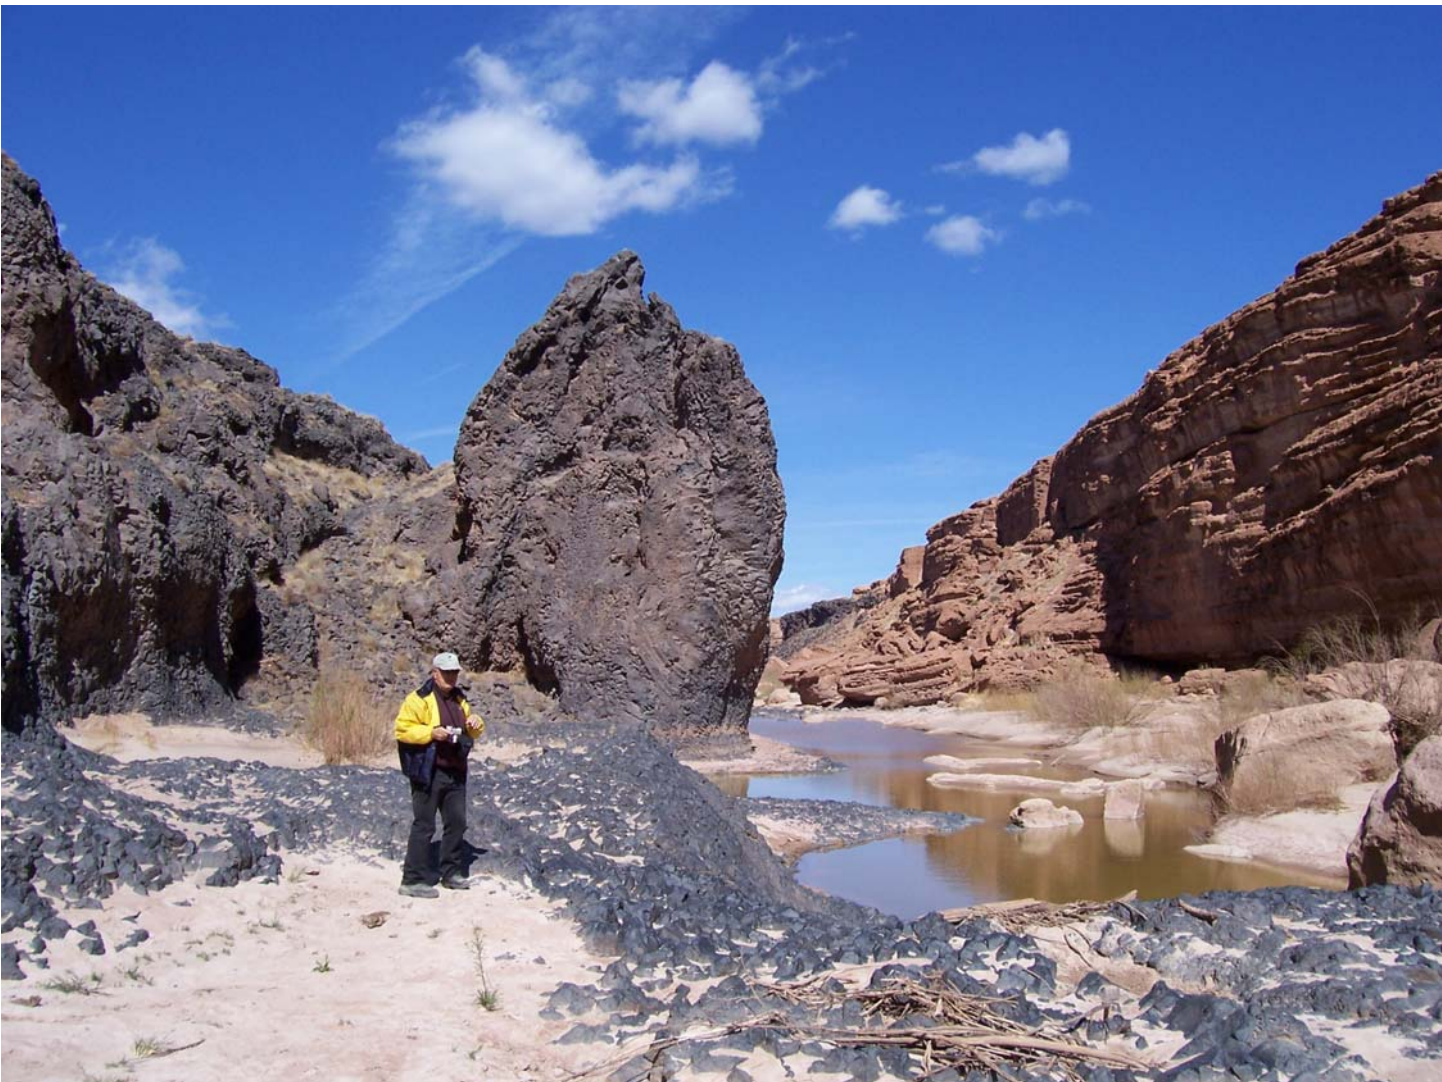
Below Grand Falls of the Little Colorado River, looking downstream. Discontinued USGS gage (LCGA3) is located behind glove shaped rock at center of photo. Water did not appear to be flowing. 4/11/2006.

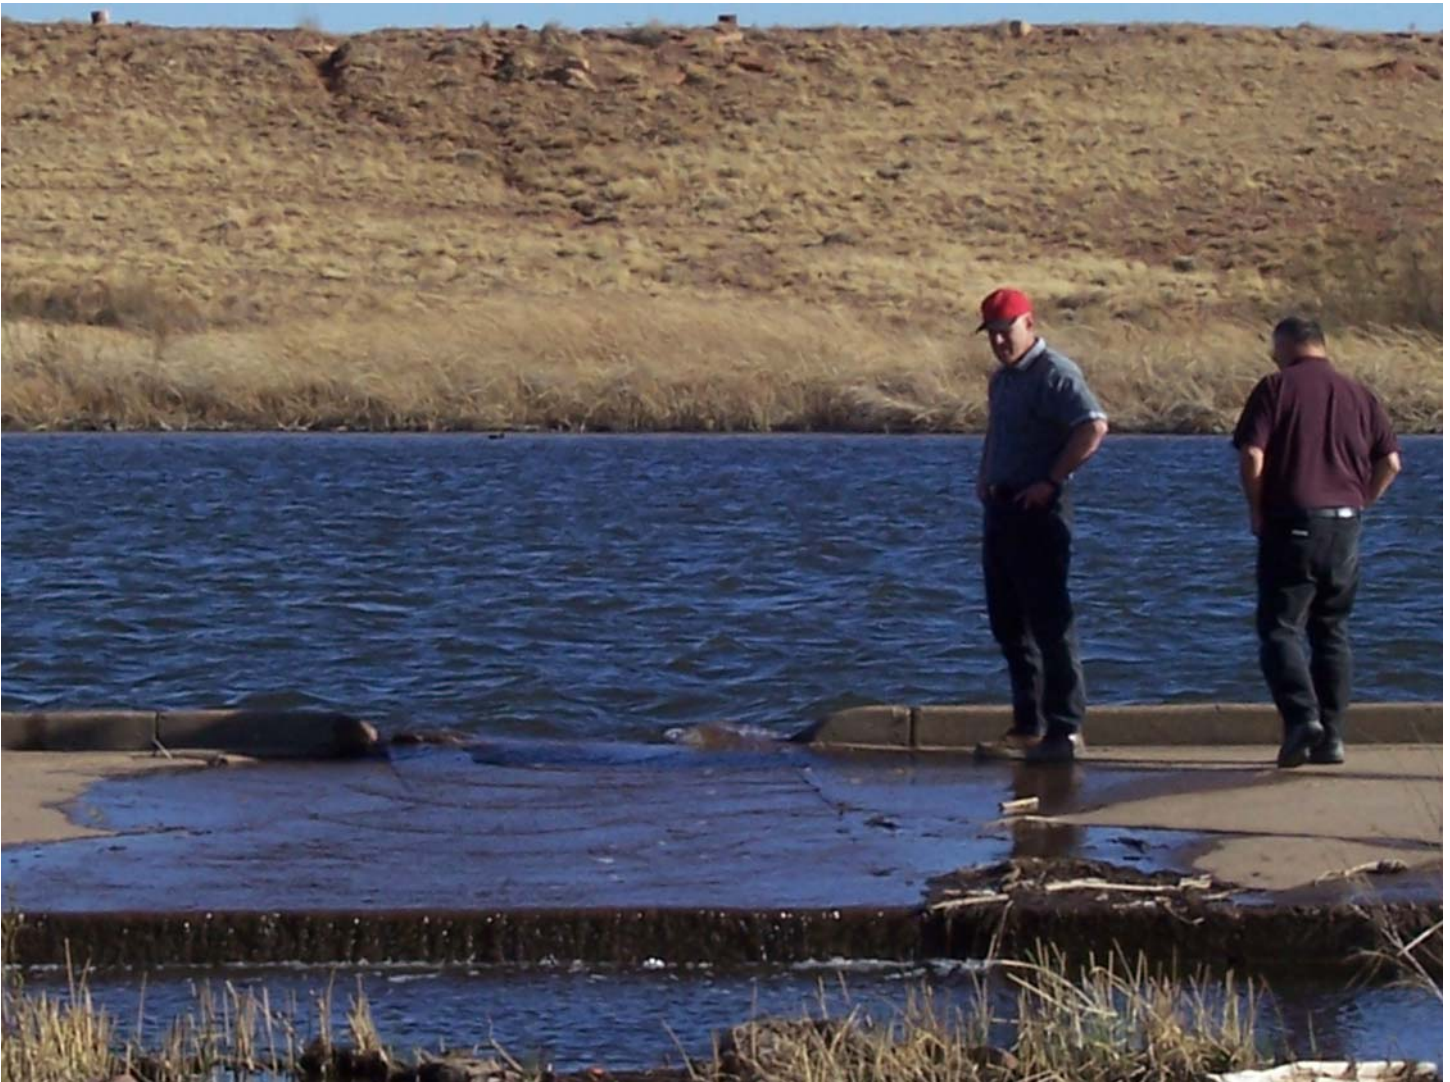
**Clear Creek:** The USGS gage (CCWA3) upstream of outlet was reporting 8.78 feet at 0.4 cfs. The new USGS gage downstream of outlet was reporting 1.92 feet at 4.5 cfs. The flow at the outlet was estimated to be 0.5 to 1.0 cfs. For water supply purposes the flow for April 1-15 2006 was estimated at 0.18 in thousands of acre-feet.

Outlet for Clear Creek Reservoir, a.k.a. McHood Lake, looking towards lake. Flow was 0.5 to 1.0 cfs. 4/11/2006.

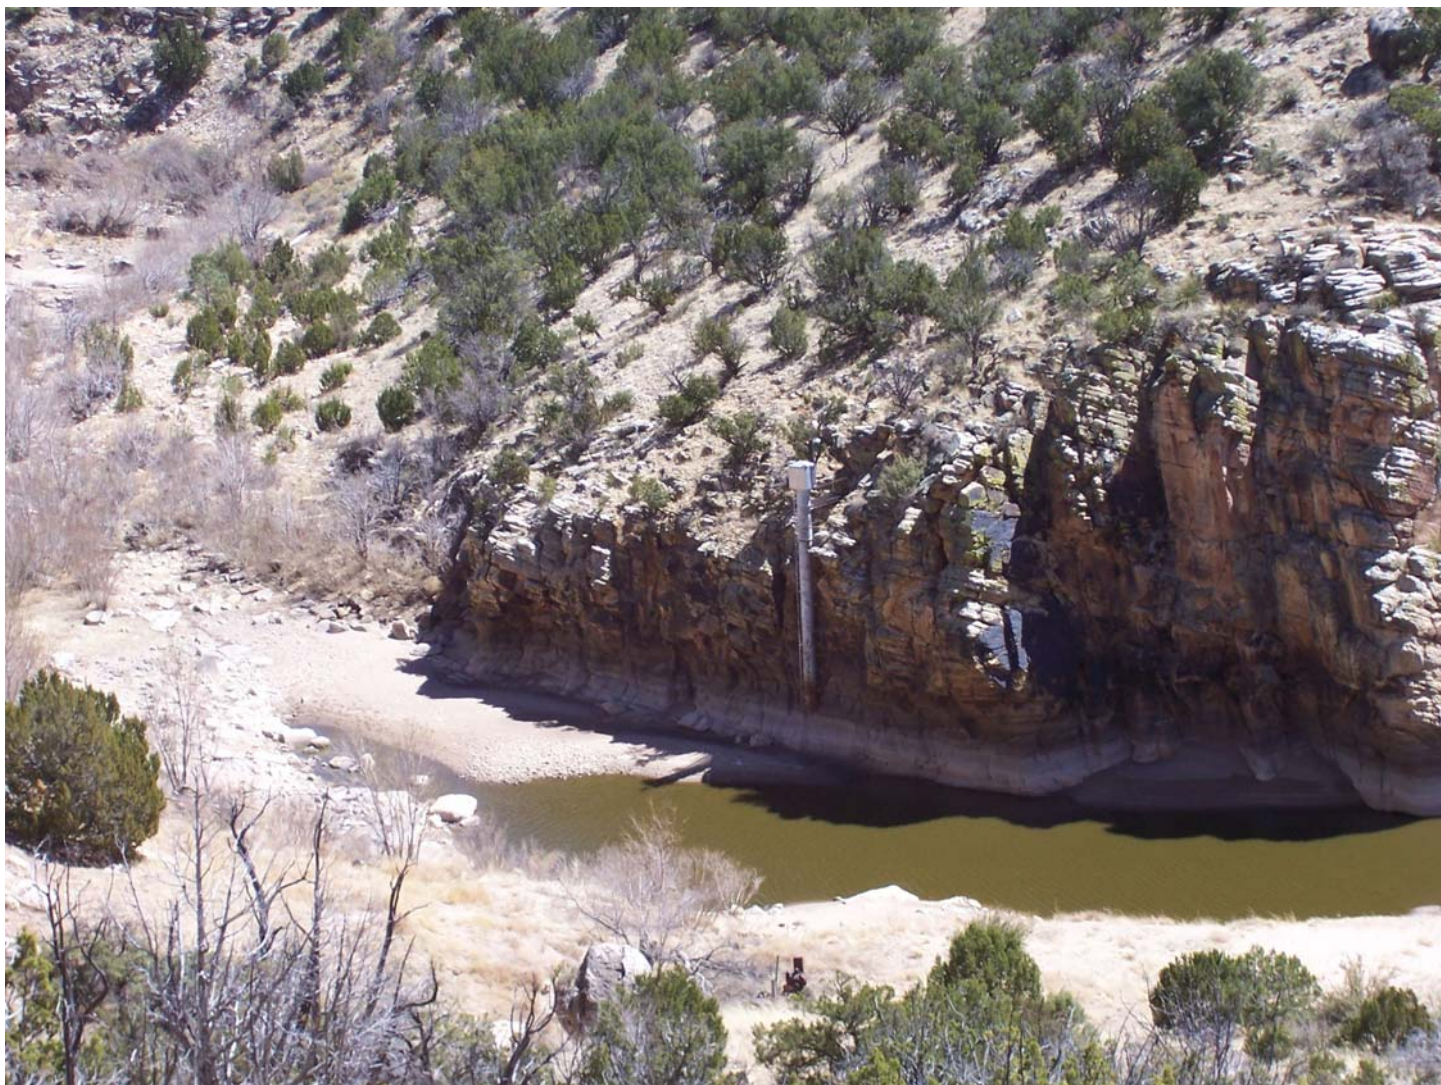
**Chevelon Fork:** This USGS gage (CHWA3) has been reporting 0 flow since 5/17/2005. The USGS road log for this site is a little bit tricky and includes such directions as “turn left at relatively large group of junipers” and “note car tire in Juniper tree.” However, without such directions this gage would be near impossible to find for someone other than a local. The gage is located on the right bank near the mouth of Wildcat Canyon. Currently, the gage bottom sits approximately 4.5 feet above water ponded in the scoured reach. Channel geometry is such that flow beyond the site will likely not occur until the in-channel-pond is filled to gage bottom. For water supply purposes the runoff at this site for January 1 2006 to April 15 2006 was estimated at 0.0. Minor, moderate, and major flood stages were determined to be 14 feet (9,500 cfs), 19 feet (20,000 cfs), and 21 feet (25,000 cfs). At this site bank full was determined to be 14 feet, the same stage as minor flood stage.

Chevelon Fork below Wildcat Canyon, near Winslow, AZ (CHWA3), looking towards right bank (downstream is near left edge of photo). Note upper most bathtub ring at 0 flow on canyon wall near gage. Flow is 0 cfs. 4/12/2006.

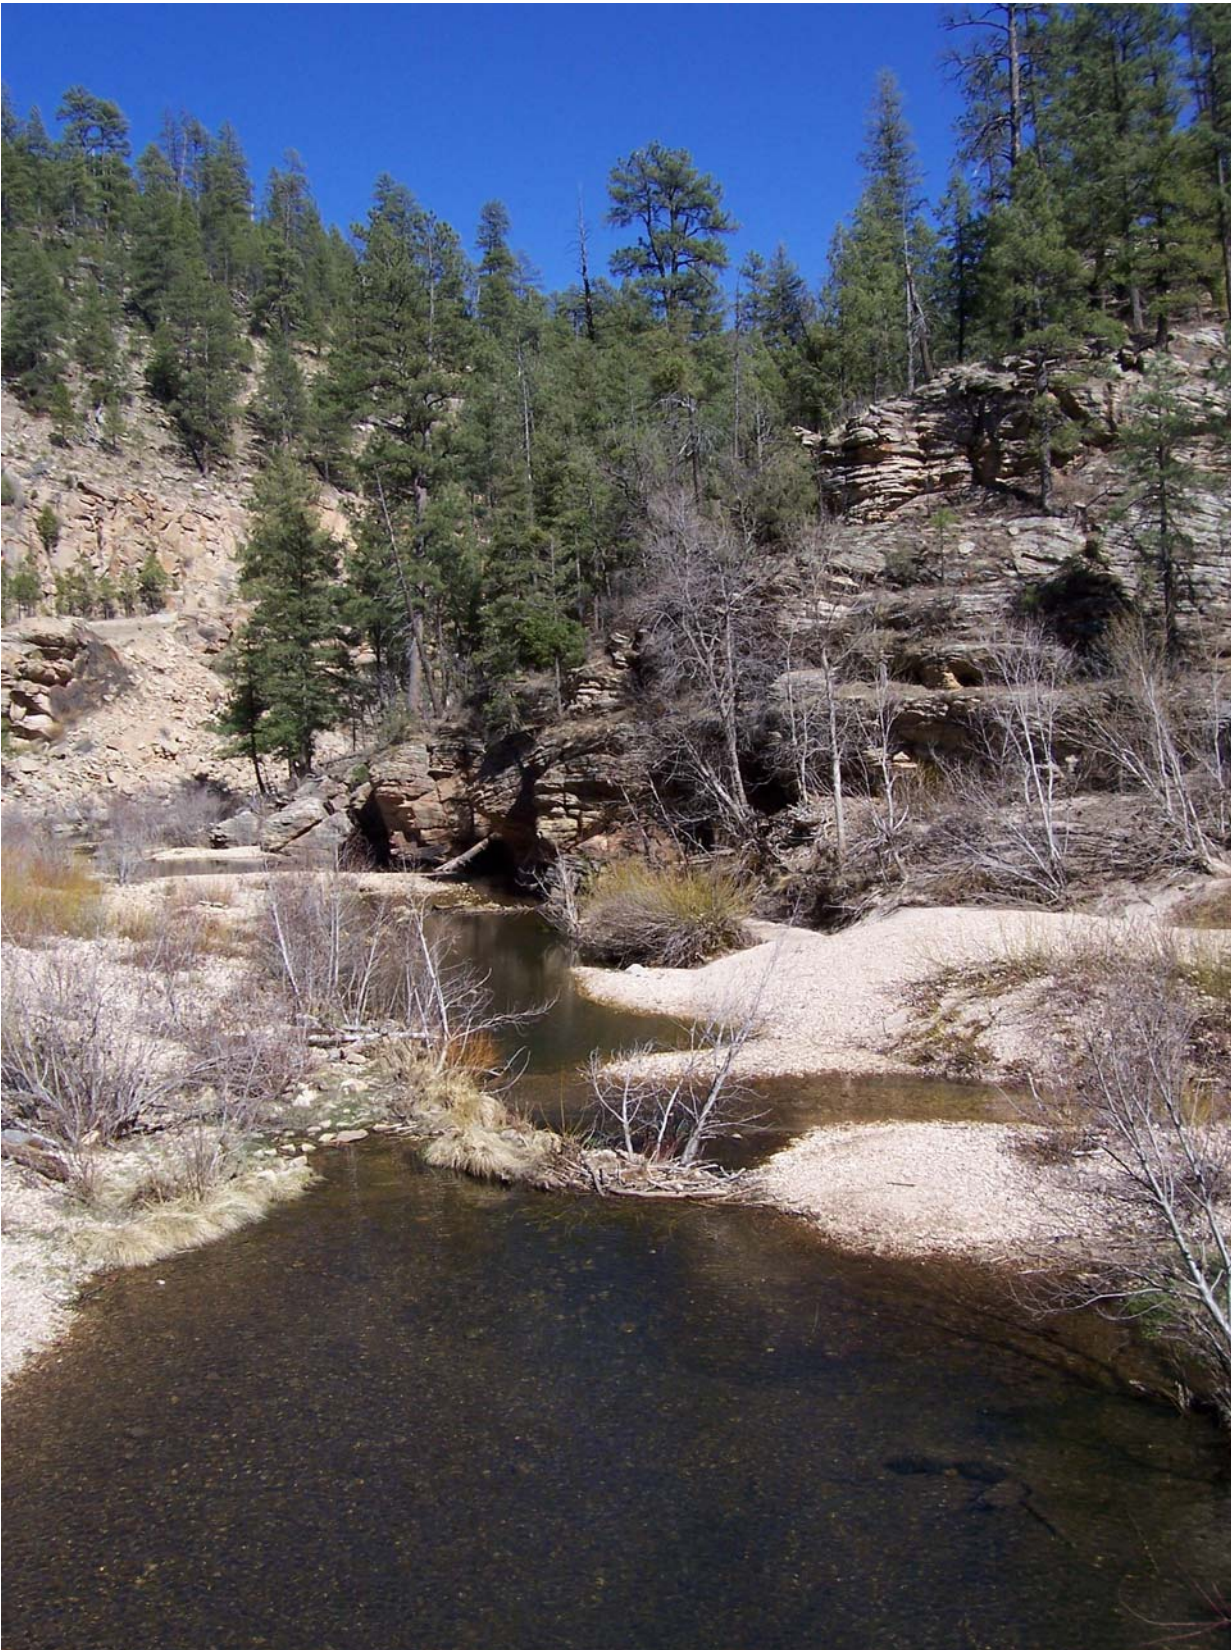
**East Clear Creek:** Since April 2005 the elevation of Blue Ridge Reservoir has been steadily decreasing from an elevation of 101 feet to an elevation of 84 feet. The spillway has not flowed since May 9, 2005. However, a small amount of water continues to be released from the base of the dam. Flow of East Clear Creek approximately 1.0 miles downstream of dam was estimated as 1 cfs.

East Clear Creek below one-lane bridge located approximately 1.0 miles downstream of Blue Ridge Reservoir, looking downstream. Flow in foreground was estimated at 1 cfs. Flow from tributary at right edge was estimated at 0.5 cfs. 4/12/2006

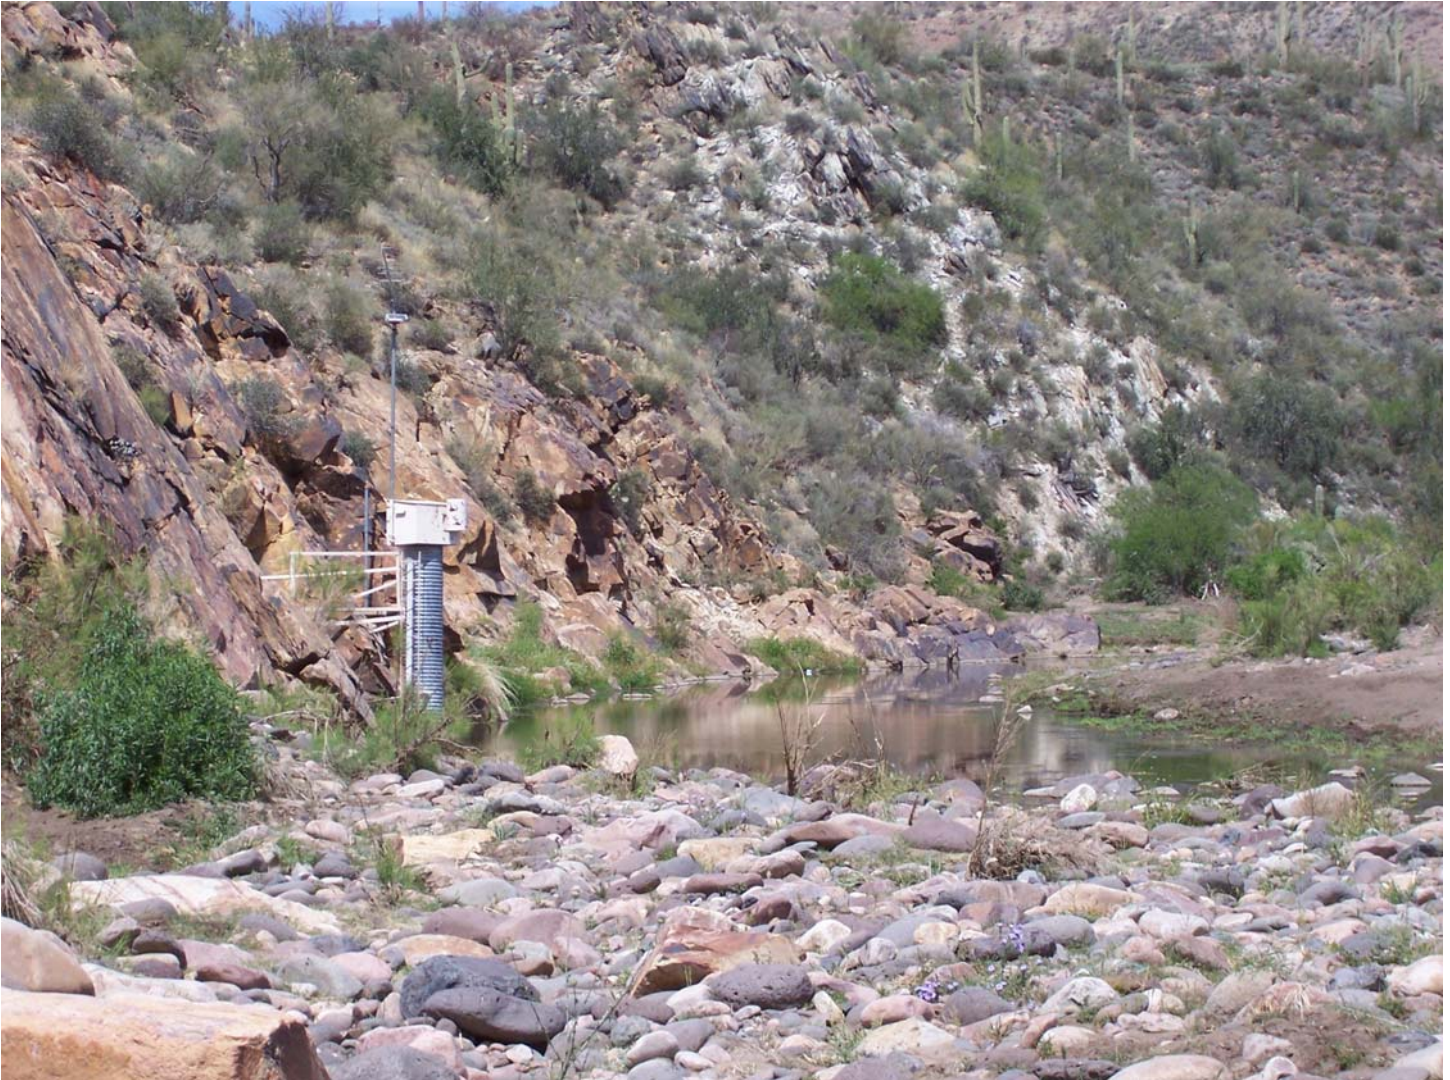
**New River:** The USGS gage, New River near Rock Springs, AZ (NWRA3) may be requested as a forecast point in the future. Flow at time of visit was reported as 0.2 cfs at 1.0 foot. Minor, moderate, and major flood stages were determined to be 10 feet (11,700 cfs), 12 feet (18,800 cfs), and 14 feet (28,000 cfs). At this site bank full was determined to be 8 feet.

New River near Rock Springs, AZ (NWRA3), looking upstream. 4/13/2006
